Service Bulletin

Service Bulletin # TS-0025: Load Guide Relocation

Condition: Potential for Load Guide Mounting Bracket to Break

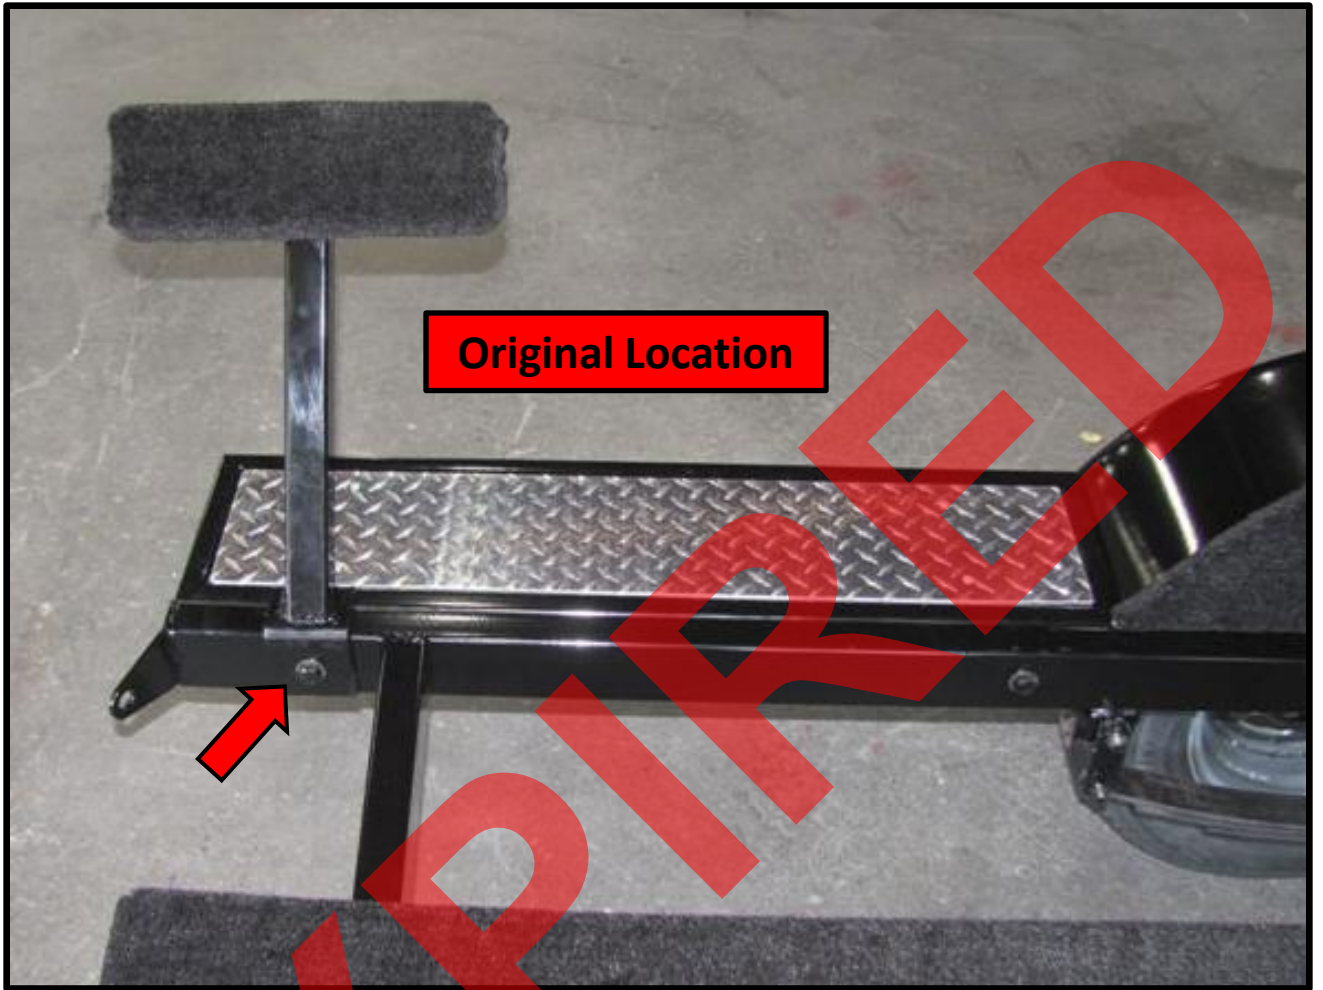
Figure 1

It has been determined that the load guides on the affected models manufactured between April 26, 2010 and September 1, 2011 have the potential to break at the bend in the mounting bracket due to vibration and resulting in metal fatigue if left in the rearmost mounting location as shown in Figure 1.

Corrective action for this condition is to inspect the load guides for evidence of metal fatigue or cracking and relocate from rear-most mounting position to forward position as shown in Figure 2. Replace any affected load guides with part #115426 (3") or part #115427 (4") load guide kits. The part number required will be determined by model and serial number of trailer as designated on the bill of material by a 3" or 4" component.

1. Remove load guide from rear step box hole.
2. Use the bolt, washers and nut from load guide to reassemble the rear portion of the box.
3. Apply these steps to both left and right sides.
