## SERVICE CAMPAIGN BULLETIN

**CAMPAIGN REF :** 008  
**TITLE :** Door latch replacement  
**DOCUMENT # :** 11 A 011

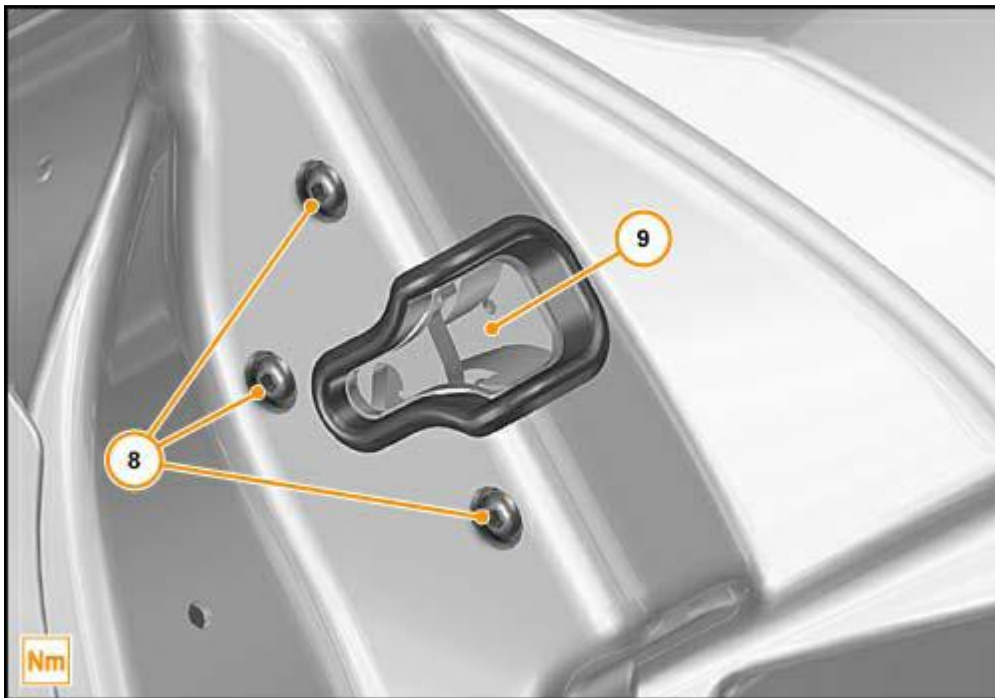
**SITUATION :** Quality Engineering at McLaren Automotive have identified that the existing door latches are susceptible to water ingress and therefore at significant risk of failure.

11. Remove bolts (8). M6 x 10 8 Nm

12. Remove door latch (9).

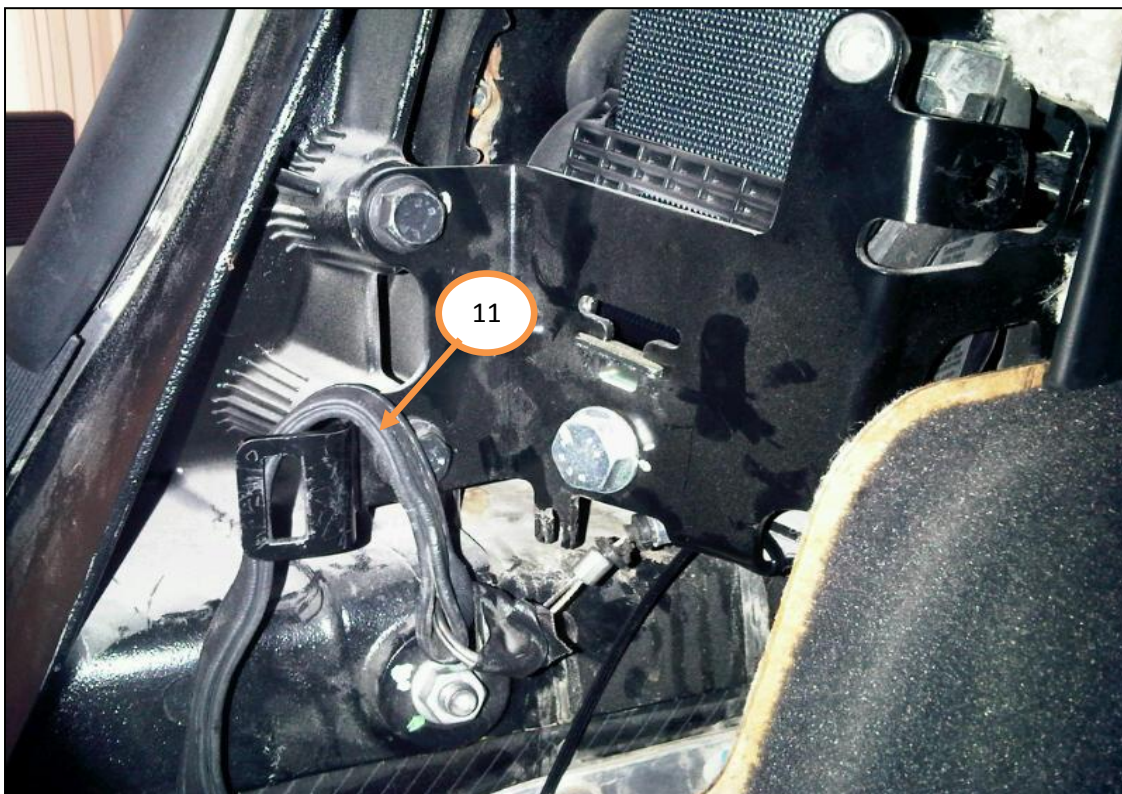
Below is an example of the incorrect routing (11).
