## SERVICE CAMPAIGN BULLETIN

CAMPAIGN REF : 010  
TITLE : Secondary latch re-work  
DOCUMENT # : 11 A 014

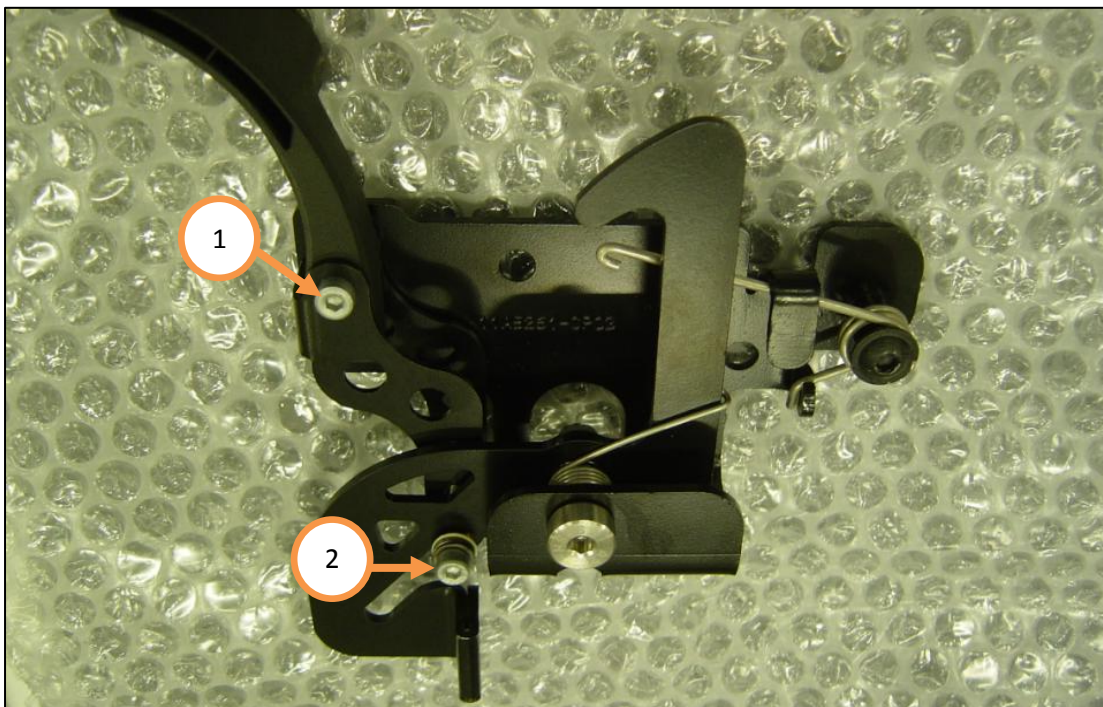
1. Over tightening of fixing (1) will result in the potential of the secondary latch failing. Free play should be present between the igus bush and link arm (2).
