## SERVICE CAMPAIGN BULLETIN

**CAMPAIGN REF:** 017

**TITLE :** Right hand driveshaft check

**AFFECTED VEHICLES :** 12C Coupe

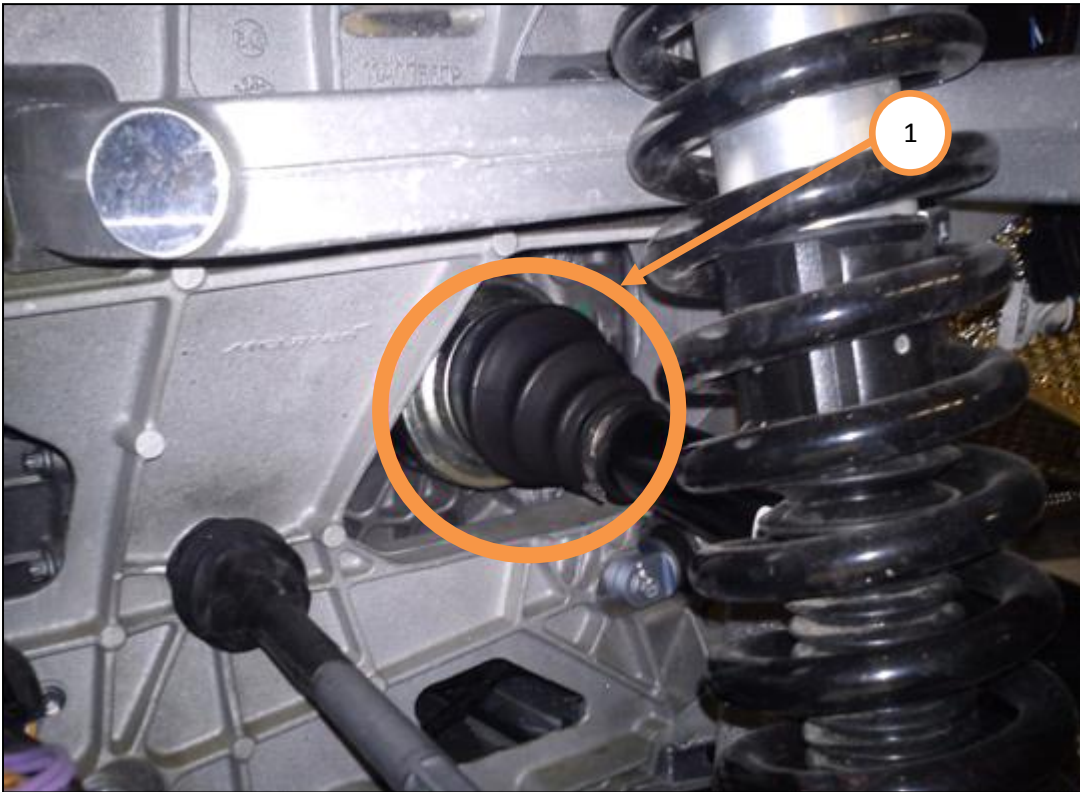
4. Check the right hand driveshaft (1) for excessive movement.

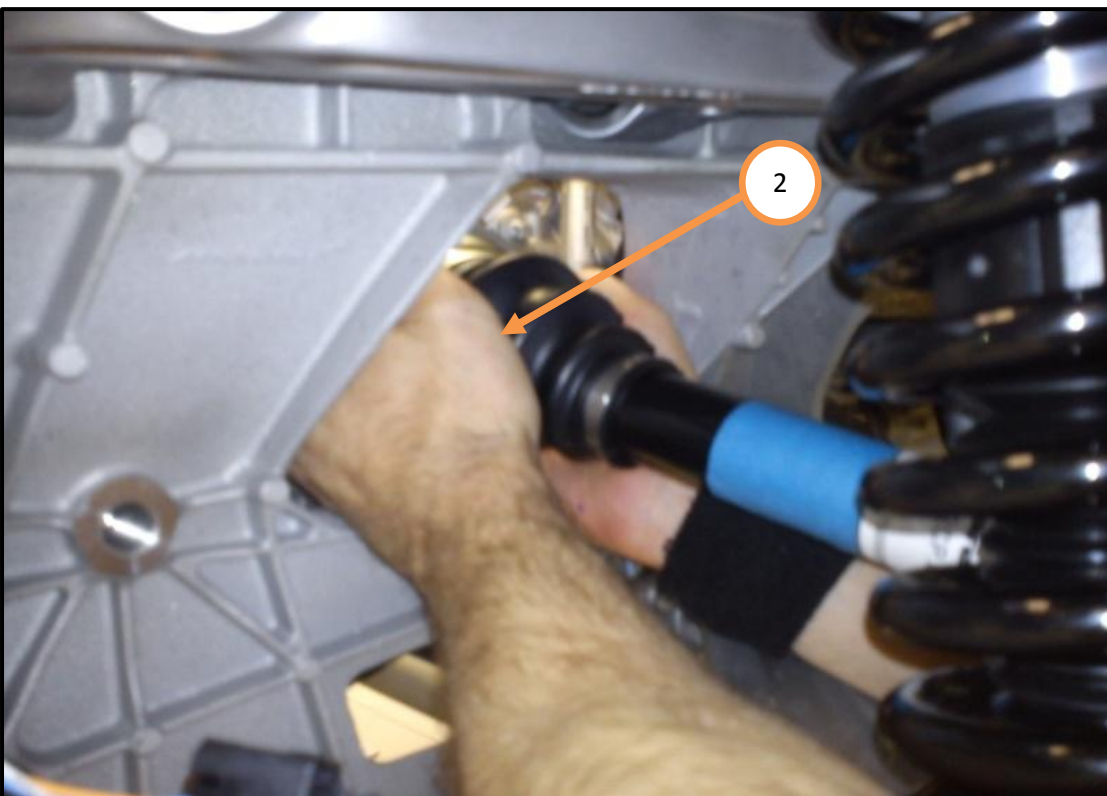
5. Using both hands work the driveshaft backwards and forwards and attempt to pull the driveshaft away from the dual clutch transmission.

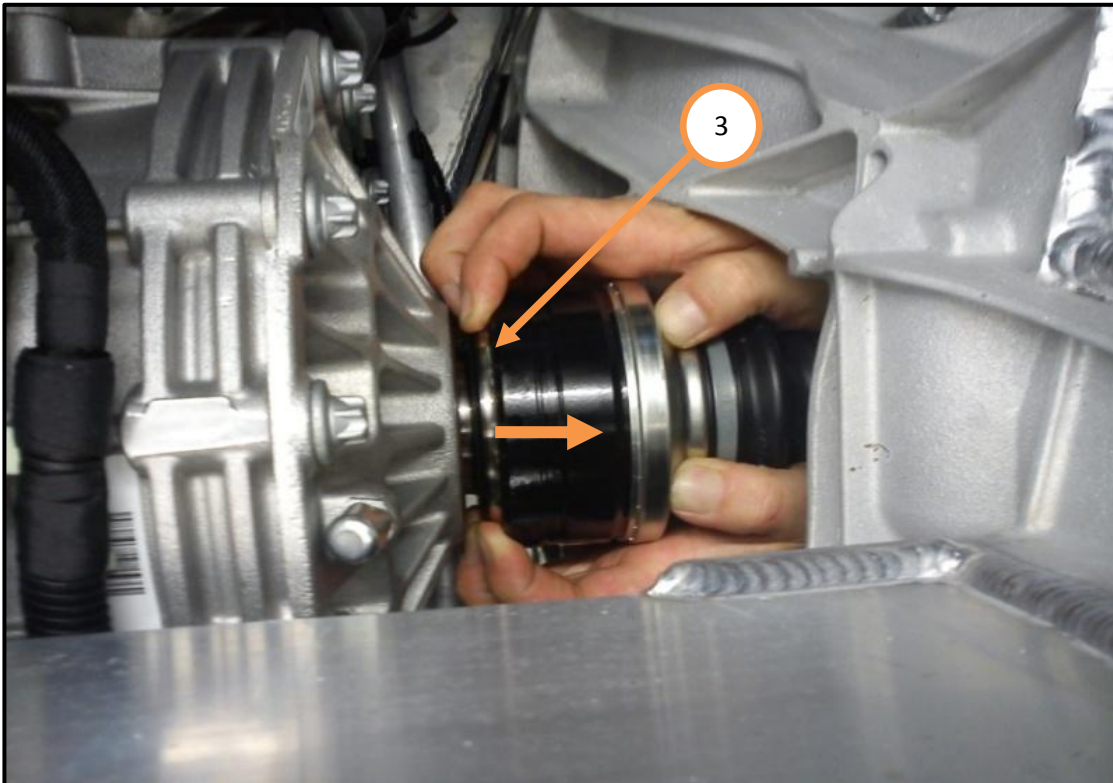
6. If moderate force is applied and the driveshaft does not come away from the dual clutch transmission (3), proceed to point 14.

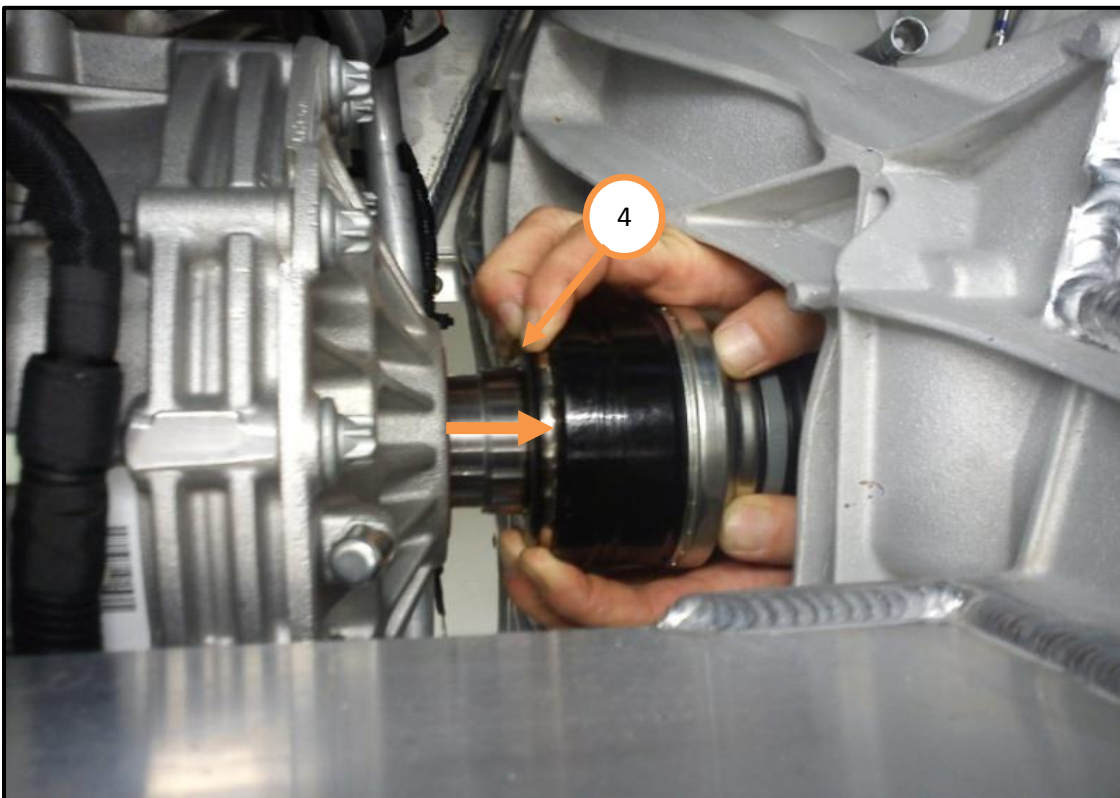
7. If the driveshaft comes away using moderate force (4) the driveshaft will have to be replaced following the instructions 8-14.
