## SERVICE CAMPAIGN BULLETIN

**CAMPAIGN REF :** 011

**TITLE :** Software platform release

**DOCUMENT # :** 11 M 019

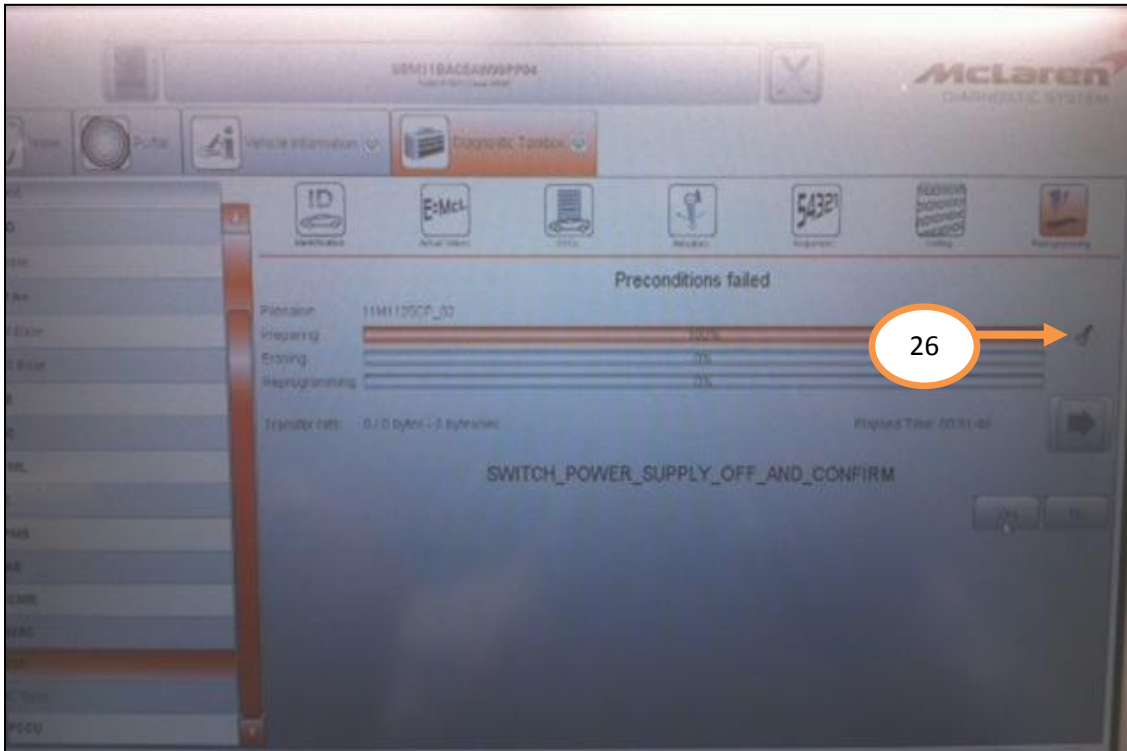
13. If the download is successful proceed to point 16. After the preparation phase of the download the system **may** inform the operator that the “Preconditions failed”. In this circumstance the ESP control unit will require a power cycle (26).

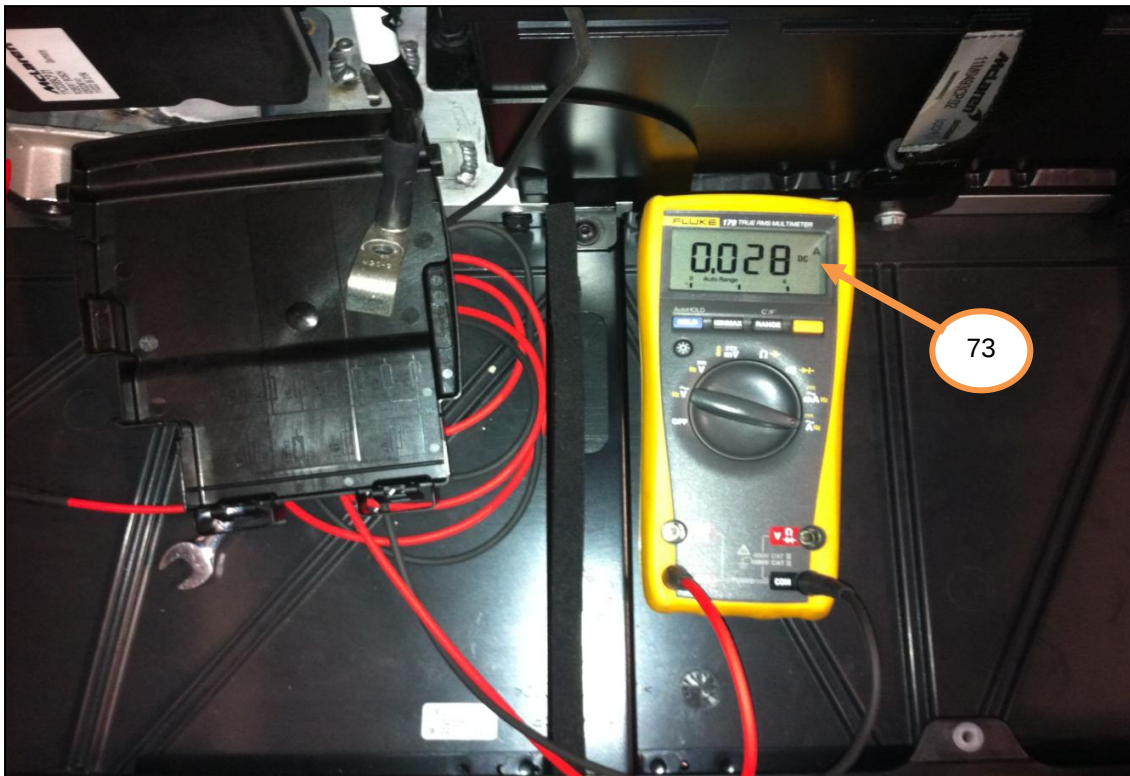
54. Read multi-meter display (73). If the value is consistently over 50 mA contact your Regional Aftersales Manager.
