## SERVICE CAMPAIGN BULLETIN

**CAMPAIGN REF :** 013  
**TITLE :** Software update  
**DOCUMENT # :** 11 M 021  
**AFFECTED VEHICLES :** 12C Coupe

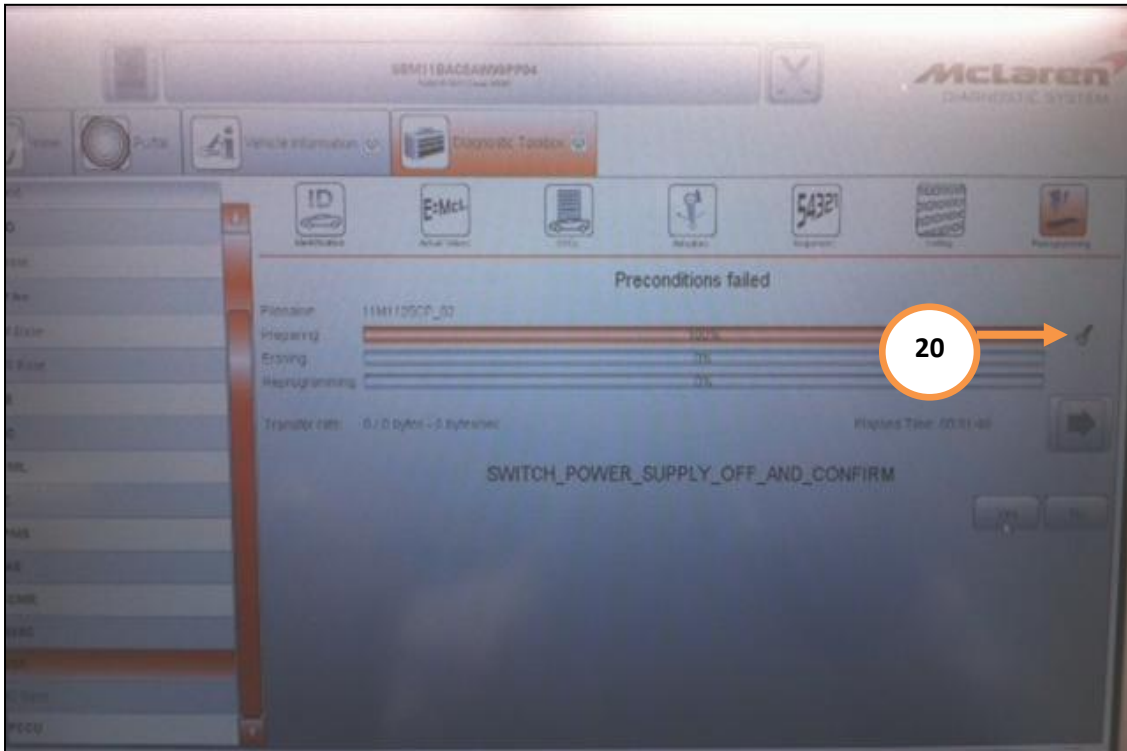
10. If the download is successful proceed to point 13. After the preparation phase of the download the system **may** inform the operator that the “Preconditions failed”. In this circumstance the ESP control unit will require a power cycle (20).
