## SERVICE CAMPAIGN BULLETIN

CAMPAIGN REF : 018  
TITLE : Electric seat rework  
DOCUMENT # : 11 N 002  
AFFECTED VEHICLES : 12C Coupe

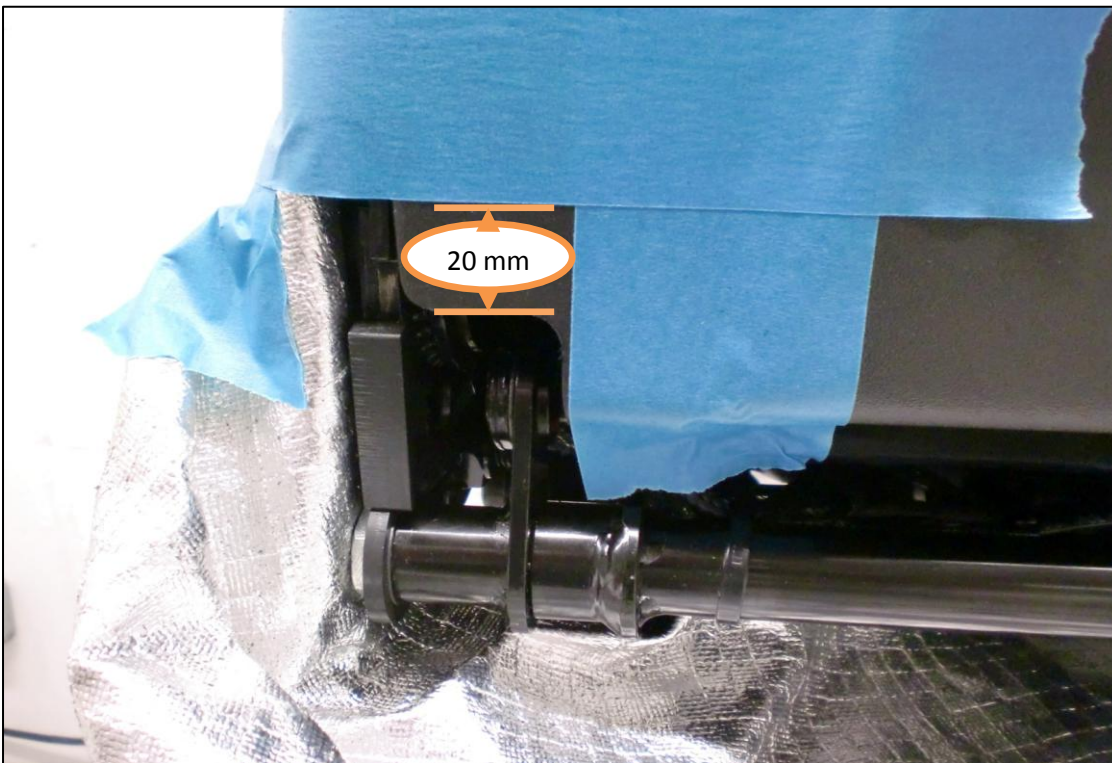
4. Mark out seat back area as shown below:

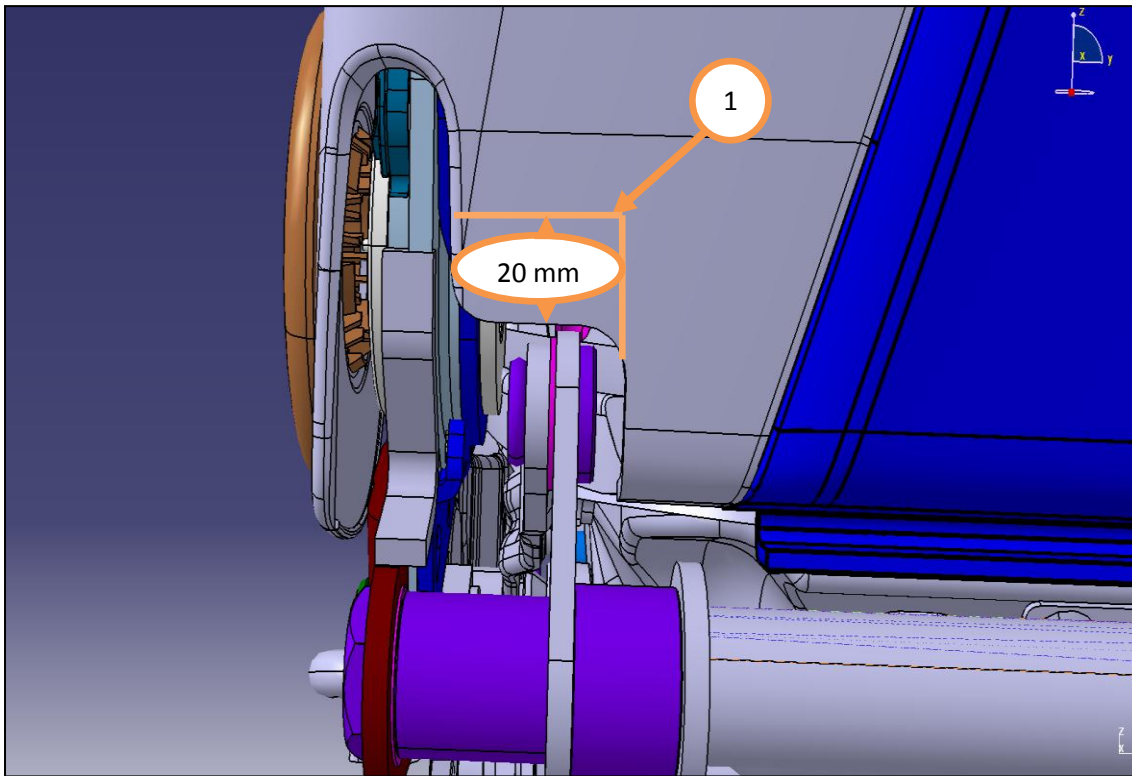
5. Cut away 20 mm of seat back plastic (1).

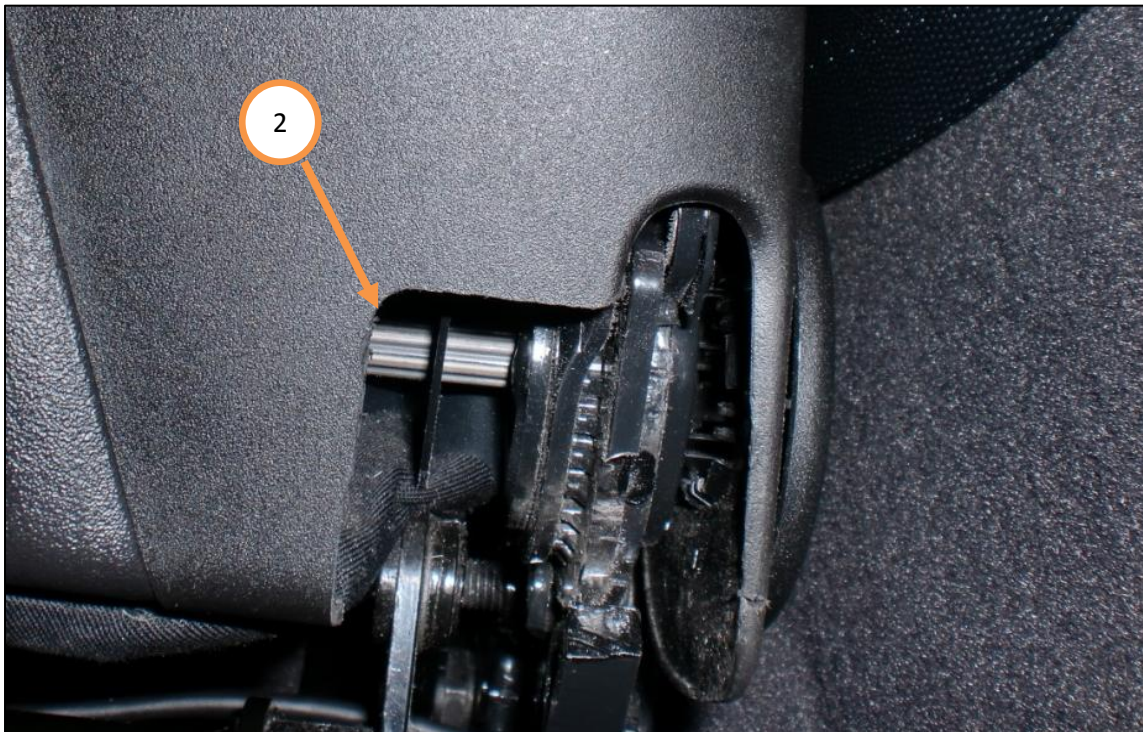
6. Ensure the sharp corners are rounded off, leaving no sharp edges (2).

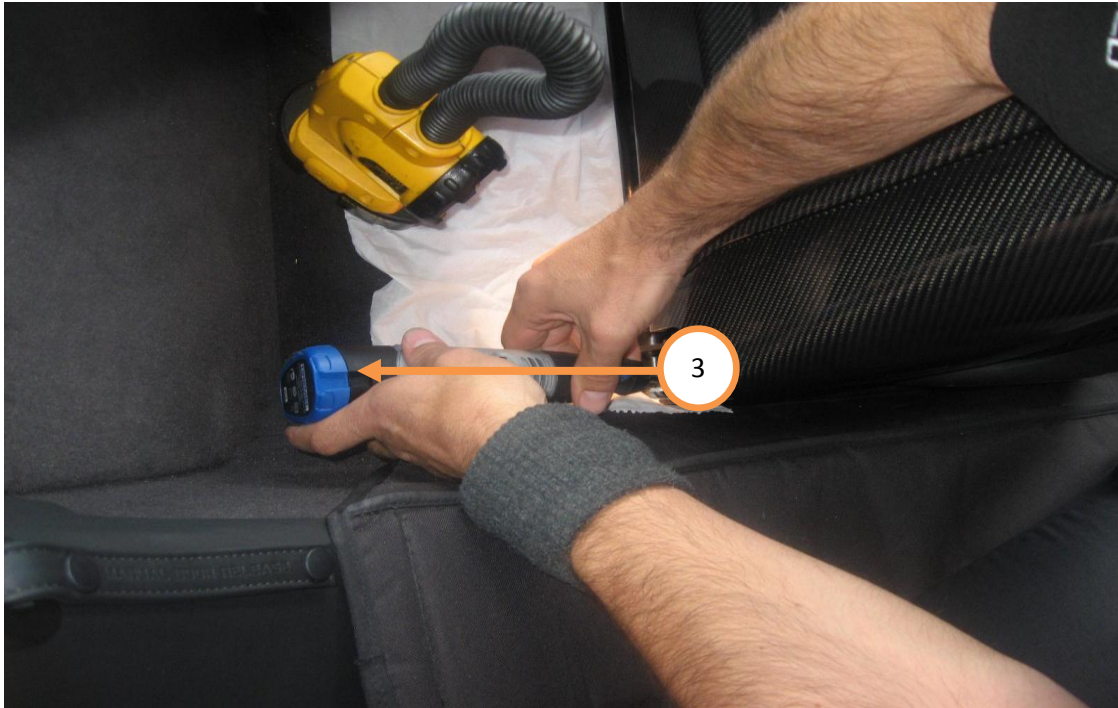
**Care point:** McLaren Automotive Recommend the use of a Dremel tool (3) to cut away the top section of the lower back stop.

**Care point:** Sparks will be produced when cutting the top section of the lower back stop. McLaren Automotive recommend placing heat resistant protection around the area.

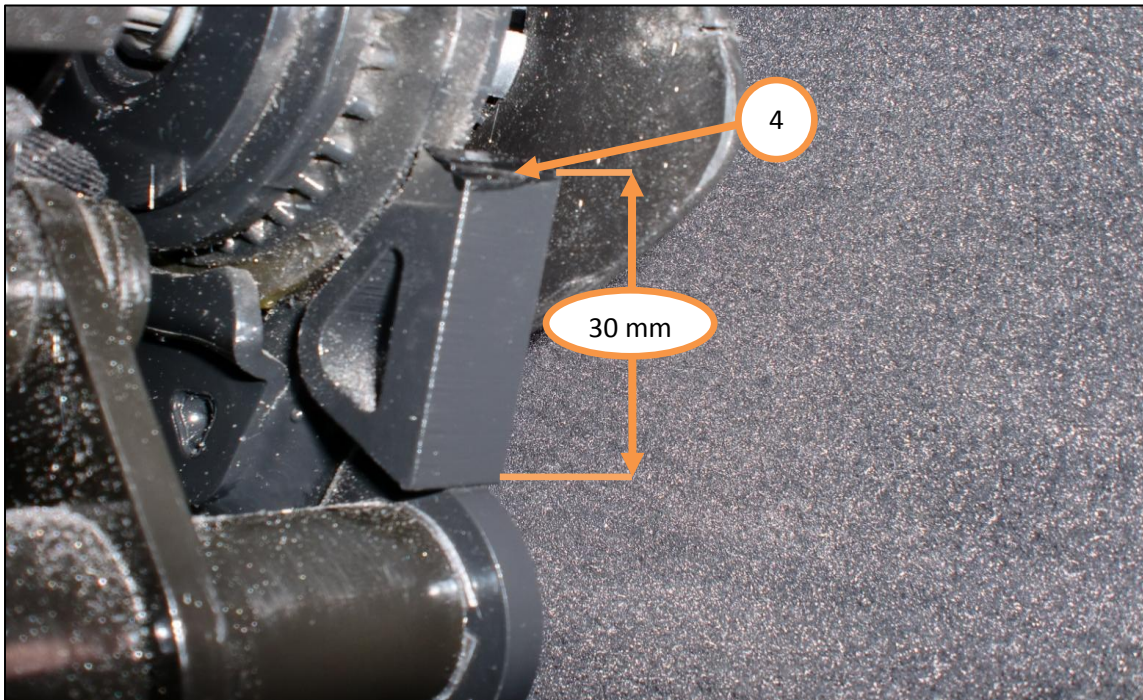
7. Cut away the top section of the lower back stop leaving 30 mm remaining (4).

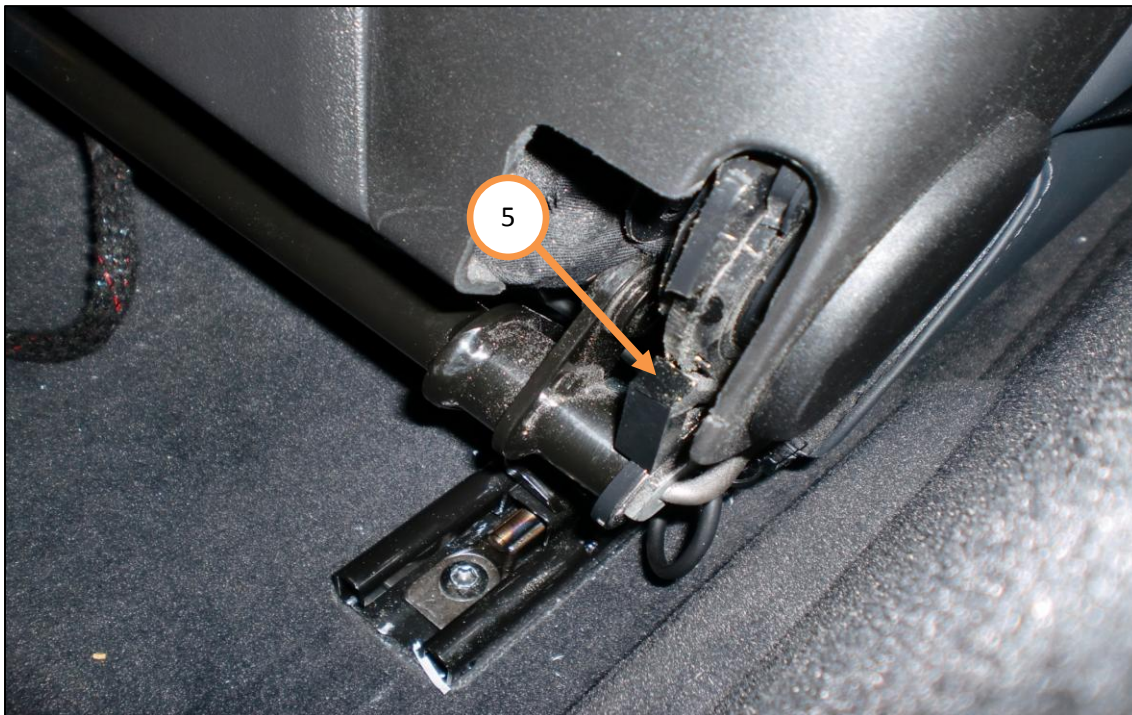
8. Clean away metal and plastic filings from the mechanism and paint the exposed metal (5).

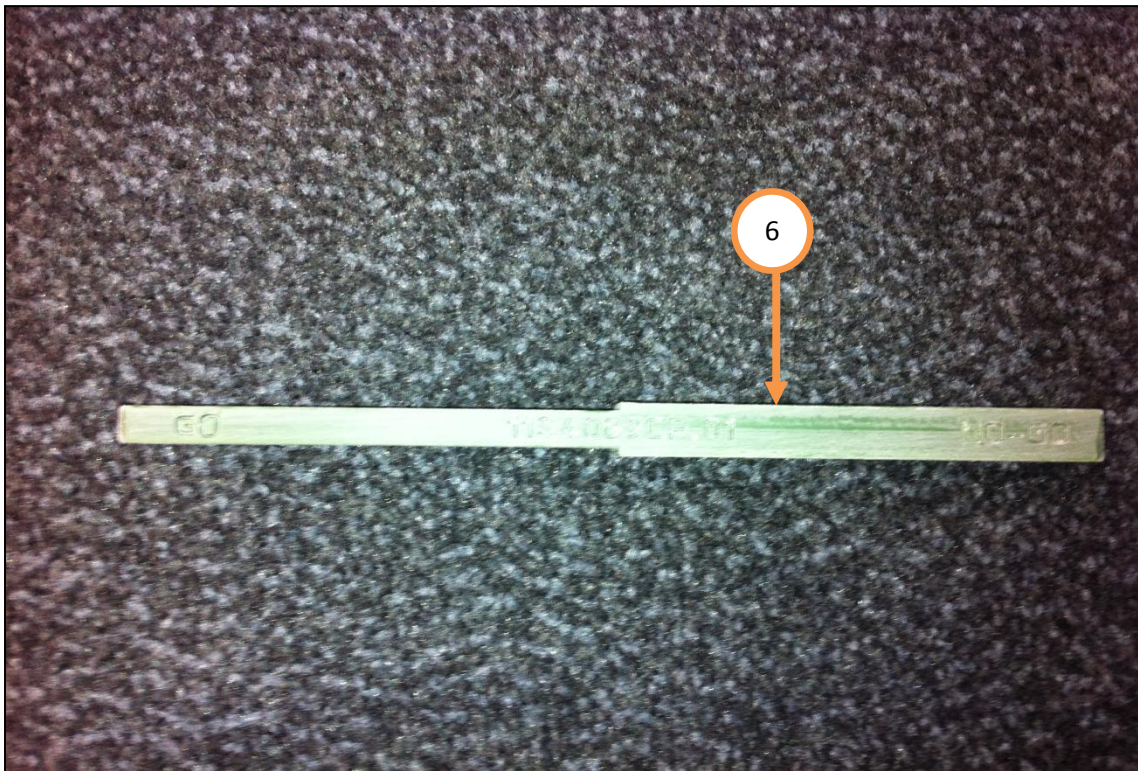
**Care point:** A seat calibration gauge (6) will be free issued in order to perform the below seat calibration process on affected vehicles.

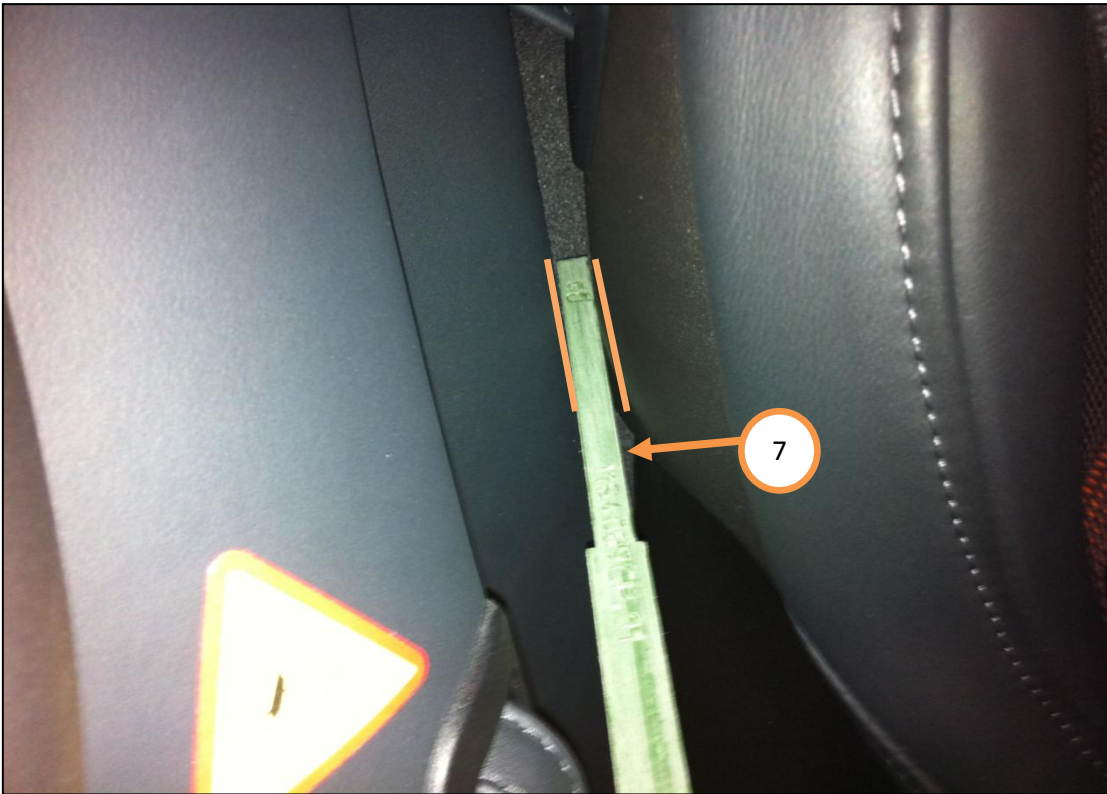
17. Adjust the backrest angle until the desired gap between seatback and B-Pillar has been achieved using the seat calibration gauge. The gap **must not** be narrower than the end of the calibration tool (7). The tool should move freely between the seatback and the B-Pillar

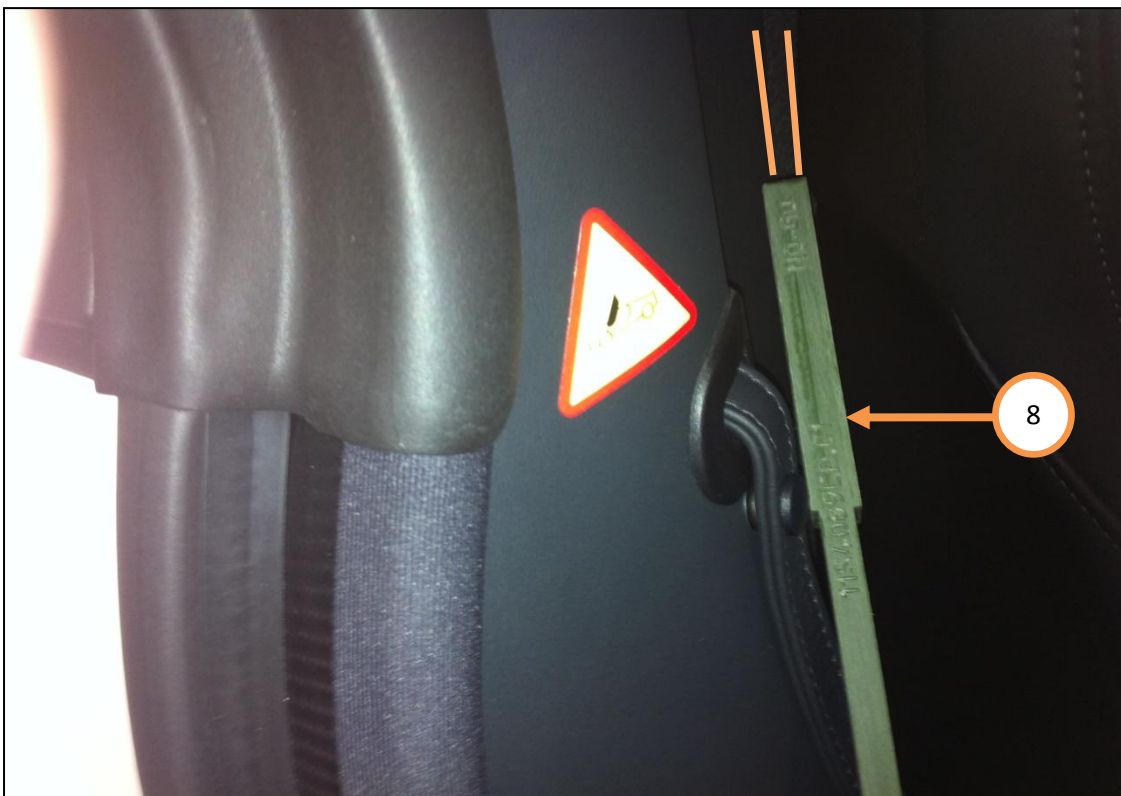
18. The gap **must not** be wider than the wide end of the seat gauge (8). If the seat is in the correct position the tool should not be able to fit between the seatback and B-Pillar.
