## Mounting bolt of HV connection to HV battery broken during installation

| Topic number | LI54.10-P-049523 |
| Validity | Models 221.095 and 221.195 (HYBRID) |

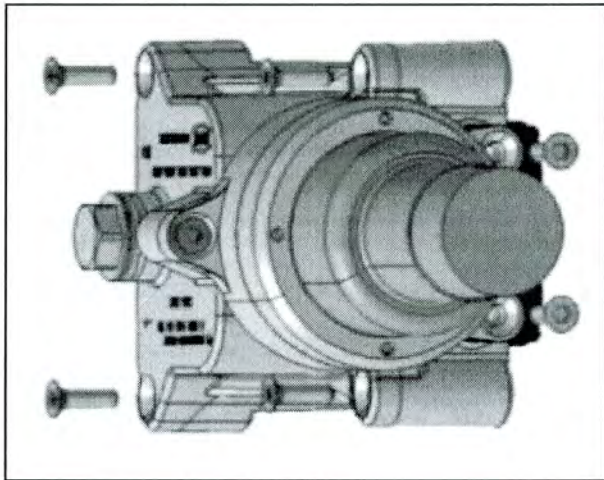
| File | Designation |
|---|---|
| HV Stecker 1_2.JPG | Unscrew bolted connection of connector housing (6 bolts) - Attachment 1 |

The mounting bolt at the HV connection to the HV battery shears off when retightened.

Excessive stress on mounting bolt due to failure to comply with tightening torque of 5 Nm.

1. Perform power disconnect - AR54.10-P-1150SXH.
2. Unplug HV connector.
3. Unscrew HV connection. To do this, unscrew the six mounting bolts (T10 Torx socket) of the housing (see attachment 1).
4. Remove housing cover.
5. Remove retaining ring of bolt.
