## Cracking noises at the front seats when operating the height adjustment

| Topic number | LI91.10-P-051831 |
| Design group | 91.10 Front seats |
| Validity | MODEL 220.### ## up to 264959 |

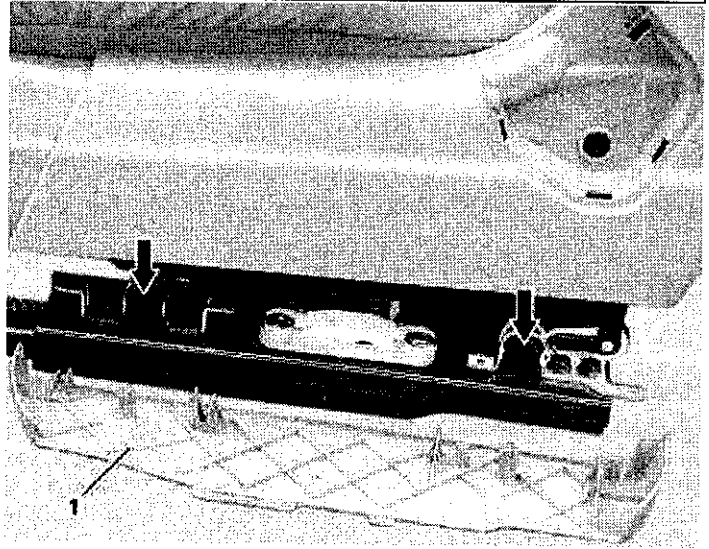
P91.10-2483-11.jpg:

Cracking noises at the front seats when operating the height adjustment.

Cracking noises when operating the height adjustment.

| Attachments | |
|---|---|
| P91.10-2483-11.jpg | 1 Plastic cover |

- 1 Move front seat height adjustment upwards.
- 2 Detach plastic cover (1) from seat.
- 3 Grease tubular frame with lubricant at the mounting hole for the plastic cover (1) on the inside.
- 4 Reattach plastic cover (1) to seat.
