**Oil leakage in M156/M159**

| Topic number | LI01.40-P-051897 |
| Design group | 01.40 Crankcase, timing case cover, end cover |
| Validity | M156/M159 |

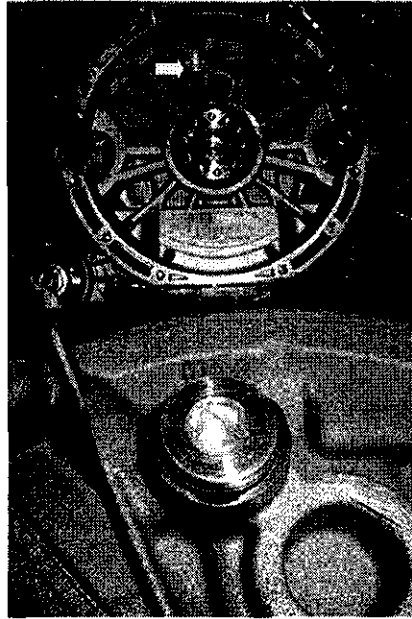
3.jpg:

1. Crankshaft sealing ring
2. Crankcase bedplate porous
3. Core hole bolt of pressure oil duct leaking
4. Porosity in vicinity of oil drain screw on timing case cover of M159

| Attachments | |
|---|---|
| 3.jpg | Crankcase pressure oil duct bolt |

- Re. 1. Carefully remove crankshaft Simmerring seal and check ventilation bore for free passage (see attachment)
- Re. 2. Clean crankcase, spray with talcum powder and check seal. Replace crankcase if necessary.
- Re. 3. Unscrew bolt; the thread may be slightly damaged. Install steel bolt and tighten to tightening torque of 45 Nm +/- 4 Nm.

If still leaking, replace crankcase.

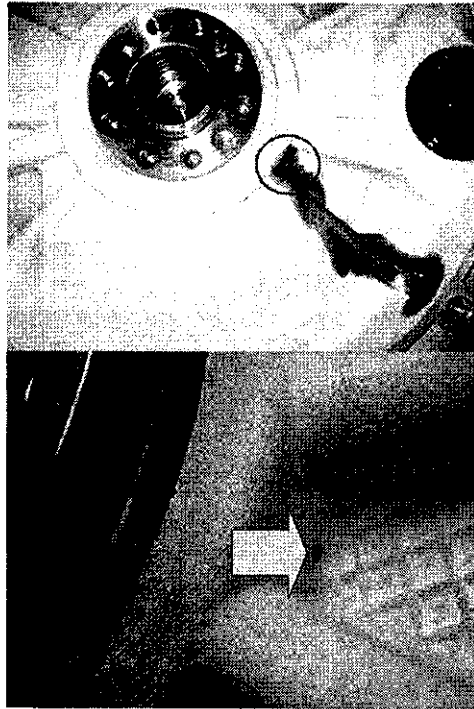
4.jpg:

| Attachments | |
|---|---|
| 4.jpg | Crankcase bedplate leaking |

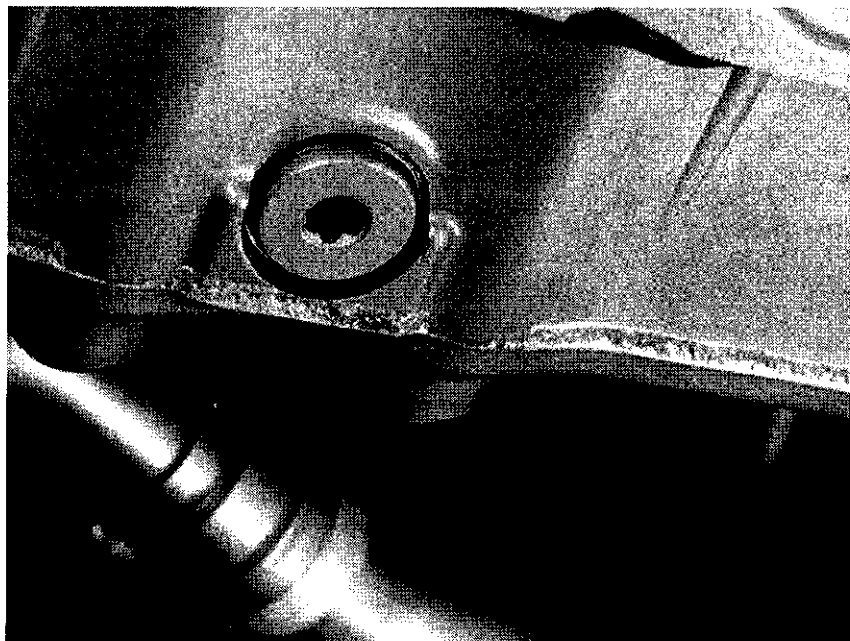
5.JPG:

| Attachments | |
|---|---|
| 5.JPG | Timing case cover oil plug |

- Re. 4. Open the DTS online case and contact DTS to process the case further. All relevant information including illustrations of the affected oil leak area must be attached to the case.

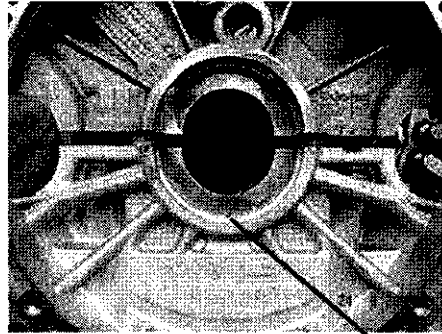
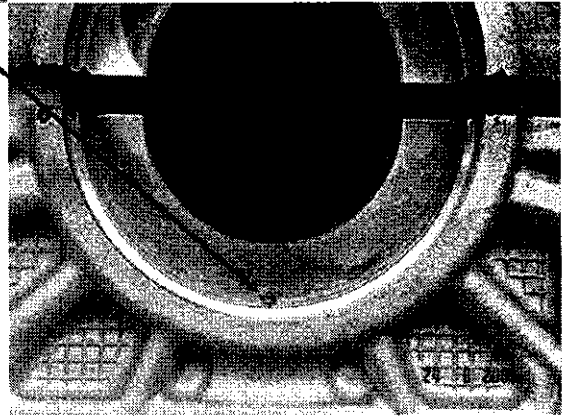
1.jpg:

| Attachments | |
|---|---|
| 1.jpg | Ventilation bore 1 |

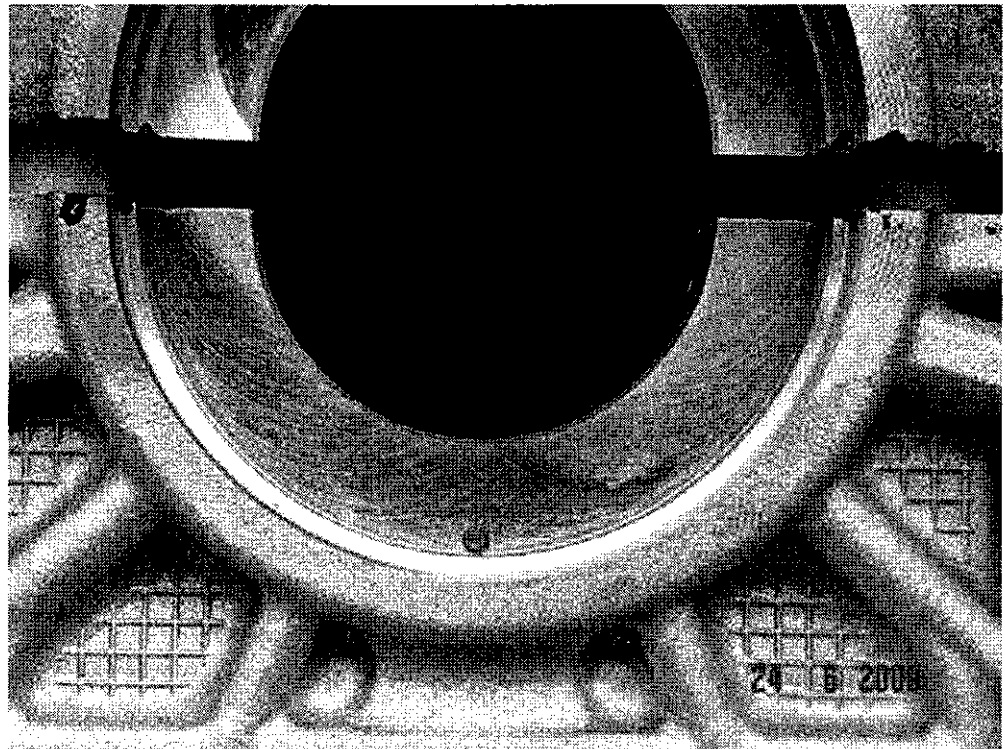
2.jpg:

| Attachments | |
|---|---|
| 2.jpg | Ventilation bore 2 |
