ARTICLES CONTAINED IN THIS ISSUE

SUBARU

QUALITY DRIVEN™ SERVICE

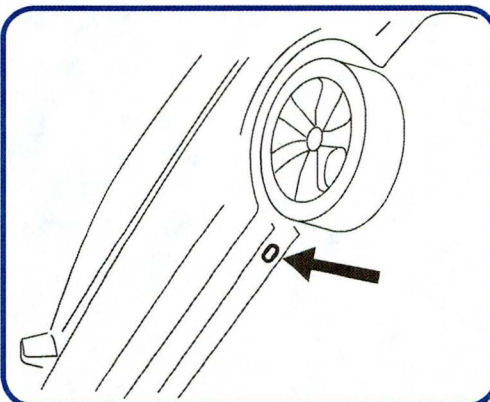
Be advised, the rubber tie-down hole plugs you are used to seeing and installing on BRZ models during PDI will be included and require installation into 2013MY Impreza and XV Crosstrek models. Currently, the timing and / or VIN break information for this change has not been finalized, but we can

report that you will start seeing the plugs included with the tool kit on these models in the near future. The Service Manual will also be updated with this change accordingly.

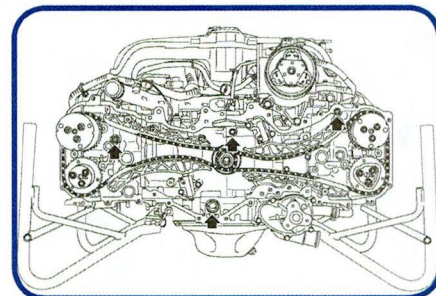
02 FRONT CHAIN COVER OIL LEAKS

When sealing a front timing chain cover to repair an engine oil leak, it is not necessary to replace the oil filter to perform the repair.

We have noticed an increase of claims charging out oil filters when resealing front chain covers.

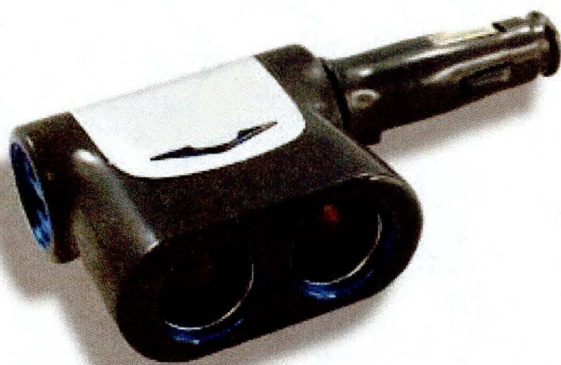
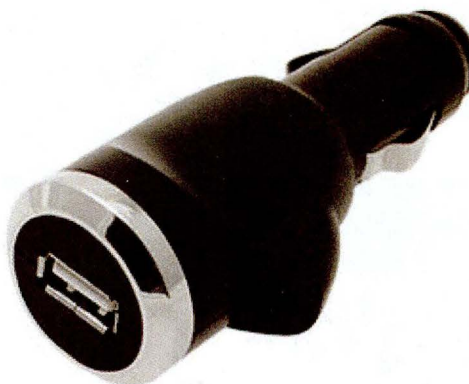
07 ODS CODE 29 OR 37, ELECTRICAL DEVICES AND AIR BAG SYSTEMS

Should you encounter a 2010-13MY Legacy or Outback with a code 29 (ODS Failure), 37 (Buckle switch RH failure) or a combination of the two codes, check to see if the customer is using a low-quality aftermarket phone charger or power splitting device in either of the power plugs. Several cases of these codes have been traced back to low-quality accessories being plugged into the power outlets causing electrical or radio frequency interference with the ODS module. Removal of the accessories usually eliminates the condition allowing the DTCs to be cleared. If the condition persists after the removal of the devices, proceed as usual with diagnostics.

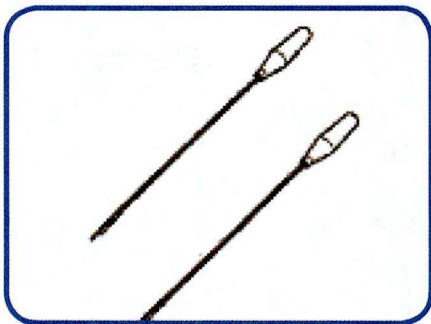
14 POWER STEERING SYSTEM TEST HARNESS PROBE

When performing diagnostic steps for DTCs related to the Electric Power Steering System on the 2012 and 2013 Impreza, some flow charts mention using a tester and test harness. The test harness being referred to is actually a set of probes used for checking smaller connector pins during diagnosis. In the General Description section of the Service Manual for the Power Assisted Steering System Diagnostics, the special probe tool is listed. The part number is 34199AG100 (Special Tool Harness).

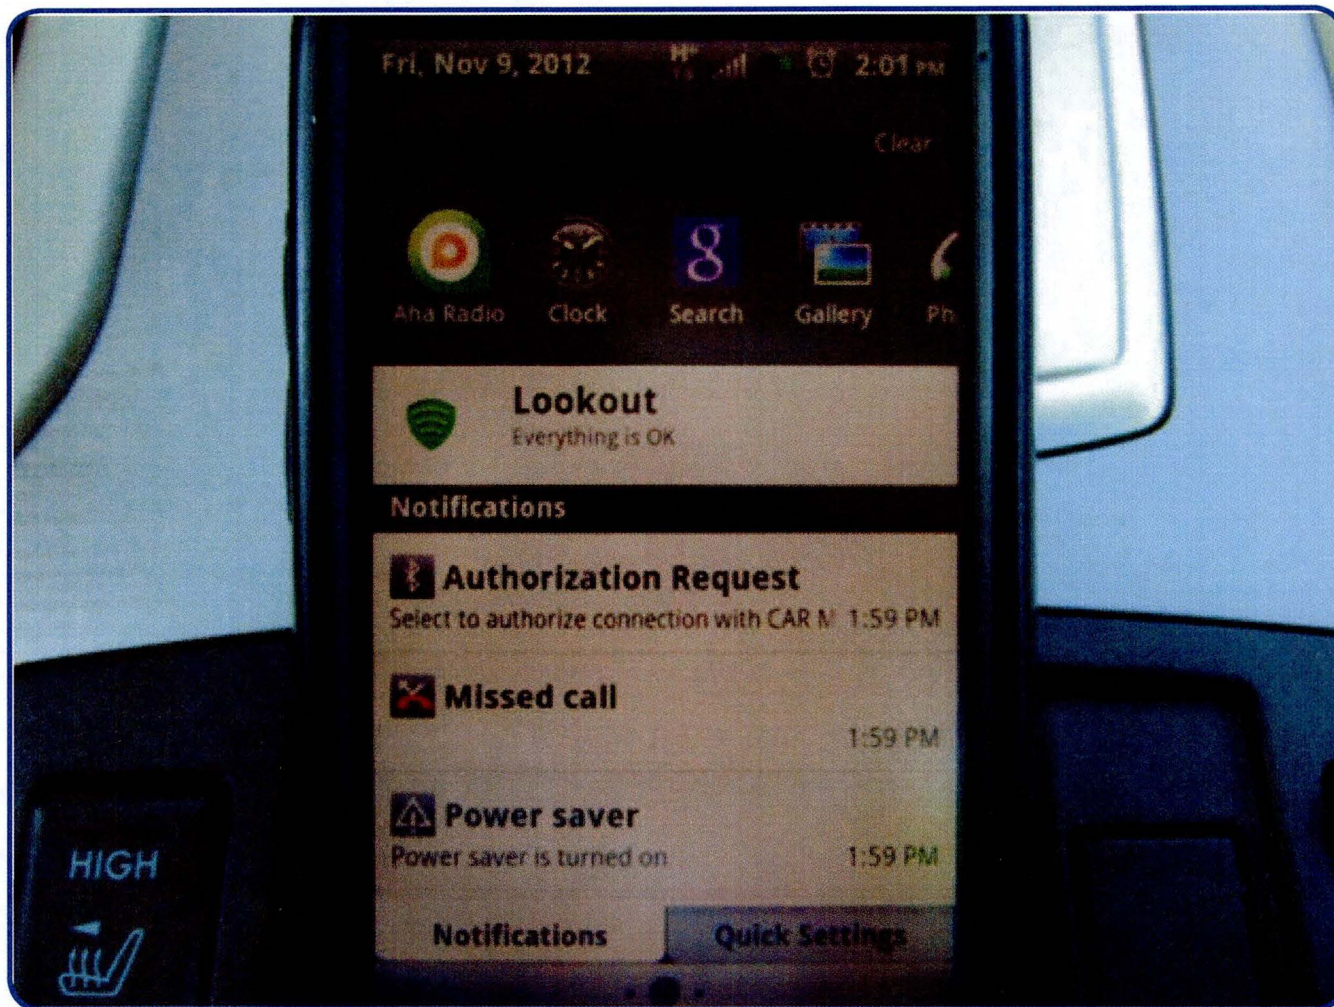
Should you encounter a customer concern of trouble pairing their phone to either a new or exchange audio unit, make sure the phone has been “authorized to pair” with an audio system as shown below. Often times, a customer may miss a screen showing this message “Authorization Request”. This screen disappears very quickly and should be checked if you encounter pairing issues. The photo below of this screen shows an Android phone.

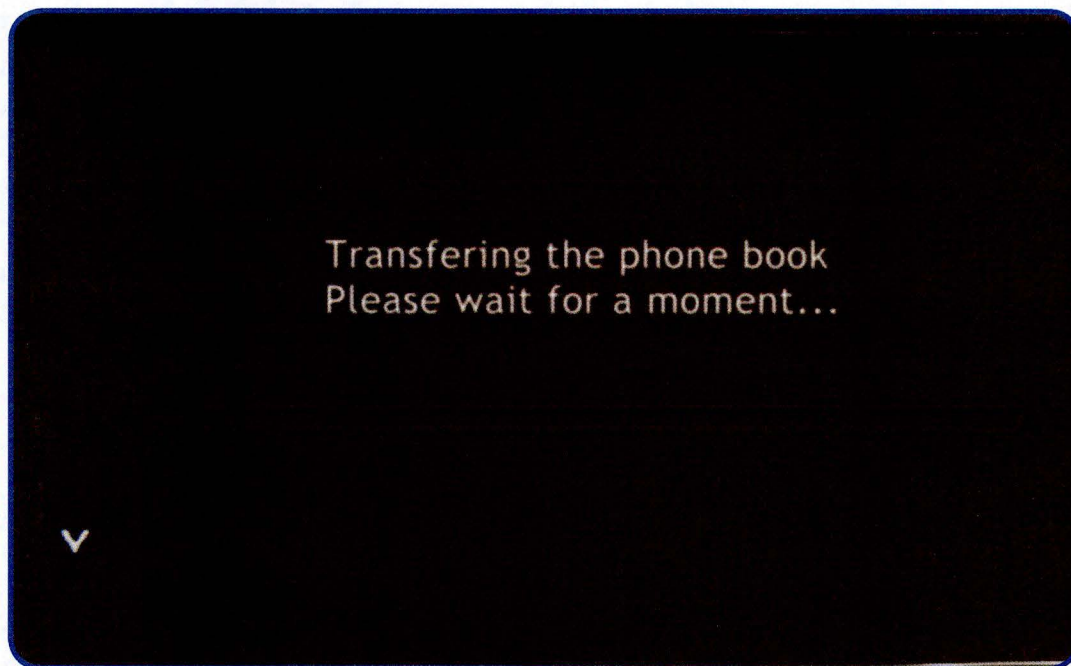
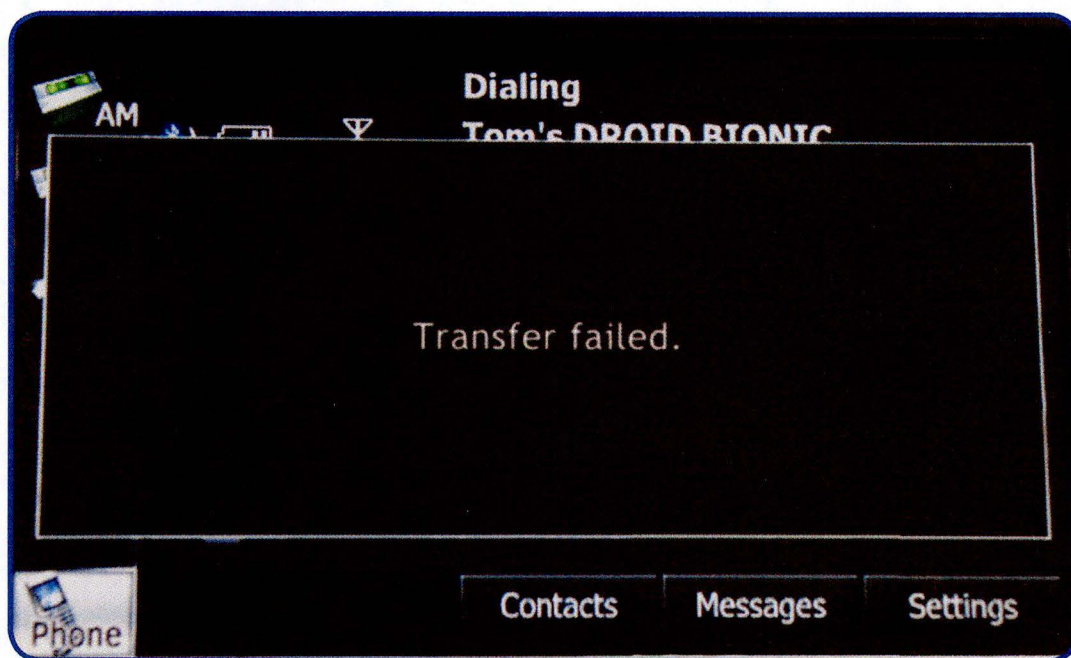
Currently, the iPhone® does not transfer phone books to Subaru audio/navigation units. Any concern in this area is simply one of compatibility. Another concern a customer may experience is a variation in the length of time the message “Transferring the phone book. Please wait for a moment” appears. There have been some cases where the customer believes a system freeze-up has occurred due to the time the message was displayed. The two most common causes for this are background functions of the audio/navigation system operating at the same time and performing certain functions simultaneously to the phone book loading. Trying to activate additional functions during this time will merely compound the condition by drawing down system resources even further. If the message “Transferring the phone book. Please wait a moment” remains on, it is best to let the process

complete or time out and a "Transfer failed" message appears before attempting to activate other system features. The other common cause of an extended "Transferring the phone book. Please wait a moment" message is similar to the above information where the customer's phone is waiting for permission to be given by the user to allow the transfer of this information. Again, this message may appear very quickly on the phone screen and the user may miss it if they are not expecting it. By giving the phone permission to transfer the requested information, the amount of time to transfer the phone book should be reduced. Please see the screen shots below for what these messages look like on the audio unit display.
