# Service Bulletin

Bulletin No.: PI0168A

**Subject:** Poor AM Radio Reception, Static Noise

**Models:** 2010 Buick LaCrosse Built Prior to February 15, 2010  
2010 Cadillac SRX Built Prior to December 12, 2010  
2010 Chevrolet Camaro  
2010 Chevrolet Equinox Built Prior to February 22, 2010  
2010 GMC Terrain Built Prior to February 22, 2010

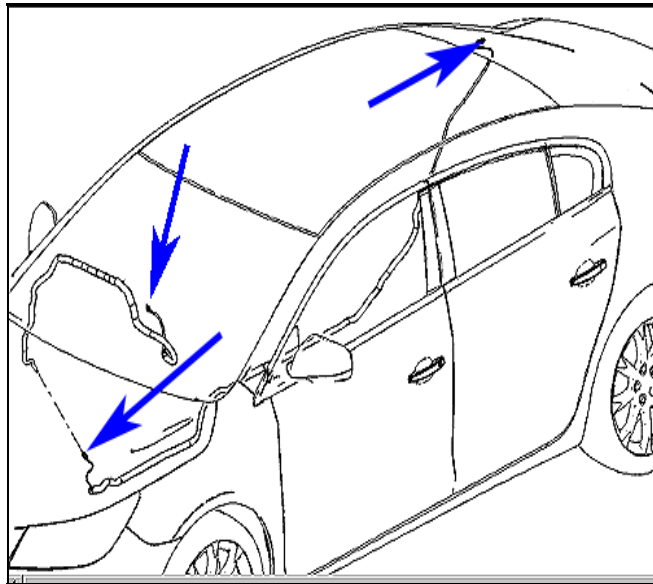
2486042

Buick LaCrosse connection location shown.

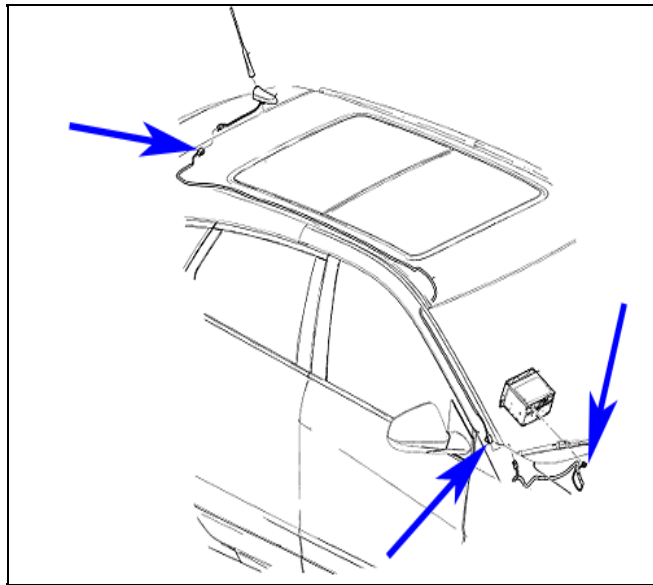
2486045

Cadillac SRX connection location shown.

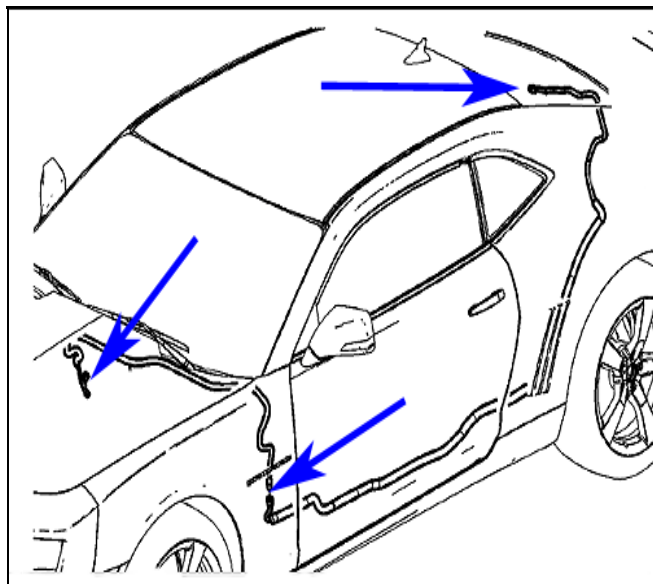
2486039

Chevrolet Camaro connection location shown.

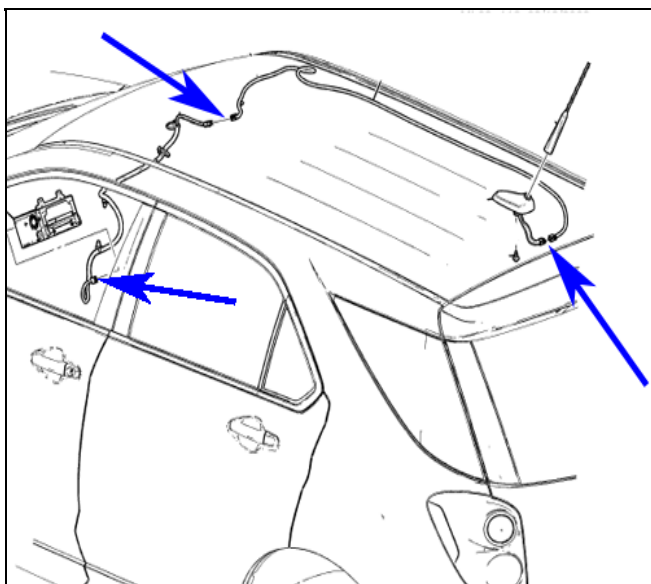
2486041

Chevrolet Equinox and GMC Terrain connection location shown.
