Service Bulletin

Bulletin No.: PI0216A

Subject: Locating/Repairing Noise or Rattle from Rear of Vehicle When Driving over Rough Surfaces

Models: 2011 Buick Regal
Built Prior to VIN Breakpoint B1013646

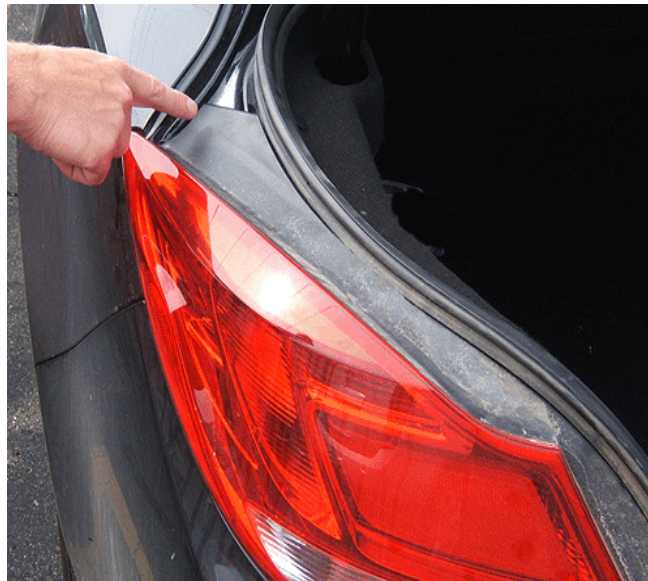
2523039

The cause of this condition may be that the upper corner (1) of the left or right tail lamp is contacting the body sheet metal when the vehicle is driven on rough roads. Lightly pressing on this area of the lamp will often verify the condition.

Earlier builds may have no bumper/insulator in this area and later builds may have a hard rubber bumper on the underside of the lamp housing, which may have shifted or come loose.

Do This	Don't Do This
Add a foam pad insulator to the affected tail lamp.	Do not replace the rear package shelf, shelf components or tail lamp assembly.
