# Service Bulletin

Bulletin No.: PI0240B

**Subject:** Front Fascia Lower Air Dam Exhibits Poor Fit and/or Appears Mismatched, Wavy or Gapped to Fascia

**Models:** 2010-2013 Cadillac SRX

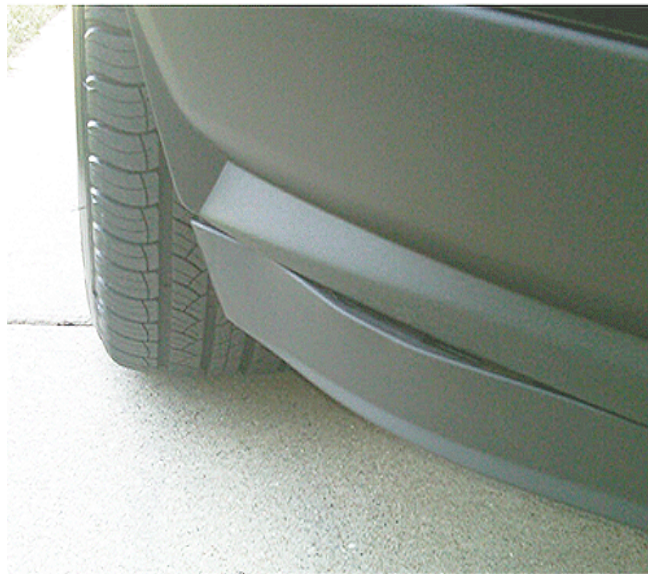
#### Passenger Side Air Dam

Some customers may comment that the front fascia lower air dam fits poorly to the fascia. The common descriptions are that the dam appears mismatched, wavy or gapped to the fascia. Some examples are shown in the graphics below.

The concerns may be caused by improper installation of the front fascia lower air dam during PDI. The two previous examples showed incorrectly installed second location attachments on each side of the air dam. A close-up graphic of the driver side (shown below) indicates that in both second attachment locations, the air dam tongue (1) was not properly installed into the channel on the fascia.

**In order to obtain the proper fit, it is important to follow the Installation instructions included in each front lower air dam kit. No additional parts are necessary as all components are included in the kit.**
