Bulletin No.: PI0464A

Subject: Tire Wear Characteristics of 16" Goodyear® Integrity Low Rolling Resistance Tires

Models: 2009-2013 Chevrolet Impala

Equipped with P225/60R16 Tires (RPO QPX)

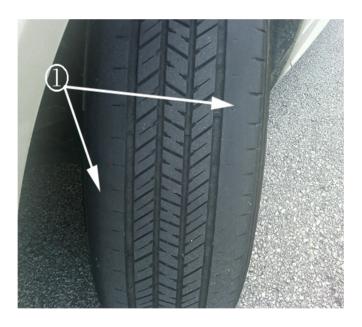
2608997

Normal Wear Pattern

Tires that exhibit this type of wear are considered normal. There is no need for wheel alignment, nor is this any indication of the tires being run at too low an air pressure.

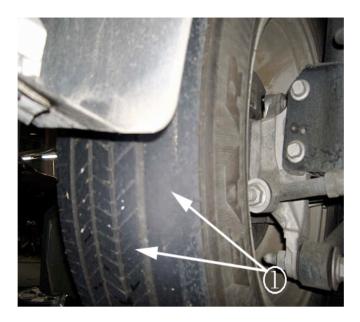
2608986

Abnormal Wear Pattern

Tires with wear concentrated to the outer or inner side that is not uniform across the tire (as shown above) may indicate the need for alignment, suspension component repair or be the result of aggressive driving.

Follow the tire rotation schedule as explained in the vehicle owners manual and assure that the tires are kept at the recommended pressure as shown on the vehicle tire placard. More frequent tire rotations may be desirable if the vehicle is driven aggressively, or signs of uneven wear occur ahead of the recommended rotation intervals.
