Service Bulletin

Bulletin No.: PI0504C

Subject: Navigation Radio Will Not Display Map Data, Message Display is On

Models: 2011 Cadillac Escalade Models
Equipped with Navigation Radio (RPO GMQ)

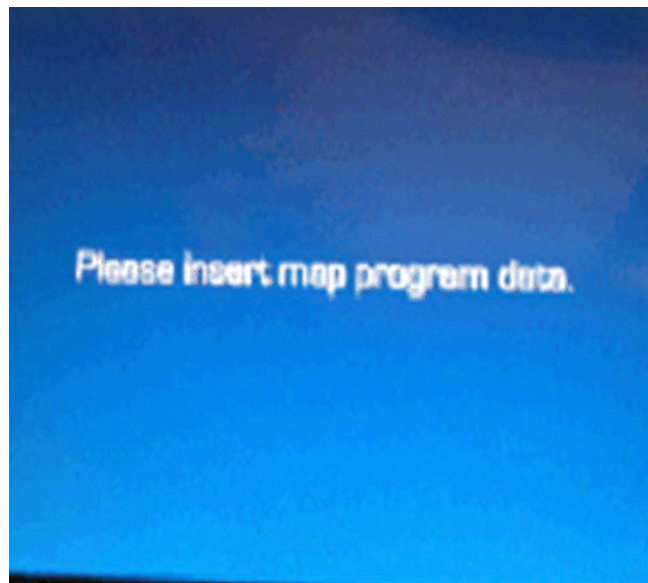
2680133

- Most commonly, the system continuously shows the "Updating in Progress" screen.

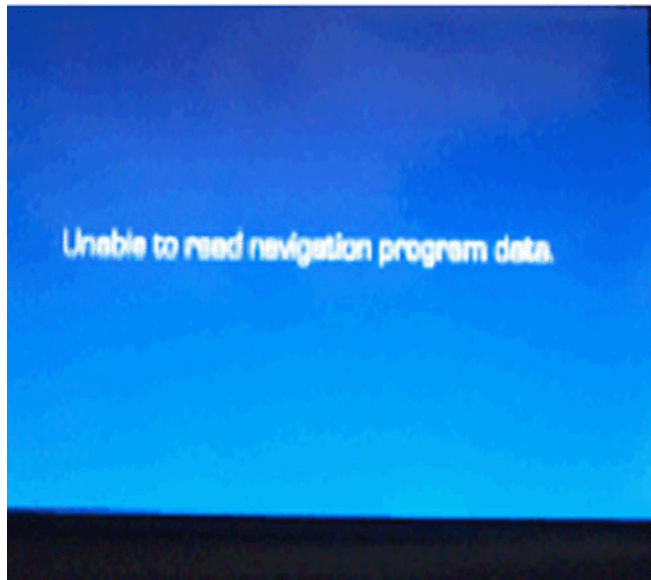
2680138

- Another screen that may also be seen is the "Please insert map program data" screen.
