Service Bulletin

Bulletin No.: PI0731A

Subject: Spare Tire Jack Storage Compartment Door Difficult to Latch or Falls Open Due to Inability to Latch

Models: 2009-2012 GMC Acadia

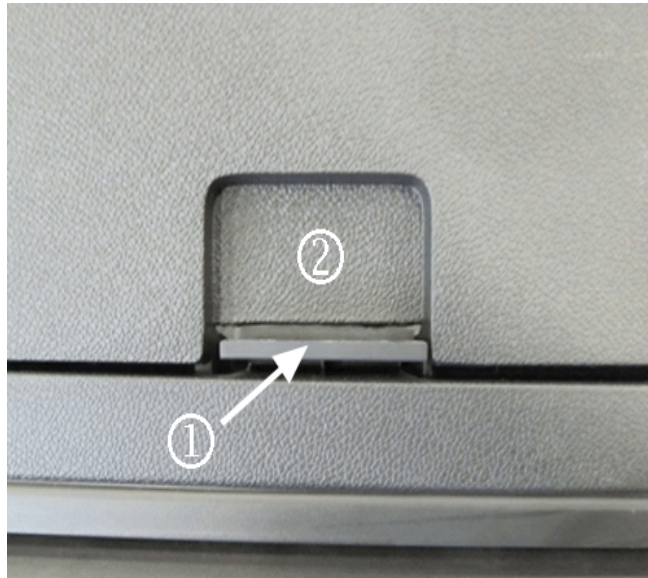
3136473

Some customers may comment that the jack storage compartment door may be difficult to latch or may fall open on its own because of improper latching.

The cause of this condition may be that excessive interference may exist between the storage compartment door latch (1) and the body side trim panel (2), not allowing the door to latch properly.

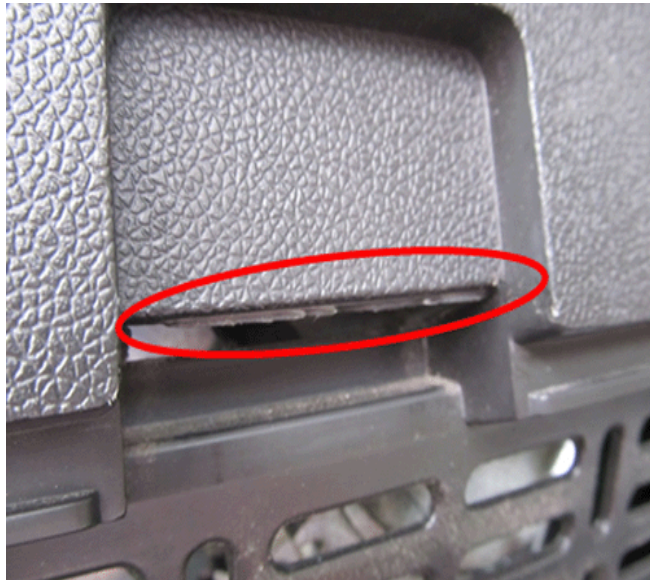
3136474

Note: The excessive flash may be folded back behind the panel and difficult to see, but it can still be detected by feeling the back side of the trim panel opening.

In many cases this interference is caused by excessive flash on the inside edge of the body side trim panel opening, preventing proper engagement of the latch.
