Service Bulletin

Bulletin No.: PI0762B

Subject: Coolant Leak at Water Pump

Models: 2011-2012 Chevrolet Cruze
Equipped with 1.4L Turbo Engine (RPO LUJ)

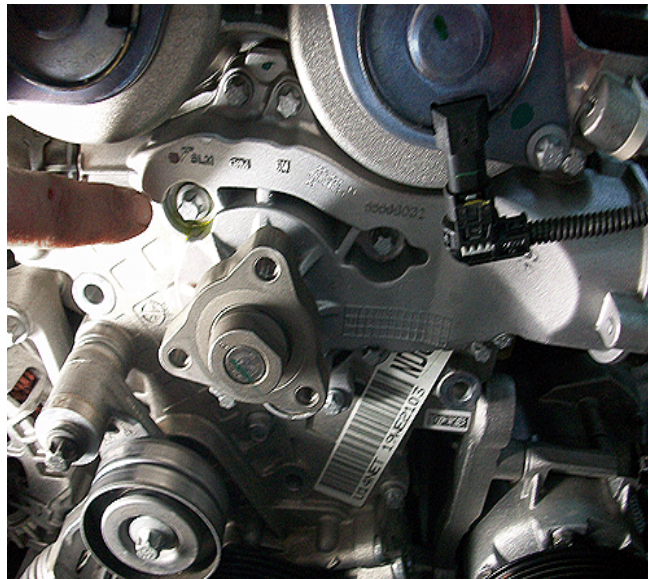
Coolant may be leaking from the water pump mounting bolts.

If the water pump mounting bolts are leaking, do not attempt to tighten or put sealer on the bolts. The water pump and gasket should be replaced.

Important: DO NOT replace the water pump mounting bolts when replacing the water pump.

The water pump does not come with the gasket. The water pump and the water pump gasket should be ordered separately.

When replacing the water pump, the thermostat housing seal and engine mount bracket bolts also need to be replaced.
