# Service Bulletin

Bulletin No.: PI0813

**Subject:** Driver Airbag Light Flashing and/or Passenger Airbag ON Indicator Does Not Illuminate with Passenger Present After SDM Reprogramming

**Models:** 2012 Chevrolet Camaro  
2013 Chevrolet Malibu

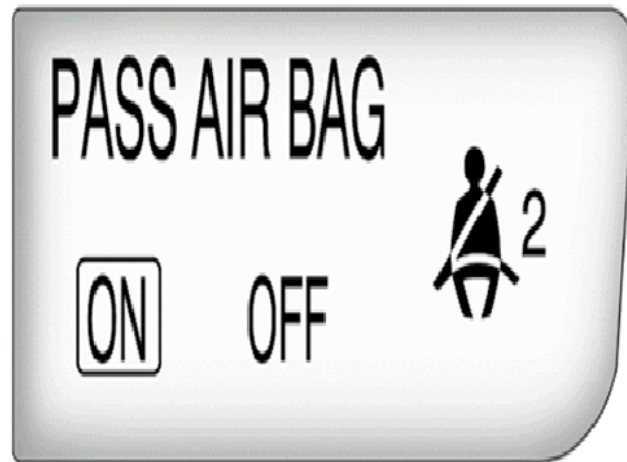
## Passenger Airbag Indicator (Malibu)

Some customers may comment that driver airbag light is flashing in the cluster and/or the passenger airbag ON indicator does not illuminate when a passenger is present.

This condition occurs when the SDM (Inflatable Restraint Sensing and Diagnostic Module) setup has not been completed after reprogramming. If the Setup is not completed, the airbag indicator located in the cluster will flash continuously and the "Passenger Airbag ON" indicator will not transition to ON when a person is in the passenger seat.

Using the SPS tool, select "SDM Inflatable Restraint Sensing and Diagnostic Module – Setup" on the Supported Controllers screen.
