Service Bulletin

Bulletin No.: PI0820

Subject: Rear Speaker Distortion, Rattle or Vibration in Rear Package Shelf Area (Rear Window Panel Trim)

Models: 2012 Buick Verano

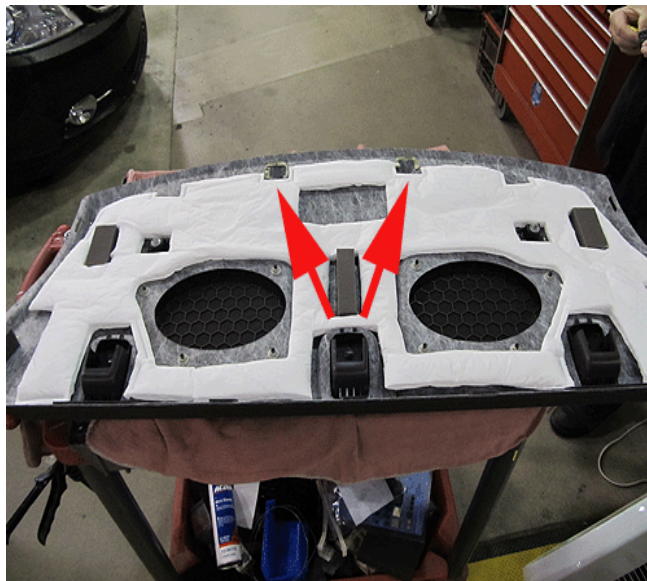
2911296

This condition may be caused by an adhesion failure on the rear window trim panel attachment and/or insulation components. The two clips located at the rear of the panel are the most likely to come loose, however all of the glued on components should be checked.

Important: For the correct material flow and open time, the hot melt adhesive working temp is 176°C to 218°C (350° F to 425°F). A hot melt glue gun with a minimum rating of 220 watts is recommended for the best results.
