# Service Bulletin

Bulletin No.: PI0827

**Subject:** Excessive Water in Door, Wet Carpet After Hard Rain or Automatic Car Wash

**Models:** 2012-2013 Chevrolet Impala

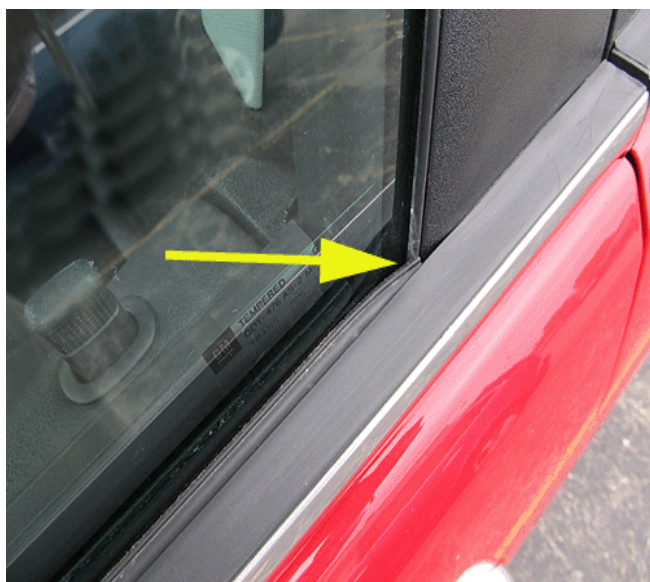
2913374

Some customers may comment that the carpet is wet or that there is excessive water in one or more of the vehicle doors. This condition is possible on all four doors. This condition occurs after a hard rainfall or the vehicle has been run through an automatic car wash.

This condition may be caused by an out of position outer window belt sealing strip (side door window belt outer sealing strip).
