Service Bulletin

Bulletin No.: PI0848

Subject: Front Side Door Window Upper Reveal Molding Fit/Appearance/Clearance

Models: 2010-2012 Buick LaCrosse
Built Prior to May 1, 2012

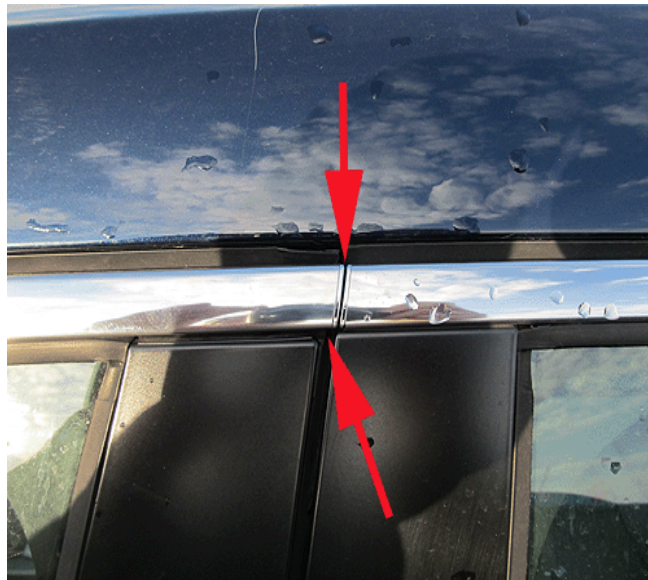
2964012

Some customers may comment that the gap between the front and rear door upper window reveal molding is too small or the front door reveal molding contacts the rear door reveal molding. This condition may be present on the left or right front door.

This condition may be caused by the metal section of the front side door reveal molding moving out of position within the molding assembly.
