Service Bulletin

Bulletin No.: PI0854

Subject: Front Door Wind Noise

Models: 2013 Chevrolet Sonic
Condition/Concern

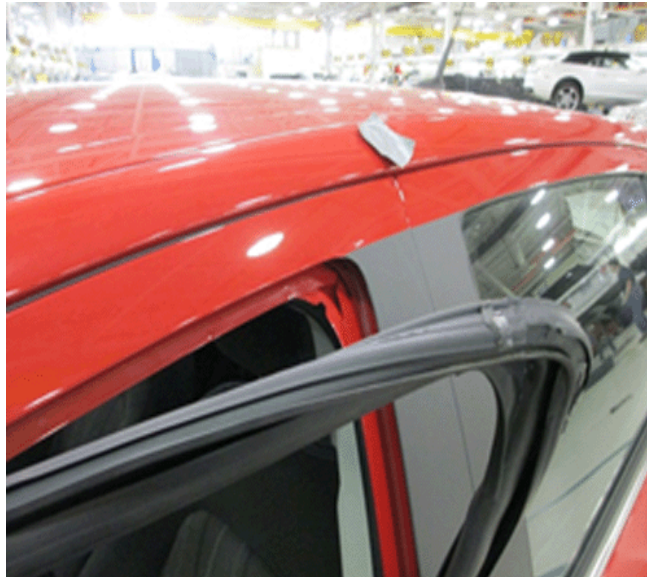
2968996

Some customers may comment on front door wind noise.

The wind noise may be coming from the die relief notch in the door. Cover the notch with tape following the procedure below:

1. Lower the front door window.

2. Carefully pull down the upper rear corner of the glass run channel weatherstrip.
3. Cut a piece of Posi-Seal Plus™ approximately 50 mm X 40 mm long.
