Bulletin No.: PI0856

# Service Bulletin

**Subject:** Flutter or Rattle Noise Heard from HVAC Vent

**Models:** 2012-2013 Chevrolet Impala  
Vehicles Built After February 15, 2012

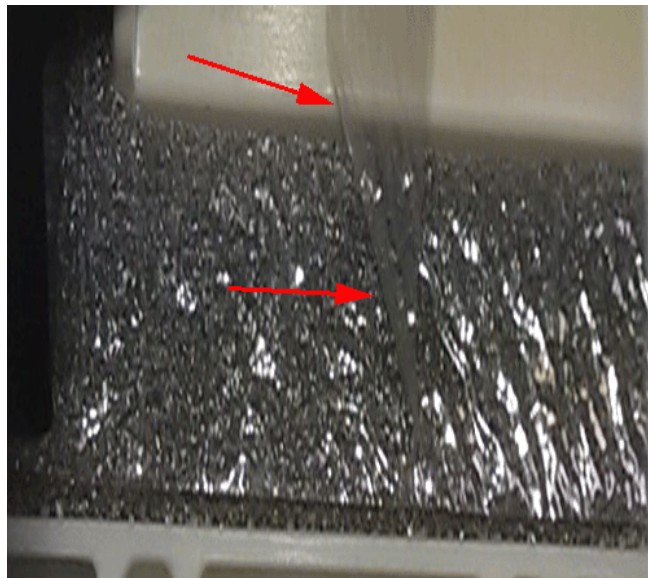
2968367

Some customers may comment on a flutter or rattle noise heard from the HVAC when using the heat or A/C. This condition may be caused by loose mylar on the foam seal under the HVAC vent doors.

**Note:** Mylar strip peeling off the foam as shown in the illustration above.

1. Remove the instrument panel carrier. Refer to Instrument Panel Carrier Replacement in SI.
2. Remove both recirculation actuators. The technician will be able to manually open the doors to get access to the foam.
