# Service Bulletin

Bulletin No.: PI0863

**Subject:** Battery Drain and/or Steering Wheel Control Illumination Inoperative

**Models:** 2013 Cadillac ATS, SRX, XTS

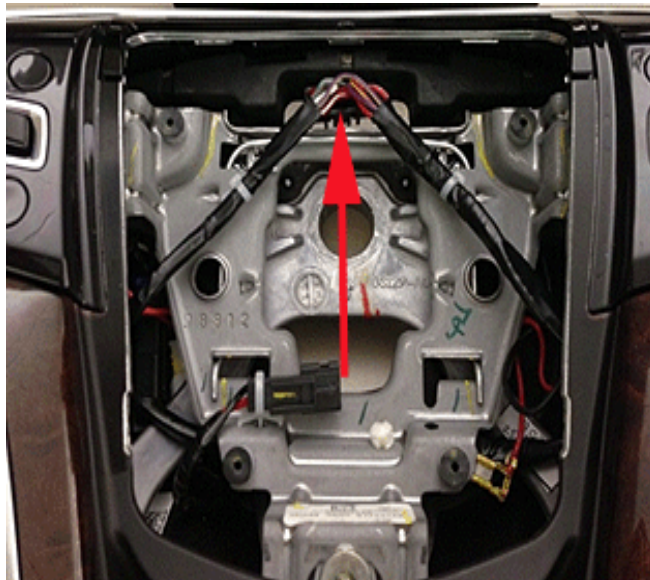
2966068

2. Inspect the steering wheel metal base plate.
  - If you see a RED or BLACK line under the airbag retention spring between the left and right branches of the main wire harness, the steering wheel has already been reworked. No further rework is required. Inspect the wiring and ensure there is no damage to wires and reposition the heated steering wheel wire harness as shown in UVD step #5. Reinstall the airbag module into the steering wheel and proceed with SI diagnostic procedures to correct the condition(s).
  - If no black or red indicator is found, proceed to step 3.

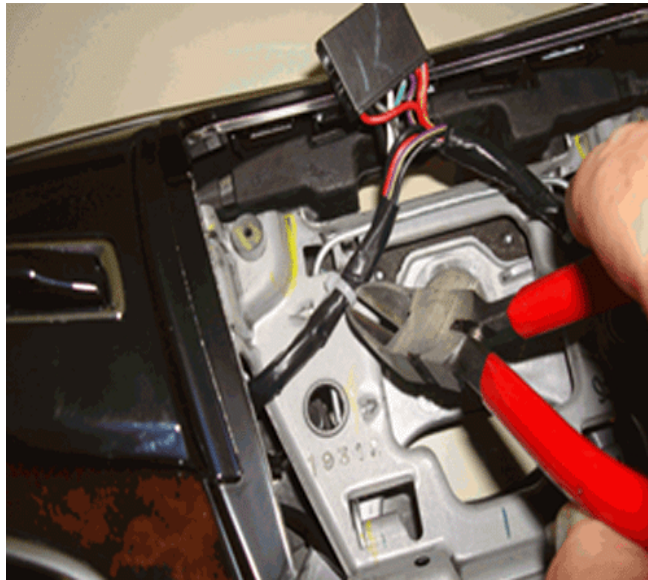
2966071

- Measure both the left side and right side harness length from the white retaining clip (wire tie) to the center of the connector (where white wire enters). The wire length should be measured from a straightened wire. The measurement should be between 50 mm and 63 mm in length for both left and right side.
- If either side measures less than **50 mm** or more than **63 mm**, proceed to step 4. If both sides are within the target measurement, proceed to step 5.

4. Cut the white wire tie that retains the incorrect length wire harness to the horn plate. It is not necessary to remove both clips for this step if one side has an acceptable length. Use care to not damage the harness. Remove the wire tie retainer from the horn plate. Use care to ensure no plastic pieces of the retainer break off and drop into the steering wheel. If plastic debris falls into the steering wheel, it may cause a rattle condition.

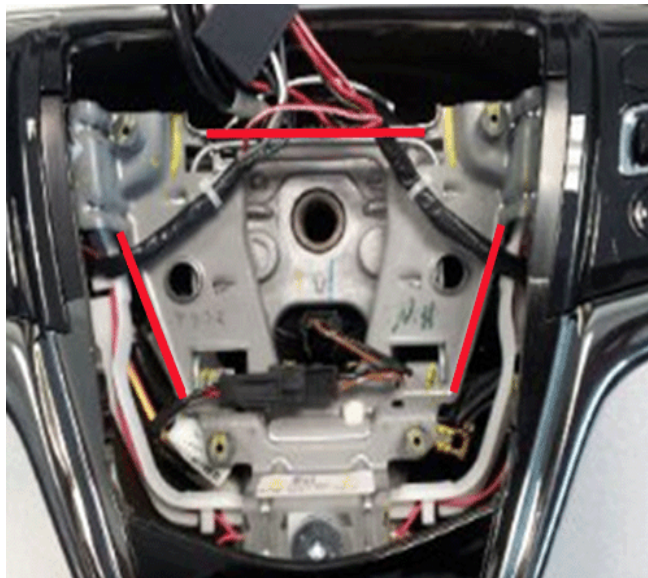
2966073

5. Carefully inspect the wires for damaged (missing) insulation. This damage is caused by the wiring making hard contact with the sharp metal edge of the stamped steel horn plate.

- 5.1. If only the insulation is damaged, apply two light coats of \*Kent Industries Liquid Vinyl Tape, Part # 99491 or the equivalent, to the wire where the insulation is nicked or missing.

- 5.2. If the insulation and the conductor (wire) are damaged, replace the affected harness.
