# Service Bulletin

Bulletin No.: PI0870

**Subject:** Transmission Unable to Shift into Gear

**Models:** 2013 Chevrolet Spark  
Equipped with 5-Speed Manual Transmission (RPO MX2)  
Built Prior to October 5, 2012

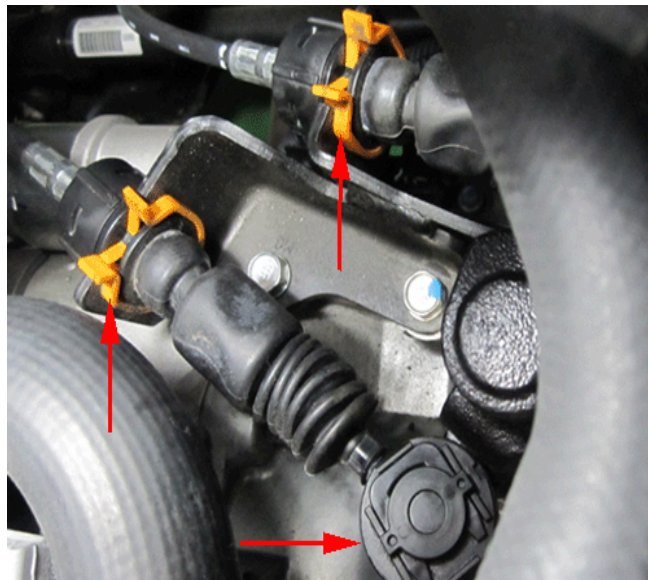
2967223

Some customers may comment that the transmission is unable to shift into any gear. This condition may be caused by either the shift cable or selector cable loose or out of place.

**Note:** One of the cable ends is located under the hose that is not shown in the illustration above.

2. Lift up on the abutments and cable ends shown in the illustration above by hand. Disassembly can happen with low force if they are not fully installed.
3. Push down the abutments and cable ends until fully locked into position.
