Service Bulletin

Bulletin No.: PIC5245A

Subject: Creak Noise From A-Pillar Area

Models: 2008 - 2013 Cadillac CTS Models

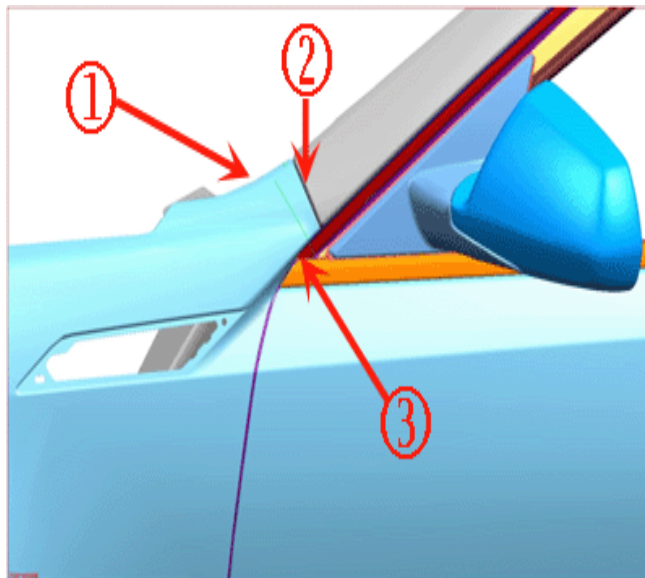
2336384

A customer may comment of a creak noise coming from the A-Pillar area when going up and down driveways (during body twist).

This may be caused by Fender to A Pillar trim contact. Refer to the picture below.

(1) - Loosen the top bolt that's near the windshield (pull out mucket to access bolt),

(3) - Then loosen the lower bolt that's in the door opening by opening the door and pulling back the rubber close out piece.

Use a clear Mylar or ultra-high molecular weight tape (min 1mm thick - obtained from local supplier or via internet search) and add between the panels.

Adjust the fender metal so you have 1mm clearance on all 3 sides (1), (2), and (3) and then tighten the fasteners down.

Note: Validate the repair by driving up and down driveways (which causes the car to twist).
