Service Bulletin

Bulletin No.: PIC5458C

Subject: Water Leak In Rear Floor Area

Models: 2011 - 2013 Chevrolet Camaro Convertible

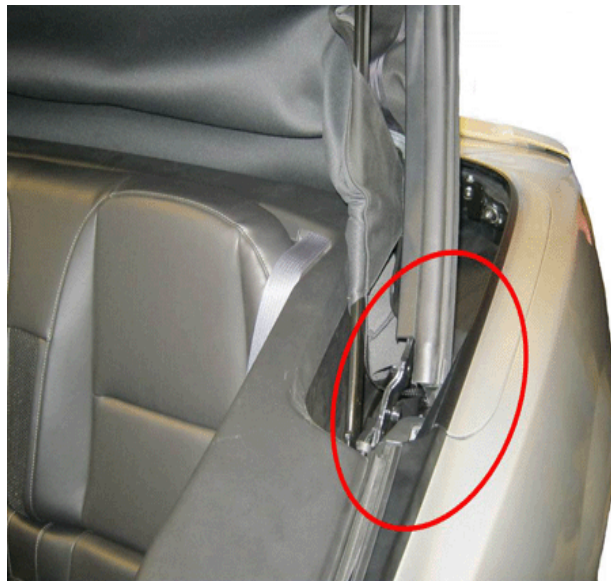
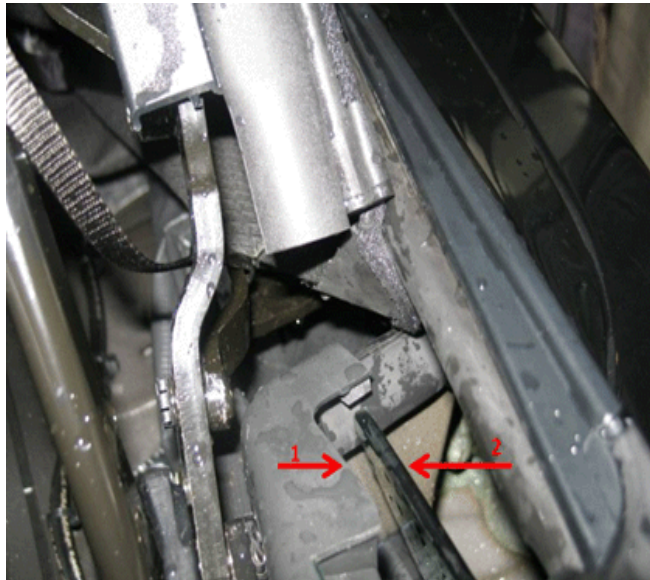
2658973

Everything to the inboard side of the rear quarter glass is considered a dry area; water should not be in the "dry area" (1). Everything to the outboard side of the rear quarter glass is considered the "wet area" (2). It is acceptable and by design that water is present on the outboard side of the rear quarter glass and in the area of the quarter glass regulator that the front drain spills into.

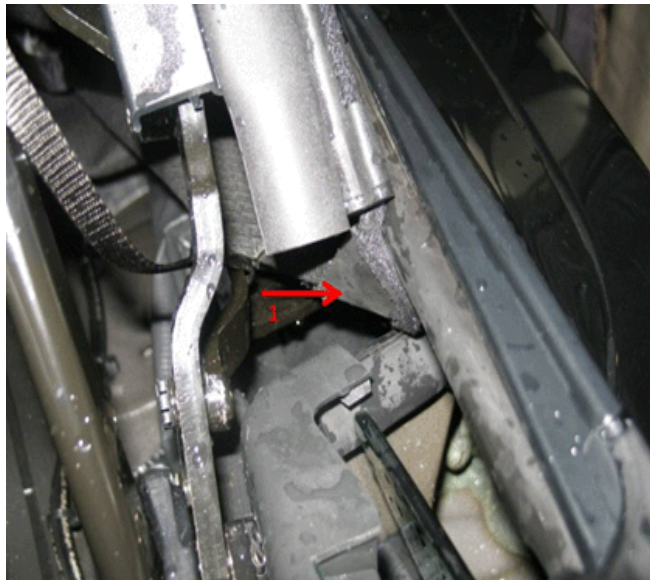
Correct Position

The water diverter that is sewn into the canvas top may be on the "dry side" of the vehicle.

With the top in the closed and latched position, have an assistant stand outside of the vehicle and run water over the top of the car. While sitting in the back seat, lift the headliner up in the area behind the quarter window. With the water running, look past the headliner to confirm the water is draining into the water management bag. If the water doesn't drain into the water management bag verify that the plastic water diverter (1) that is sewn into the top is on the "wet side" of the trim. The two pictures below show this plastic diverter in both the correct and incorrect positions.

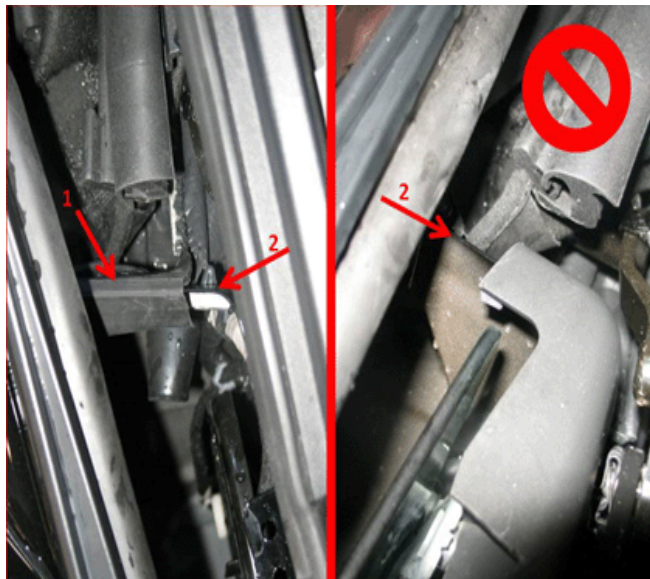
Area of concern #2

Verify the front of the water management bag is properly attached to the body sheet metal panel. In the photo below, the water bag (1) is correctly positioned and attached to the vehicle's sheet metal (2) in the LH photo. The RH photo shows the bag where it is not attached (2) to the sheet metal of the vehicle.

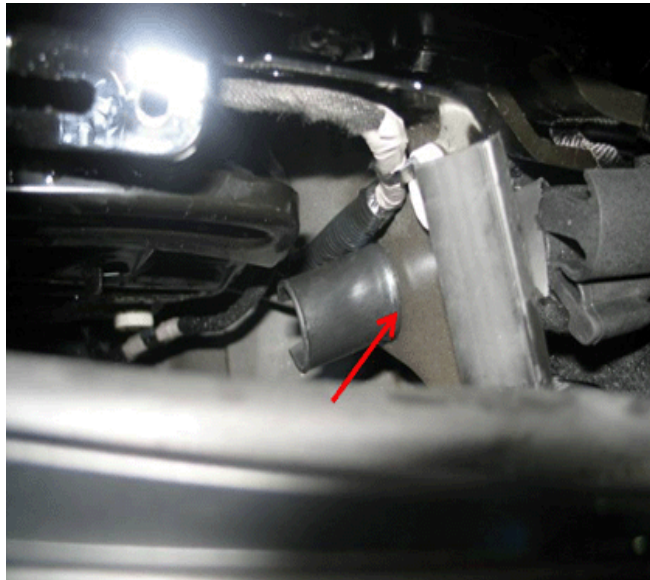
Area of concern #3

Inspect the front drains for proper installation. This can be difficult to confirm due to the limited space and limited visibility in this area. The following picture illustrates a drain that is not fully seated in position. The front drains are difficult to install and may not be fully seated in the body sheet metal panel. If the front drains were previously dislodged, it is possible that the drain may have taken set and will not remain in place. Replace the water management bag ONLY if the drain will not stay in place. Water management bag replacement can only be performed after removing the top from the vehicle.

Important: It is normal for the quarter glass window to make light contact with this drain when the window is rolled down. Modifications to the upper lip of the drain can be made if cycling the window results in the drain tube being pushed out of the sheet metal. An opening on the top of the drain tube that resembles the opening on the bottom of the tube can be made for this condition. The drain will not fall out of the body sheet metal unless the drain is not fully seated.

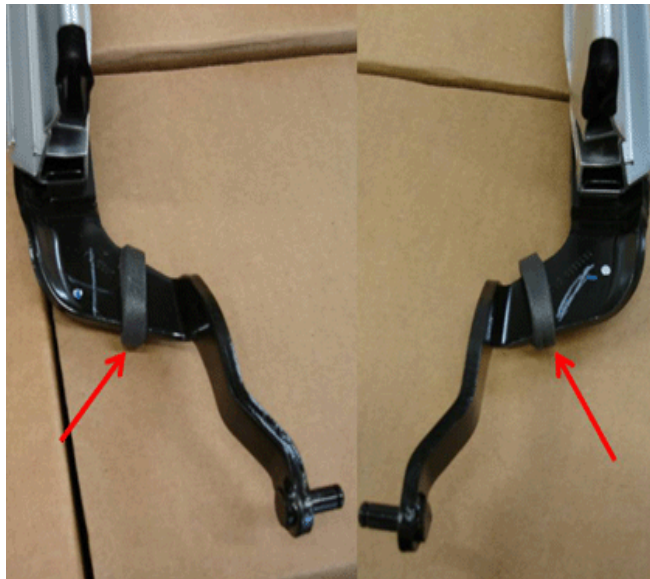
Area of concern #4

Verify the presence and proper location of the foam tape on both the left and right side 5 bow brackets, as shown in the following photograph.

By design, water runs along the folding top and down to the 5 bow and 5 bow brackets. It runs down until it hits the pieces of foam. Once it reaches this foam, it can no longer wick down the brackets and into the vehicle. Instead, the water drips off the brackets, directly into the water bag located directly below these foam pieces. If the foam pieces are damaged or missing, they will need to be replaced. If the foam pieces are still present, an additional layer of foam tape may be added on top of the existing foam pieces. This will make the foam stand taller, preventing water from overcoming the height of the foam. This peel-and-stick foam tape can be purchased at any local home improvement or hardware store.

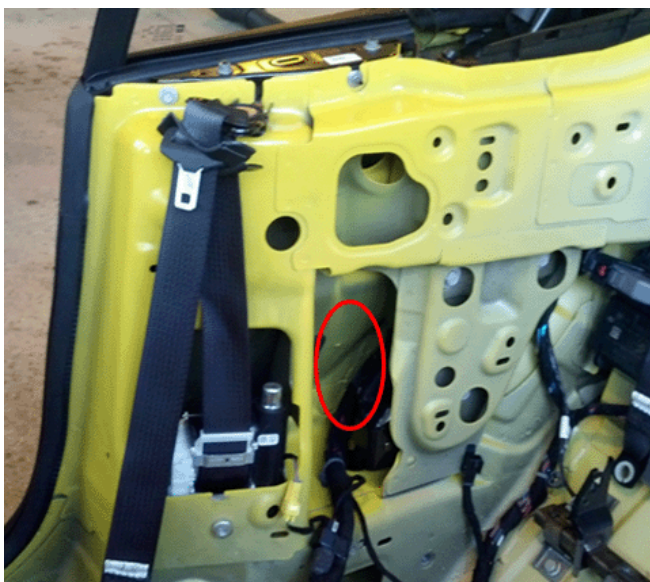
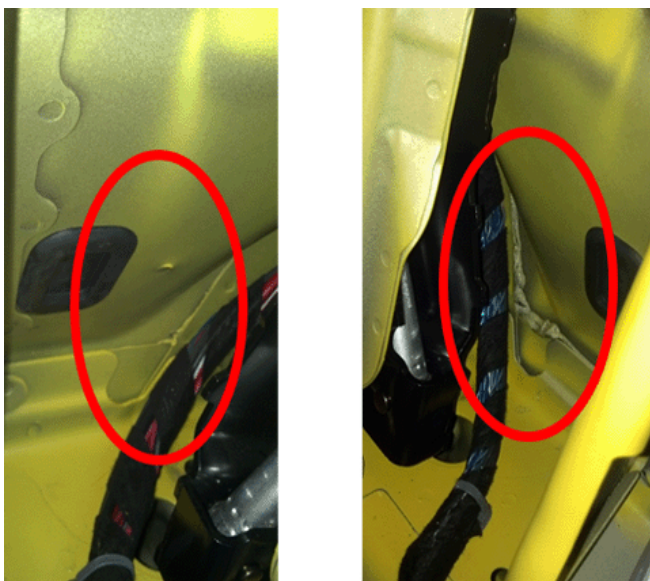
Area of concern #5

Inspect the area of the vehicle where the folding top frame is fastened in place. There may be water leaking into the vehicle between 2 pieces of sheet metal in the quarter panel area. When comparing the body seams on both RH and LH sides of the vehicle, it may be noticed that there is visible seam sealer protruding from the body seams on only one side of the vehicle. If there is no visible seam sealer on the side of the vehicle that has the leak, this may be

the cause for the concern. The first photograph below shows the area in question. The second photo shows a close up view of the circled area and the potential leak in the body seam. The LH side of the photo shows a body seam that has not been properly sealed. The RH side of the photo shows a body seam that has been properly sealed.
