Service Bulletin

Bulletin No.: 08-06-04-006K

Date: August, 2012

Subject: Information for Identifying Non-GM ECM Calibration Use and Power-Up Hardware Detection in Duramax™ Diesel Engines — Photograph Tech 2® Calibration IDs, Calibration Verification Numbers (CVNs) and Transmission Data Screen

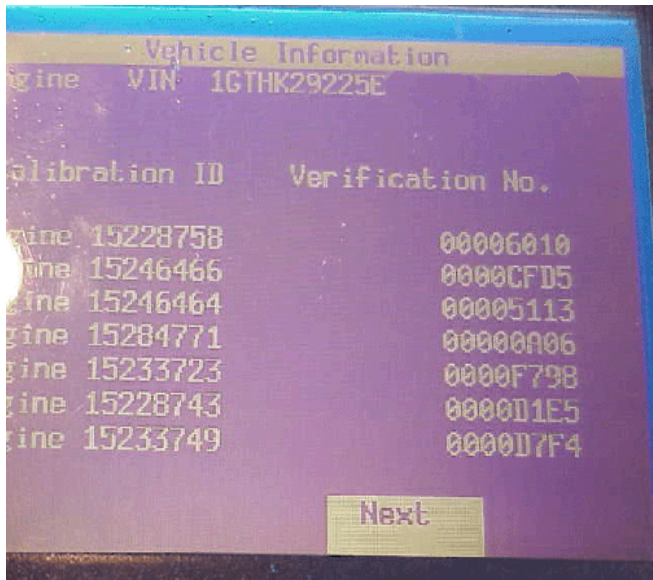
Vehicle Information Screen

17. Compare the Calibration ID and Calibration Verification Number (CVN) to the CVN shown on the TIS2WEB printout. Although the part numbers will be the same for each, it is the CVN that will determine if the calibration is GM issued. The CVNs should be the same.

- ⇒ If the CVN information is displayed as “N/A”, it will be necessary to contact the **TCSC** to obtain the CVN information.
 - ⇒ If the part numbers match and **ANY CVNs DO NOT** match the printout, it is likely that a non-GM certified calibration has been installed.

- ⇒ If **ALL** of the CVNs are **EXACTLY** the same the calibration is GM issued.

18. Take clear digital picture(s) of the Tech 2[®] Vehicle Information screen(s) showing the complete VIN, the Calibration IDs and the Verification Numbers. Retain the printout information and the Tech 2[®] screen photographs with the repair order.

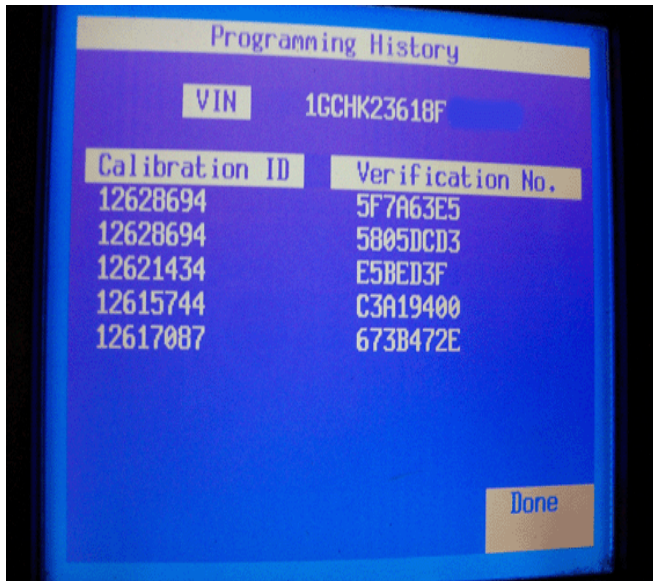
Programming History Screen

8. From TIS2WEB/SPS, record the Calibration Part Number into the CVN Database. Get the CVN.
 - ⇒ If the CVN **DOES NOT MATCH** the CVN database, an unauthorized engine calibration part **WAS PROGRAMMED** into the ECM.
 - ⇒ If the CVN **MATCHES** the CVN database, the calibration/s are GM issued and an unauthorized engine calibration part **WAS NOT** used.

9. Take a clear digital picture of the Tech 2[®] Programming History screen showing the complete VIN, Calibration IDs and the CVNs. Retain the printout information and the Tech 2[®] screen photograph with the repair order.

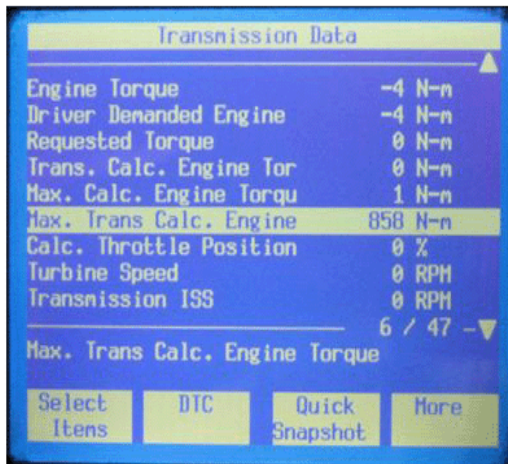
Transmission Data Screen (Max. Transmission Calc. Engine Torque Parameter)

A transmission control module (TCM) algorithm has been implemented that records a maximum calculated input torque. This information is available via the Tech 2®.

6. Take a clear digital picture in the .jpg file format of the Tech 2® screen showing the Transmission Data and the Max. Transmission Calc. Engine Torque parameter.
7. Retain the Tech 2® Transmission Data screen photograph with the repair order.
