## WC38 - Retrofitting Belt Guide (Workshop Campaign)

Vehicle Type: **911 Carrera Cabriolet (991)/911 Carrera S Cabriolet (991)**

Model Year: **2012**

Concerns: **Belt deflector for front three-point belt**

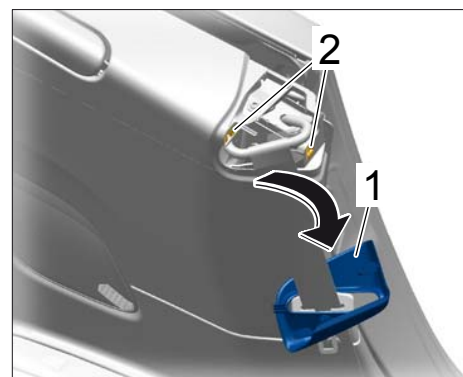
*Figure 1*

Information: This is to inform you of a voluntary Workshop Campaign on the above-mentioned vehicles. There is the possibility that the area behind the cover for the belt opening is visible on the affected vehicles due to increased component tolerances.

- 1 Open rear side windows.
- 2 Retrofit belt guide on the **left** side of the vehicle.
  - 2.1 Unclip belt deflector cover  $\Rightarrow$  *Figure 1 -1-* by pulling it forward out of the clips  $\Rightarrow$  *Figure 1 -2-* ( $\Rightarrow$  *Figure 1 -arrow-*) and leave it hanging on the three-point seat belt.
