## New Jersey Transit: Radio Compartment Rework

**Property and Top Bus Number:** New Jersey Transit 416.15, 164200, 164400, 279000, 279500, 289000

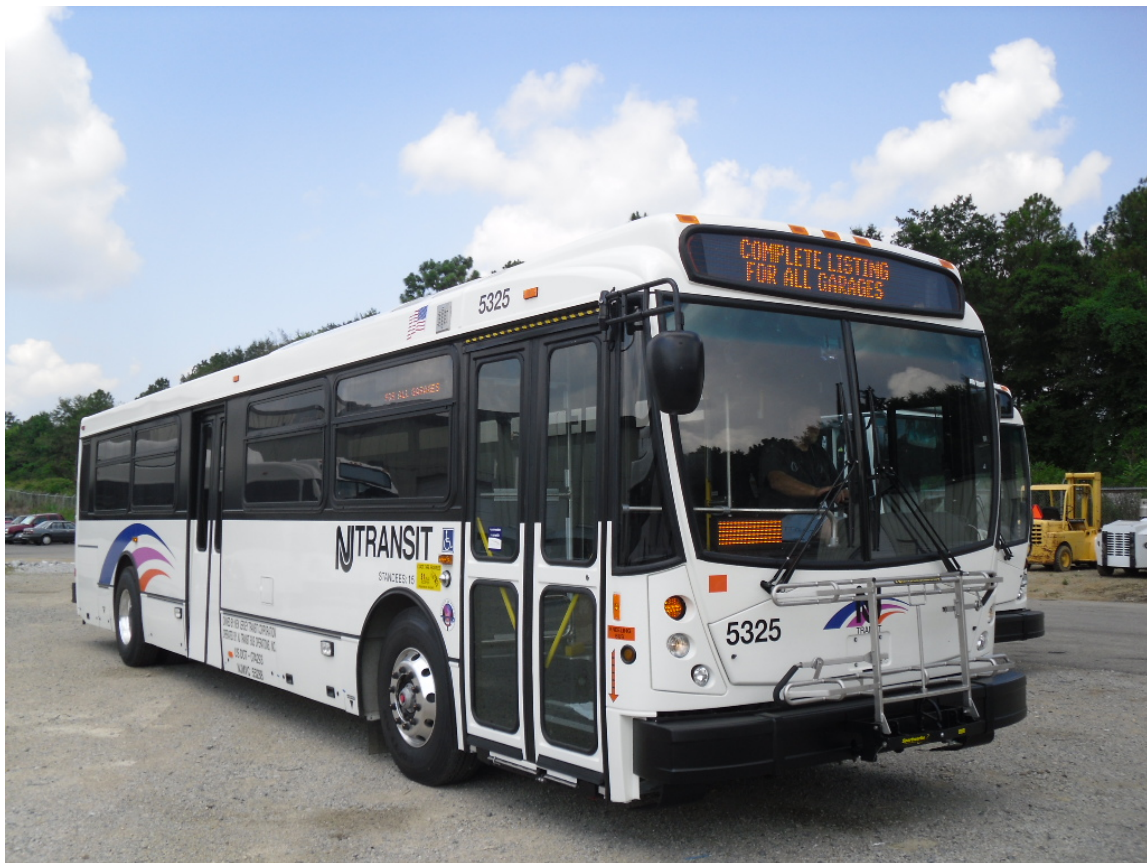
**Issue:** Radio compartment floor is flexing.

**Reason/ cause:** The weight of the radio is transmitted through four small diameter nylon spacers.

**Solution:** Discard spacers and modify the slide mounts per this work instruction (SOI).
