## INSTRUCTION TO SERVICE

<b>ITS: 5173</b>	
<b>SECTION:</b>	219 Engine and Transmission
<b>WRITTEN BY:</b>	Shaun Cardinal
<b>SUBJECT:</b>	UCAP Cabinet Cover (Legacy)

# ITS5173

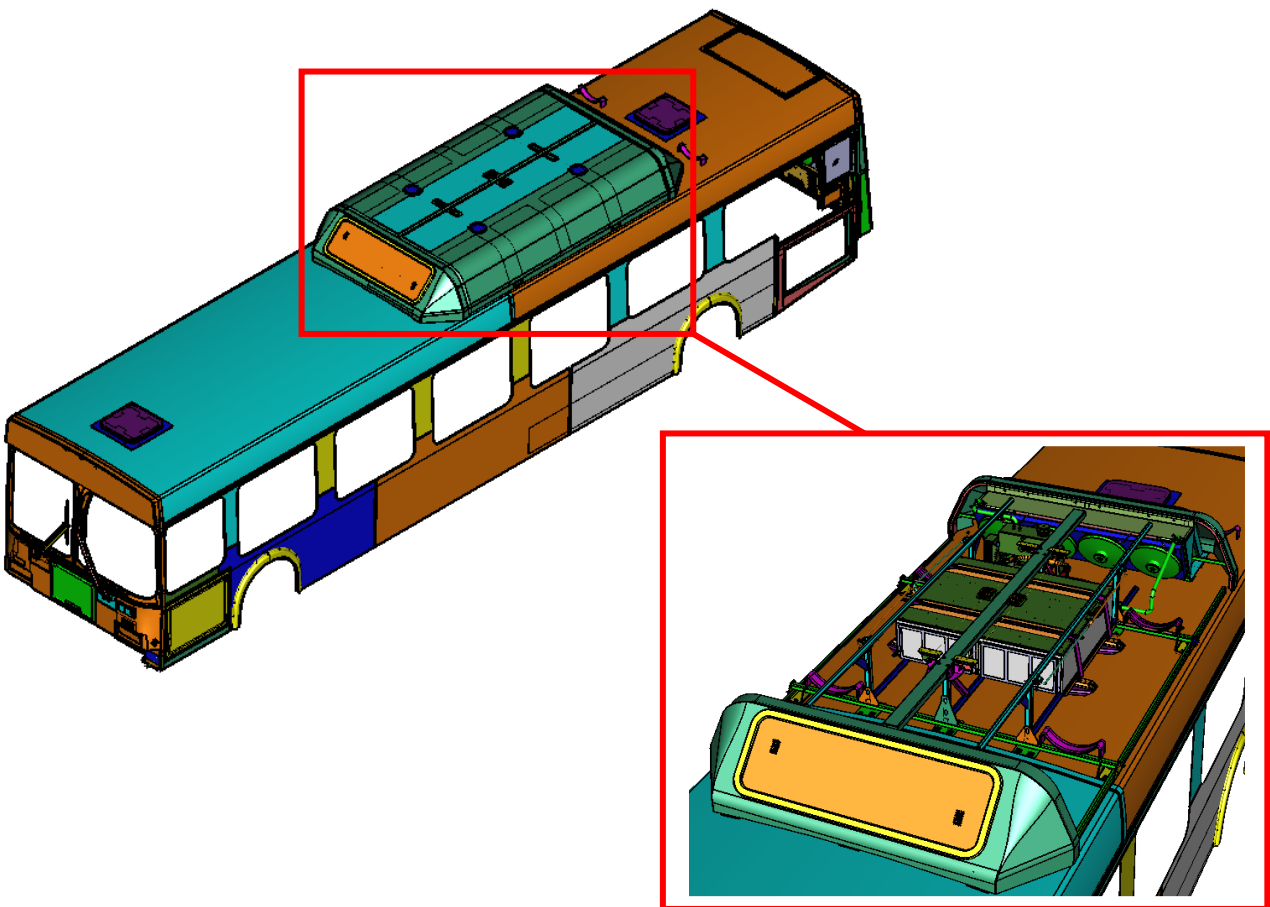
*Fig 1 – Legacy UCAP Location (doors removed for clarity)*

- a. Open the clam shell doors on top of the bus to access the UCAP assembly. See Fig 1

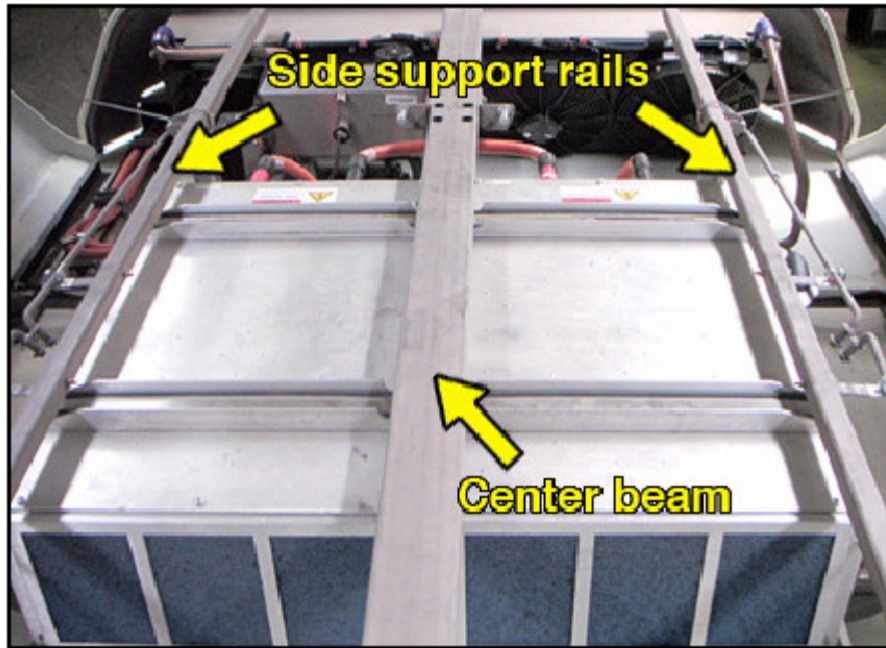
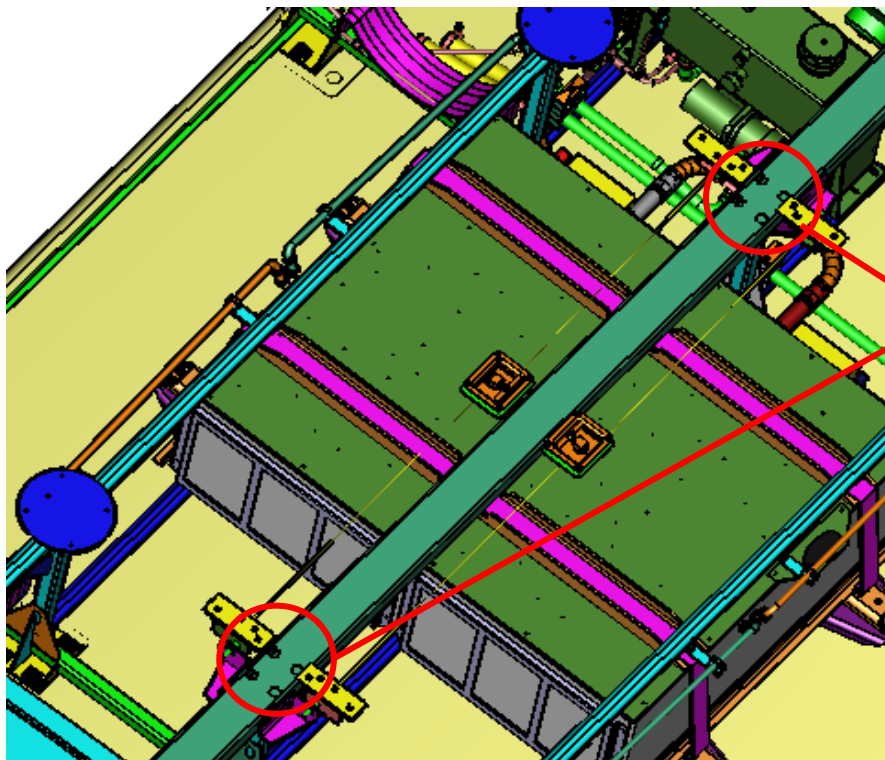
**Fig 2 – Legacy UCAP Beams**

- b. Remove the four front and rear hardware securing the center beam to the roof top frame. Trim foam strips on beam to access the hardware if required (Fig 2)

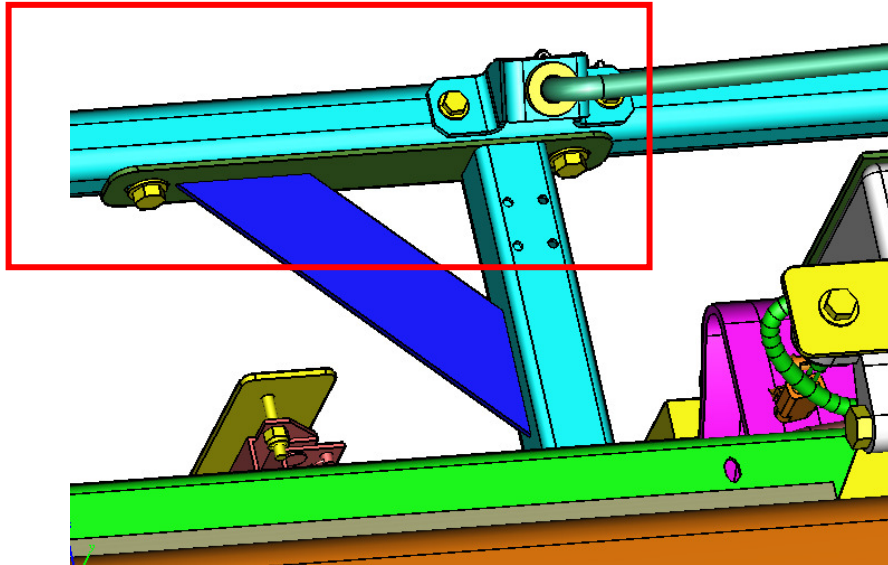
**Fig 2 – Legacy UCAP Side Beams**

- c. Remove the hardware securing side support rails (front and rear per side) see Fig 3. Before removal of curb side rail, remove coolant line clamps.

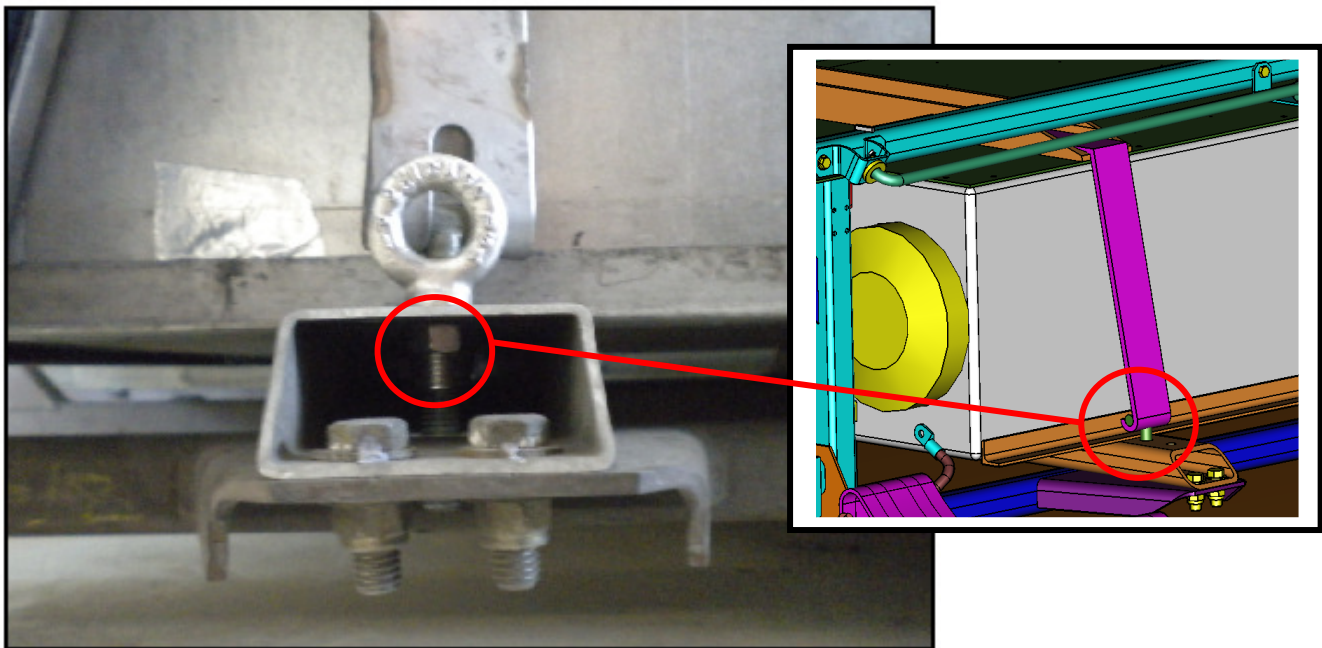
**Fig 3 – Legacy UCAP Strapping**

- d. Remove the nut holding the strap to the base (one side only) of the bus. Remove strap from base and move out of the way to gain access to the UCAP lid. See Fig 3

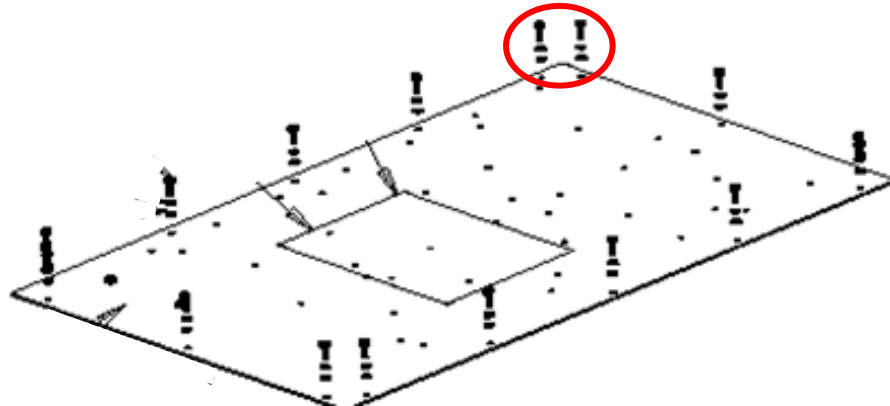
**Fig 4 – UCAP Lid Hardware**

- e. Remove all existing perimeter hardware (16x screws, washers, and lock washers per UCAP) securing the UCAP lid to UCAP box (Fig 4).

**⚠ NOTE:** Do not remove lid as it will break the weather tight seal.

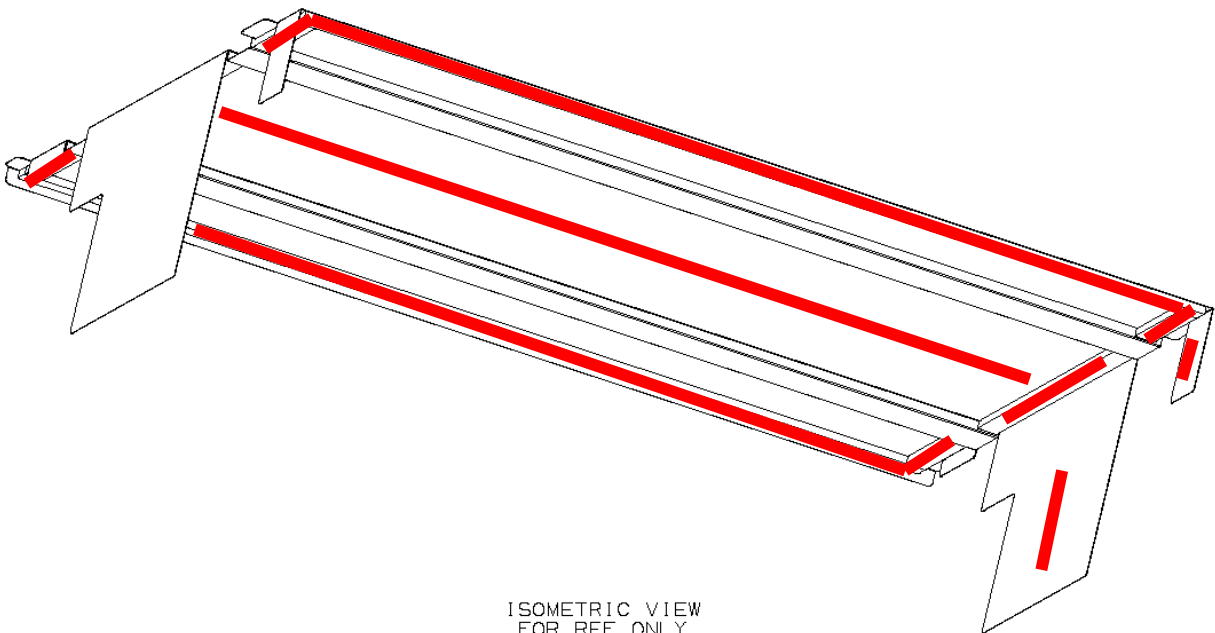
**Fig 5 –Rubatex Seal (Both Sides)**

- f. Replace hardware with new low profile hardware (**NFI PN 6409430**). Do not re-use the washers and lock washers.
- g. Install new cover assembly (**NFI PN 490384** and **NFI PN 5957793**) to the UCAP assemblies per Fig 5 and 6. Reverse steps b-d for securing UCAP.

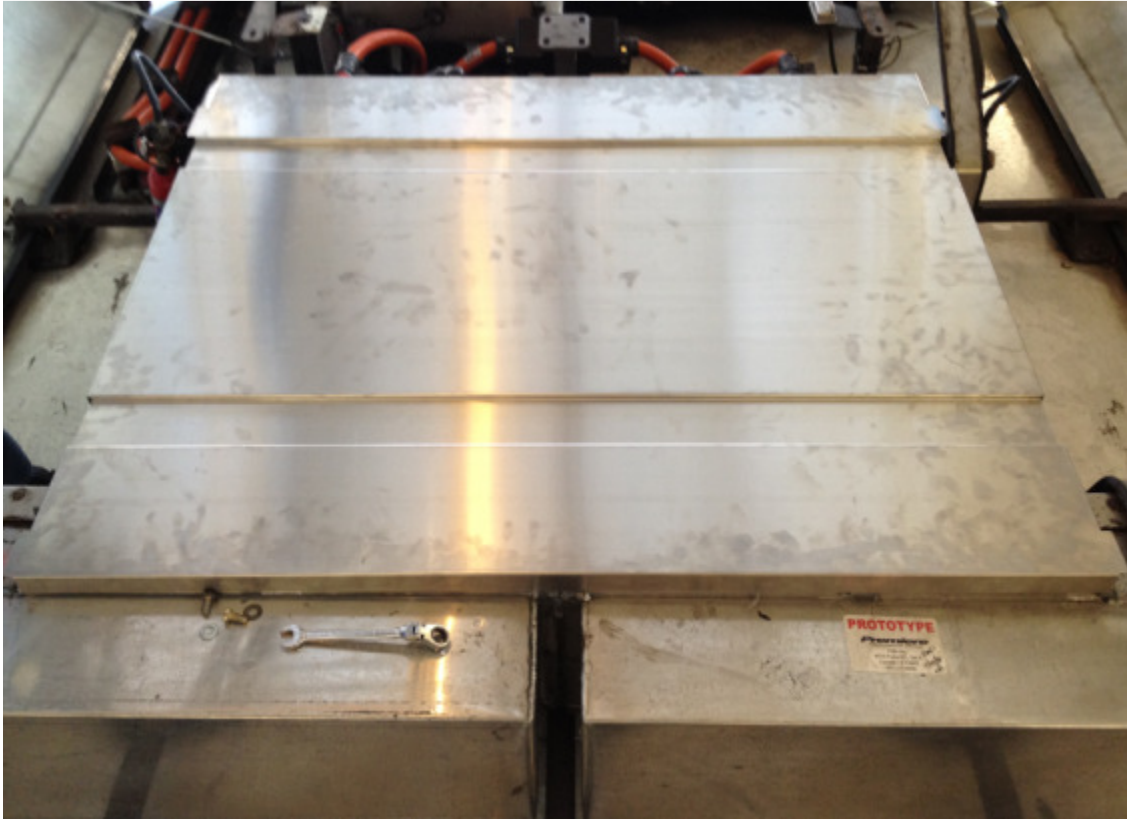
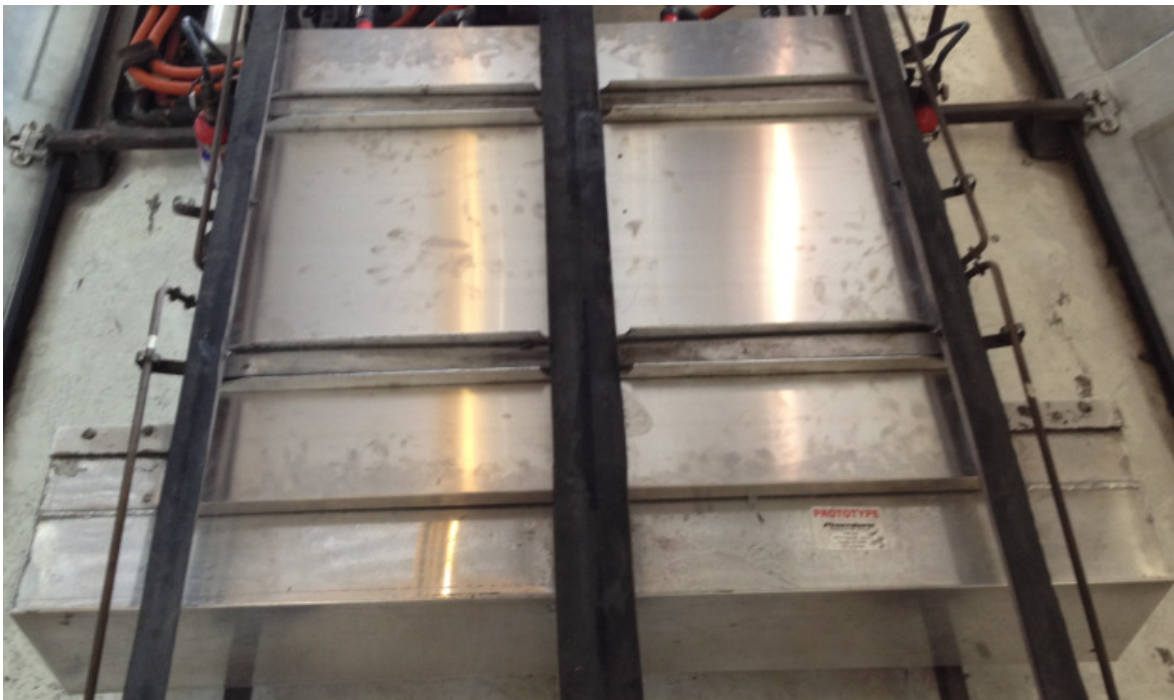
**Fig 6 – Installed Cover**
