INSTRUCTION TO SERVICE

ITS: 5184	
SECTION:	219 Engine and Transmission
WRITTEN BY:	Mike Pearson
SUBJECT:	Reroute the DEF pressure hose assembly

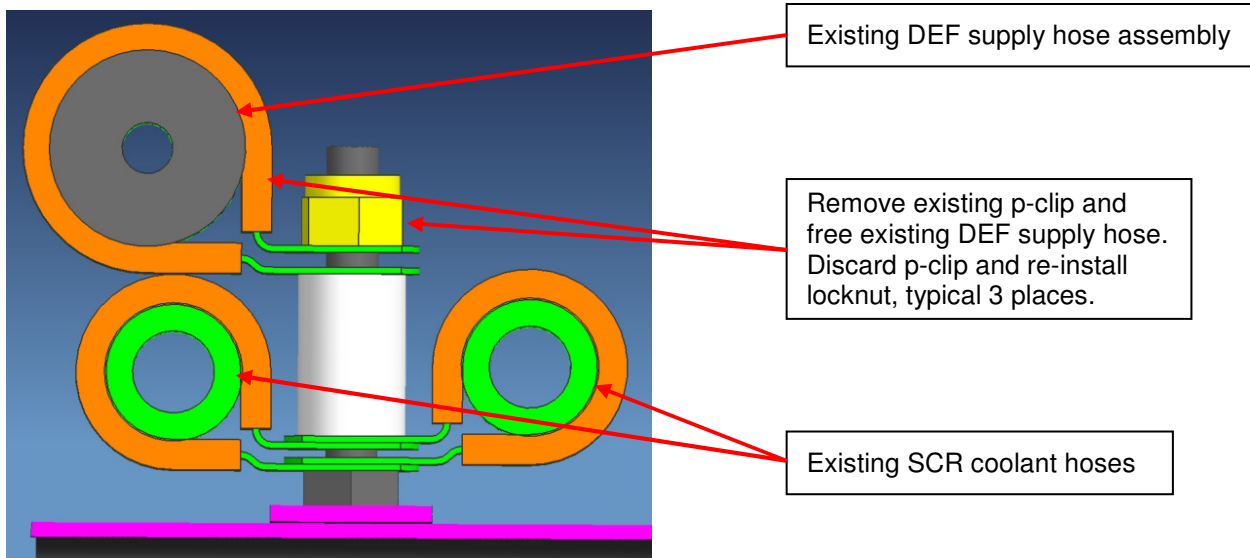
Figure 1: Existing DEF & Coolant Hose Configuration

1. Turn the main battery disconnect switch to the “OFF” position.
2. If hot, allow sufficient time for the SCR and surrounding area to cool.
3. Locate and remove the SCR grille frame assembly and set aside for reuse later in this install.
4. Remove the locknuts that hold the DEF supply and coolant hose p-clips to the compartment floor, typical 3 places. See Figure 1.

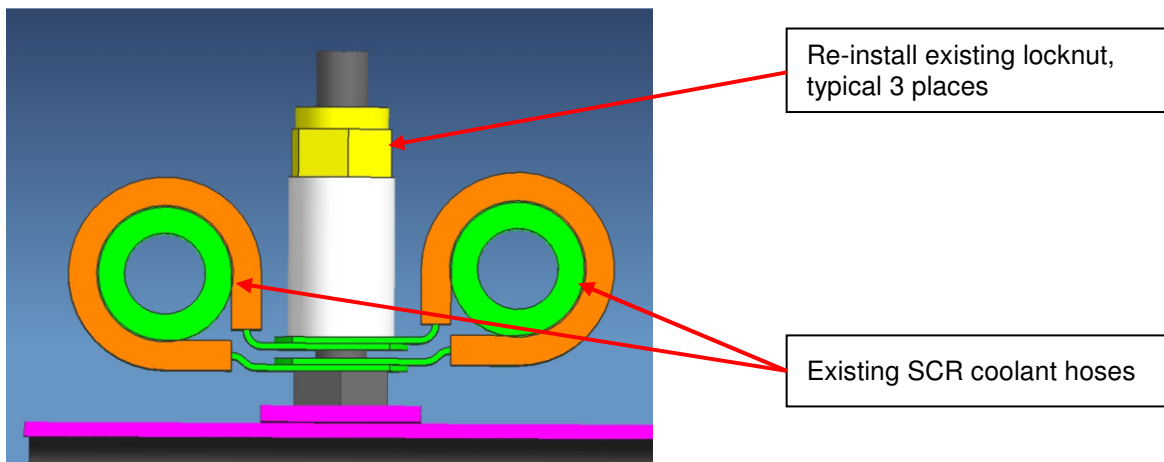
Figure 2: Re-worked Coolant Hose Configuration

5. Remove and discard the p-clips that are securing the DEF supply hose assembly only to the bottom of the SCR compartment and re-install the locknuts removed in previous step, typical in 3 places. See Figure 2.

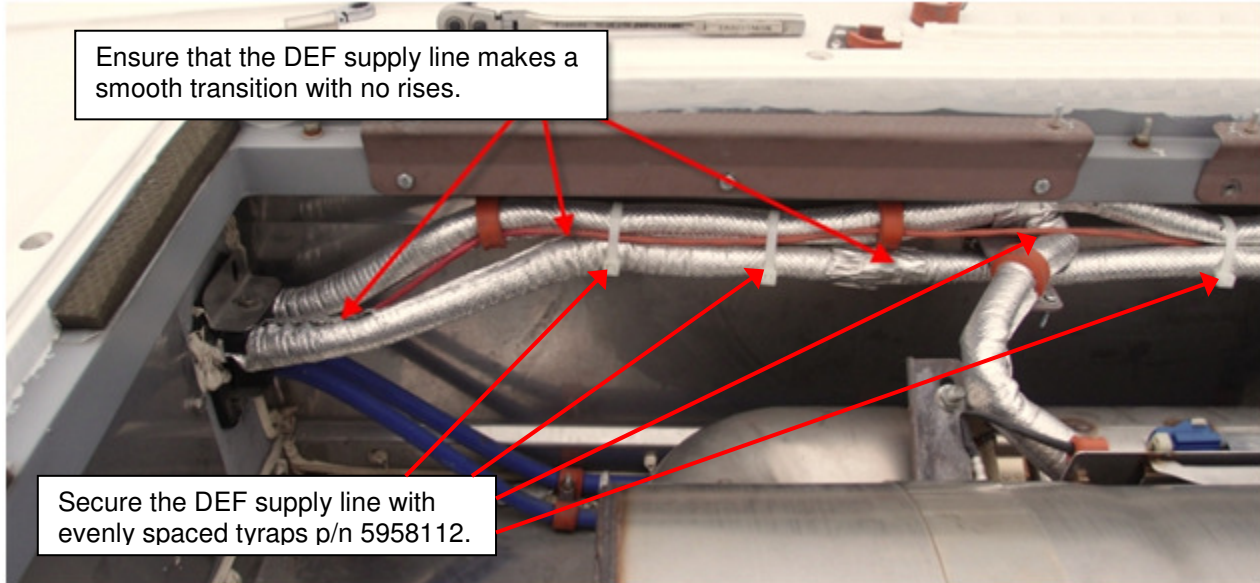
Figure 3: DEF Supply Hose Routing

6. Examine the DEF supply hose assembly insulated wrap for any tears or gaps and repair as needed.
7. Secure the existing DEF supply hose assembly to the existing SCR harness bundle using evenly spaced tyrap p/n 5958112. Ensure the DEF supply hose makes a smooth transition with no rises. See Figure 3 & 4.

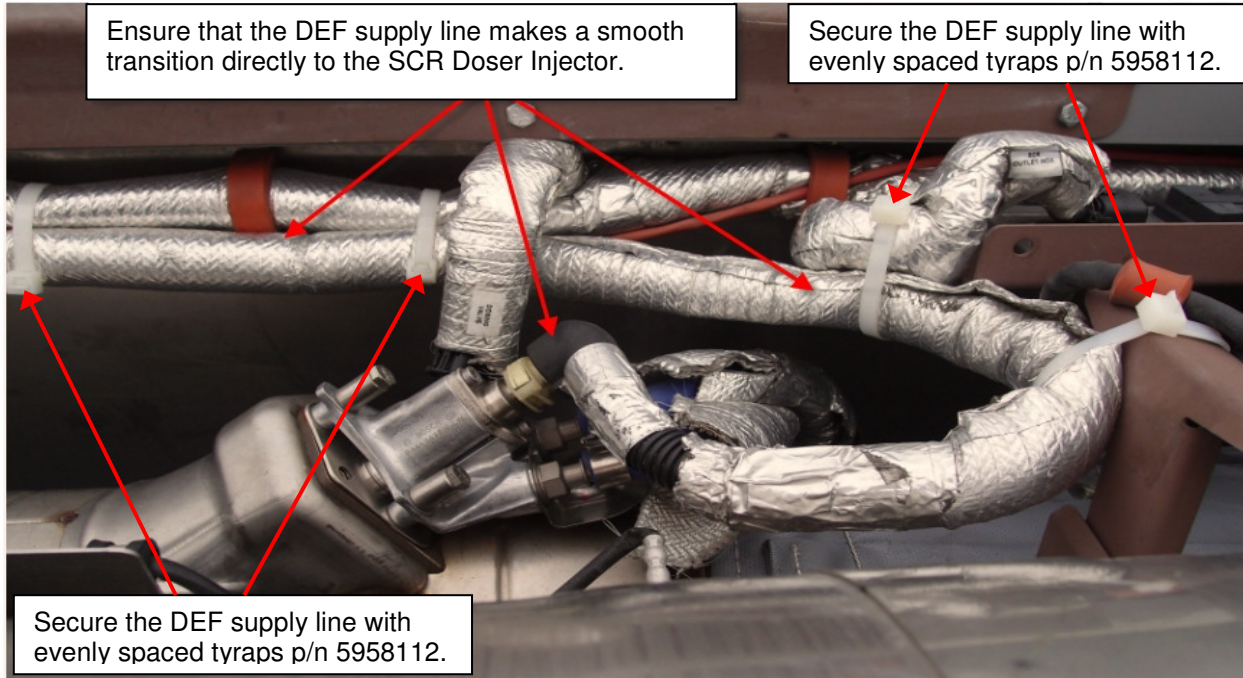
Figure 4: DEF Supply Hose Routing
