Service Bulletin

PRELIMINARY INFORMATION

Subject: Engine Overheat or Cooling Fans Inoperative

Models: 2013 Cadillac ATS

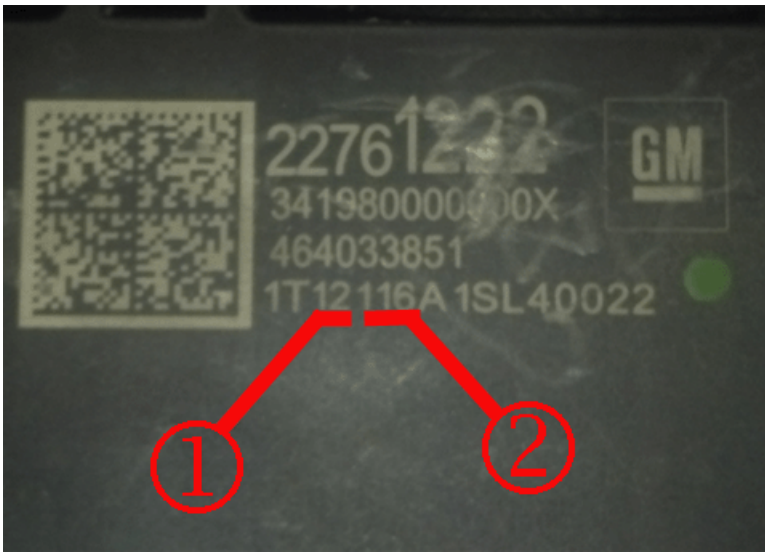
First verify if the Cooling Fan Control Module has a suspect date code (Refer to picture below).

Any date code less than 12207 (23JUL12) is suspect.

If the Cooling Fan Control Module is suspect then use the service scan tool and procedure below to perform a system check on the Cooling Fan Control Module.

Command the Engine cooling fan through states 1-5 with the engine running at idle for approximately 20-30 minutes in order to get the under-hood temperature hot (The front grille may be blocked to reduce test time).

If the electric cooling fan stops working then replace the Cooling Fan Control Module:
