Service Bulletin

Bulletin No.: PIP4885F

Subject: NQG 4WD Models With Noise, Vibration On Dry Pavement

Models: 2007-2013 Chevrolet Silverado

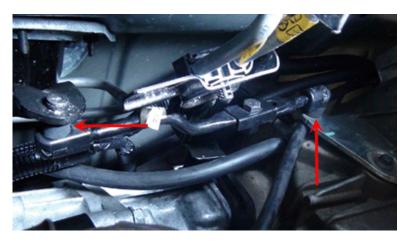
The typical noise and vibration that is heard or felt is due to a combination of the transfer case chain link frequency, engine firing frequency, tire circumference variation, and various other tolerances' in the 4 wheel drive system. The noise may seem to be increased, compared to vehicles with NQF/NQH/NP0 transfer cases due to the noise transfer path of the shift lever sticking up through the floor. The noise may also be more noticeable in vehicles equipped with vinyl flooring due to the vinyl flooring not having as much mass and noise dampening effect as carpet.

The first thing that should be done is to compare with a like vehicle. Ensure that interior content is the same i.e.: both vehicles have carpet or vinyl flooring, same model and both do or do not have plow provisions RPO VYU. Further diagnostics would include shifting the transfer case to 4WD high and then disconnecting the shift linkage from the shift lever, at one of the points shown below, and reevaluating the vehicle operation. If the noise is greatly reduced or eliminated then the shift lever is the transfer path for the noise and is an operating characteristic. No repairs are recommended for this condition.

Note: Warranty analysis on nearly every bearing that has been replaced due to customer noise complaints on NQG T-cases have been identified as no trouble found. If the noise heard while in 4wd inside the cab is eliminated by linkage removal then do not disassemble the T-case. Engineering is in the process of validating a revised shift rod to eliminate this noise and should be released 2013 time frame. Replacement of part number light duty: 15007687, heavy duty: 25910465 will not change this noise. This pi will be updated when parts become available.
