Service Bulletin

Subject: Paint Chipped Under Luggage Rack Roof Rails

Models: 2010 - 2011 CTS Sport Wagon
Built Prior To September 12, 2011

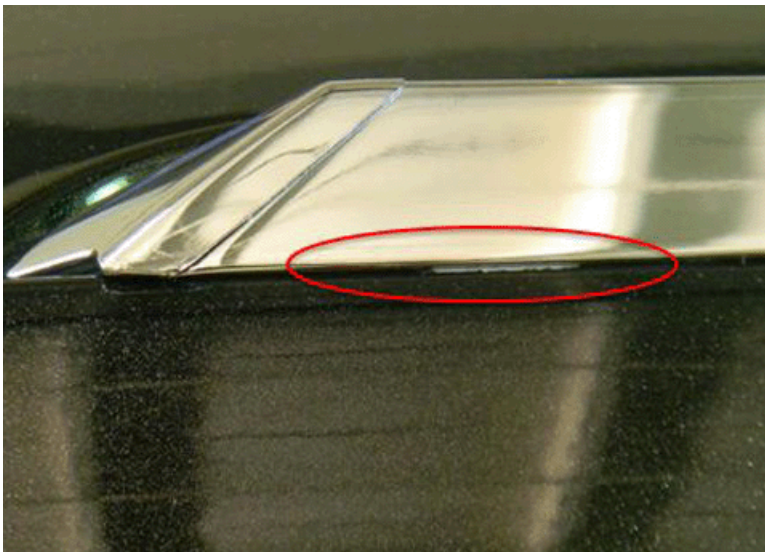
Customer may comment that paint on roof may appear chipped under the vehicle's Luggage Rack Roof Rails. This concern is due to the rail's seals allowing the Luggage Rack Roof Rails to contact the vehicle's roof.

Reference the attached photo for area of concern:

Replace both Luggage Rack Roof Rail Assemblies using current listed part numbers. Replacement assemblies have improved seals to prevent this concern. Repair paint on vehicle's roof as necessary.
