Service Bulletin

PRELIMINARY INFORMATION

Subject: Slip In Forward Ranges Immediately After Replacing The Input Housing - 621 - Check Input Housing - 621 - For Improperly Drilled Feed Holes

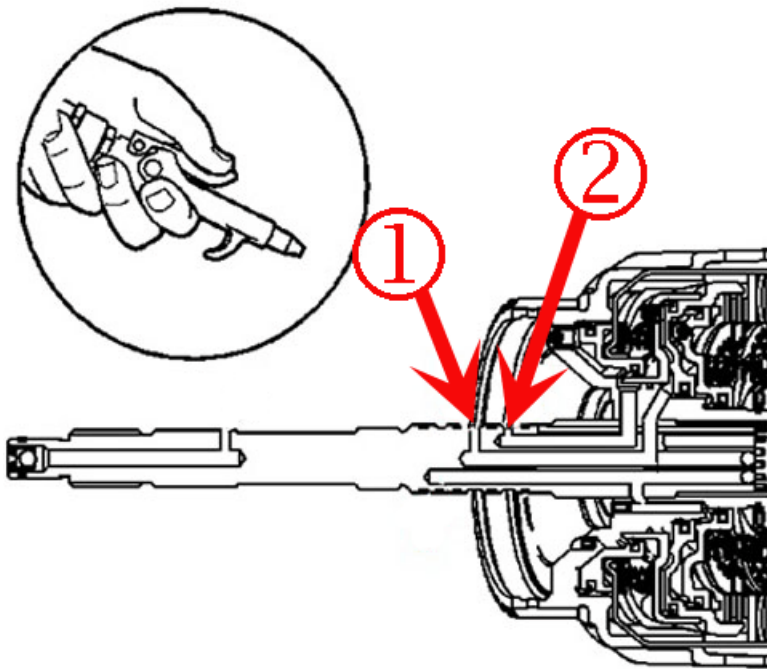
Air leaking from 3-4 apply hole may be noted when applying air pressure to the forward clutch apply hole during an air check with the Input Housing (621) fully assembled with seals and clutches.

Inspect the 3-4 clutch and the forward clutch oil feed passages for leakage between circuits. Apply regulated compressed air to the 3-4 clutch feed hole and the forward clutch feed hole one at a time with the Input Housing (621) completely assembled. See picture below.

Call out 1: Forward clutch feed hole.

Call out 2: 3-4 clutch feed hole.

Air should not leak out of the 3-4 clutch feed hole when applying air to the forward clutch feed hole and air should not leak out of the forward clutch feed hole when applying air to the 3-4 clutch feed hole. If air leakage is noted between the two feed holes the Input Housing (621) should be replaced with one from GM Service Parts. (Order new housing part number 19125752.)

Do not replace an Input Housing (621) assembly solely because of a small air leak between the shaft and housing.
