Service Bulletin

PRELIMINARY INFORMATION

Subject: Replace The Internal Transmission Wiring Harness and TCC Enable Solenoid Anytime The Transmission Is In For Service - Malfunction Indicator Lamp (MIL) With DTC P0741 Set and Harsh 1-2 Shift Vehicles Manufactured After 10/01/11

Models: 2012 Chevrolet Colorado, Express, Silverado
2012 GMC Canyon, Savana, Sierra
All Equipped with Automatic Transmission 4L60E (RPO M30). Built after 10/01/11

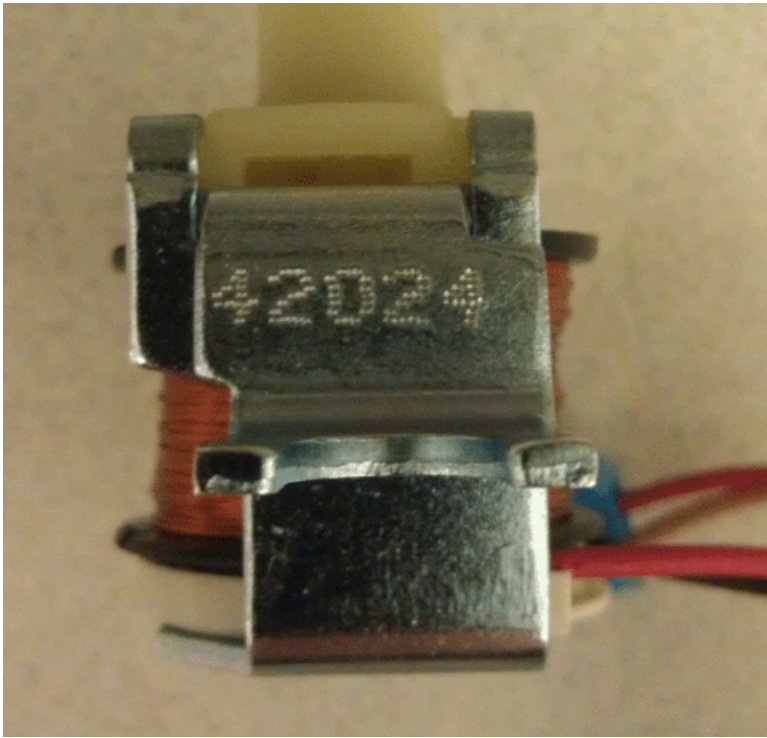
Note: To prevent multiple TCC Enable Solenoid and Wire Harness replacements check the five digit date code on the TCC Enable Solenoid body to see if it has been replaced.

The first digit (month of build) should be a 4 or higher or an alpha character. The second and third digits are the day of the month. The fourth digit should be a 2 or 3 (calendar year 2012, 2013).

The fifth digit (line of build) should be a numeric character typically a 3 or 4 Example: 42024 shown in the picture below was produced April 20, 2012 on line 4.

Any solenoid produced on or after April 17, 2012, date code of 4172# or greater, does not need to be replaced.

Important: Replace the TCC Enable Solenoid and Wire Harness part number 24237980 anytime repairs are being performed on the transmission on vehicles manufactured after 10/01/11.
