# Service Bulletin

**Subject:** MIL due to DTC P0128 and/or P0171 and No Engine Performance Concerns

**Models:** 2010-2011 Buick Lacrosse, Regal  
2010-2011 Chevrolet Equinox  
2010-2011 GMC Terrain  
with 2.4L Engine (RPO LAF)

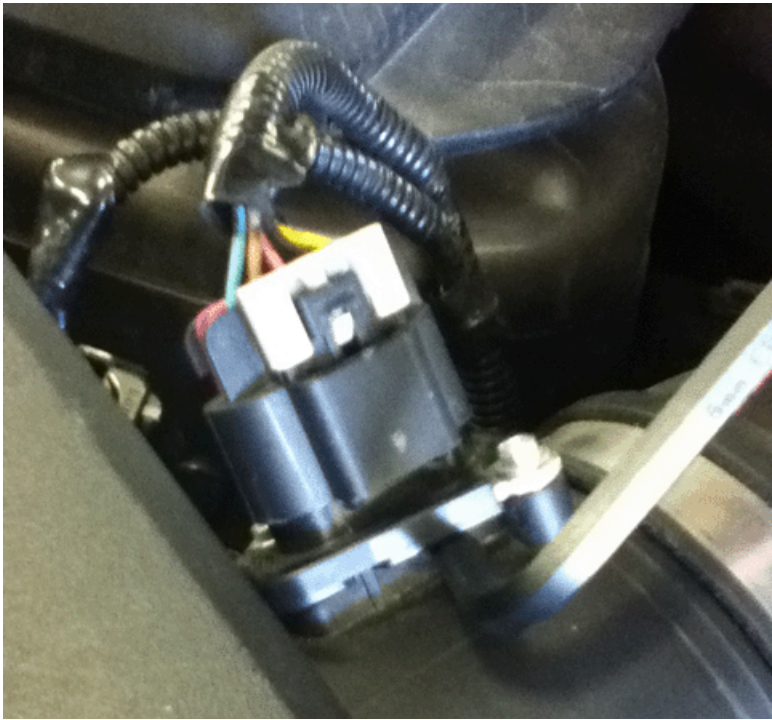
**Correct Air Cleaner Lid with a 6 mm Allen Wrench Installed for Reference**

8. For Equinox and Terrain Models Only, also inspect the air cleaner lid to ensure that it is correct by confirming the height of the MAF sensor as shown below. If the correct air cleaner lid is installed, you should be able to place a 6 mm allen wrench/bit between the MAF sensor and air cleaner housing as shown below to feel a slight drag or if you use a 7/32" allen wrench/bit you will feel a small amount of play/clearance. If the incorrect air cleaner lid is installed, it will be obvious when the allen wrench/bit is installed because there will be about an additional 1/8" of clearance present. If an incorrect air cleaner lid is found, replace the air cleaner assembly using the correct part number listed in the parts catalog, re-evaluate the concern, and submit a

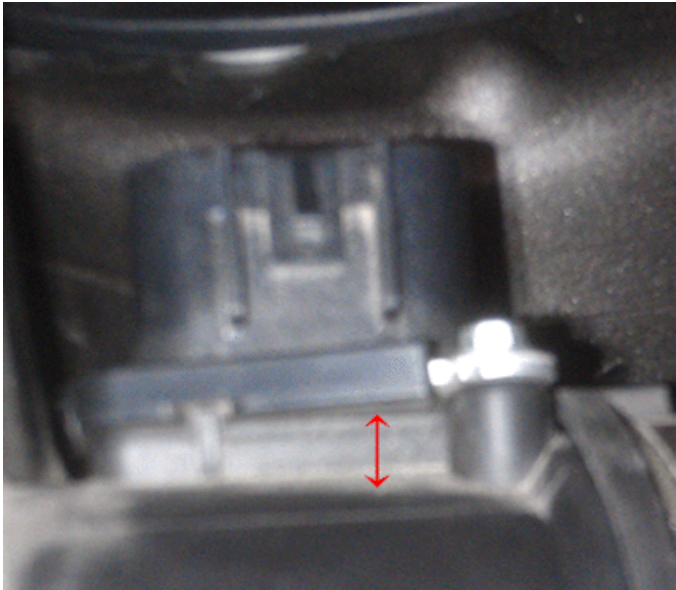
**Correct Air Cleaner Lid**

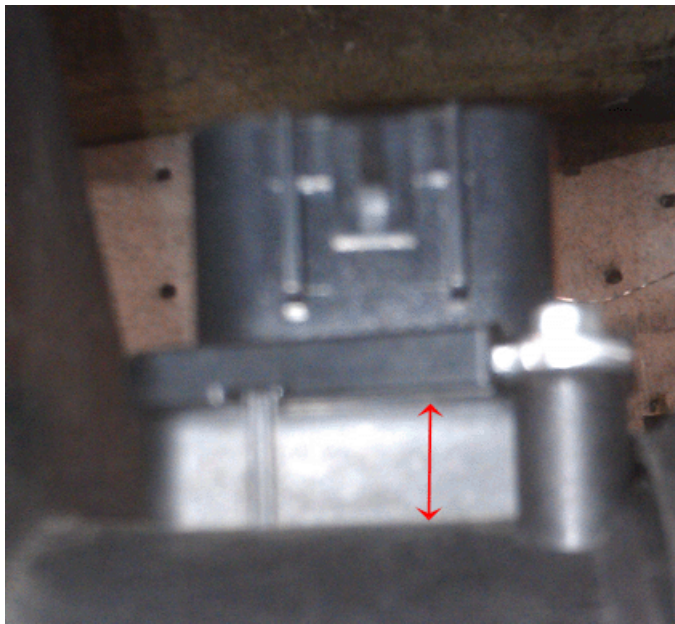
**Incorrect Air Cleaner Lid**

product report with photos by following the latest version of 07-00-89-036.
