Bulletin No.: PIC5321A

Service Bulletin

Subject: Various Electrical Problems

Models: 2010 - 2011 Cadillac DTS

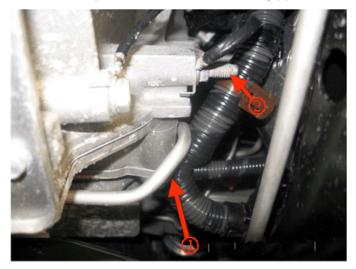
There may be an engine harness rubbing through on the lower front part of the transmission. The concern may not be limited to these conditions alone since this is a main wiring harness.

If harness is pinched (1), reroute harness, inspect for damaged wiring and repair as necessary.

Install harness clip on transmission stud as necessary (2).
