Service Bulletin

PRELIMINARY INFORMATION

Subject: Intermittent Dead Battery or Intermittent Shift to Park Message Displayed on DIC

Models: 2013 Cadillac SRX

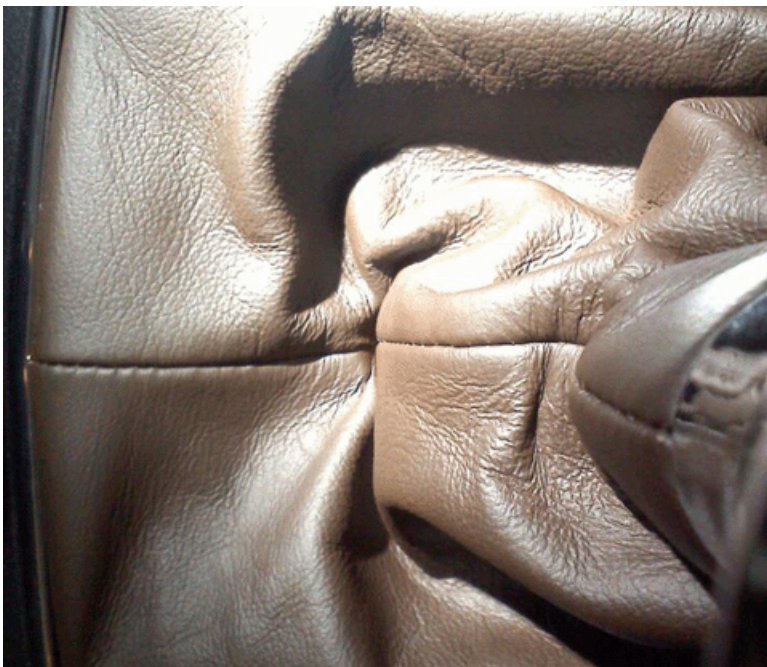
Customers may report that the battery went dead or they saw a "shift to Park" message in the instrument cluster's DIC. The shifter boot may become pinched between the shifter housing and the shifter's chrome lever. If this should happen, the transmission will be mechanically in Park and will not move, however the micro switch that sends the signal to the cluster may send the signal which will leave the ignition in the Run state.

Inspect the shifter boot for signs of being pinched. See the picture above, which shows the pinched shifter boot condition. If you find a pinched shifter boot, please request the following new shifter boot through the warranty parts center. Attached below is a form to use to order the shifter boot from the WPC. There are four different color shifter boots; see the chart below for the proper WPC part number for the color shifter boot that is needed.
