# Service Bulletin

**Subject:** Compass Inaccurate (Inspect For A Magnetic Base Roof Mounted Accessory)

**Models:** 2009-2013 Chevrolet Silverado

2009-2013 GMC Sierra

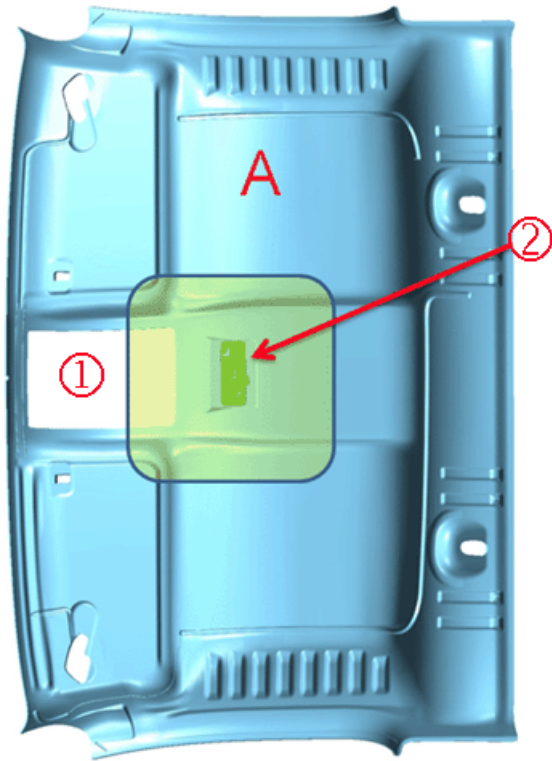
#### A. Regular Cab

1. Front overhead console
2. Compass module

Shown below is the headliner of each model and where the compass module is located. The areas shaded in yellow, around the compass module, should be avoided when placing a magnetic base roof mounted accessory on the roof. The yellow shaded area is only an estimate, and depending on the size and strength of the magnetic base, it may need to be farther away from the compass module location.

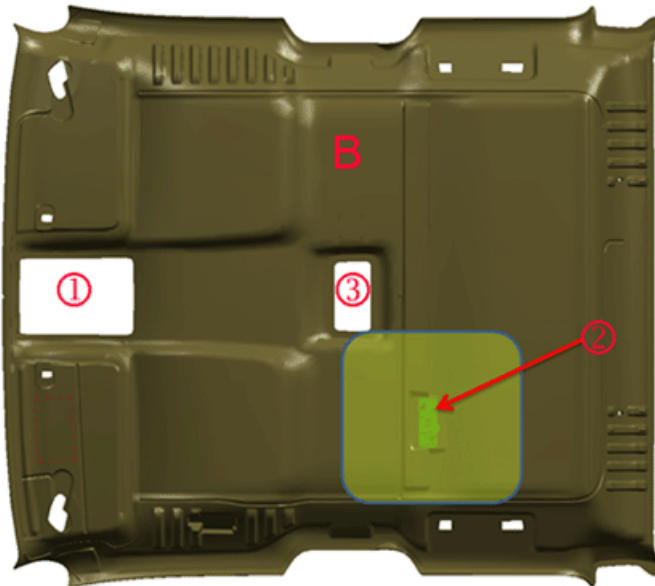
#### B. Extended Cab

1. Front overhead console
2. Compass module
3. 2nd Row Dome light

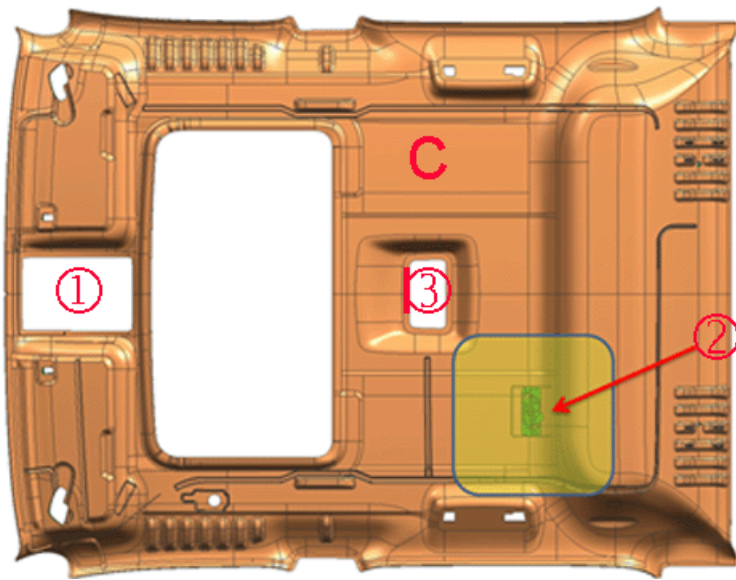
#### C. Crew Cab

1. Front overhead console
2. Compass module
3. 2nd Row Dome light
