Service Bulletin

PRELIMINARY INFORMATION

Subject: Navigation Radio Will Not Display Map Data, Message Display is On

Models: 2011 Cadillac Escalade Models
Equipped with Navigation Radio (RPO GMQ)

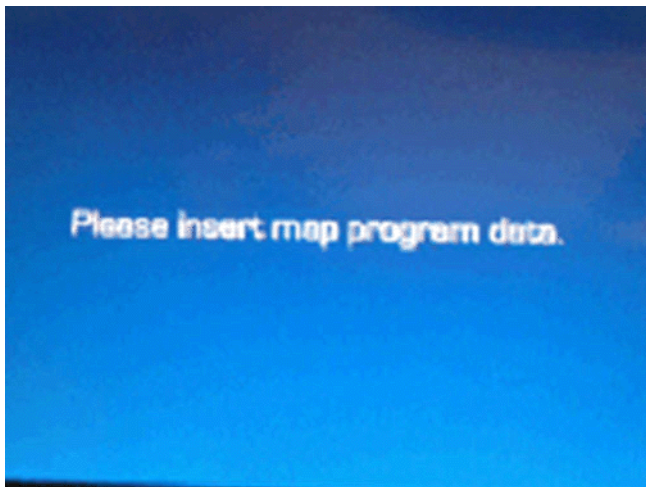
- Most commonly, the system continuously shows the "Updating in Progress" screen.

The cause of this condition may be anomalies in the software.

Do This	Don't Do This
Install the 2012 MY, (version 2012), or Newer Nav Service Compact Flash Card and load software into the radio.	DO NOT replace the radio.

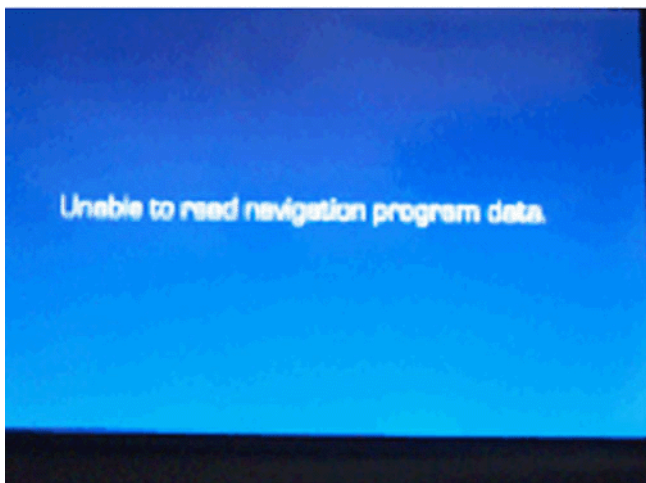
- Another screen that may also be seen is the "Please insert map program data" screen.
