Service Bulletin

Subject: Pulsation or Vibration Felt in Steering Wheel During Moderate Brake Apply at Highway Speeds

Models: 2013 Cadillac XTS Limo (RPO V4U, W30) Hearse (RPO B9Q) Armored Car (RPO B05) Models

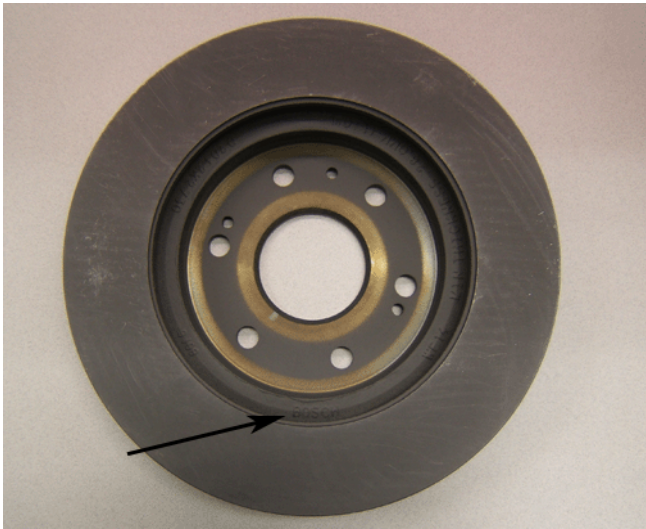
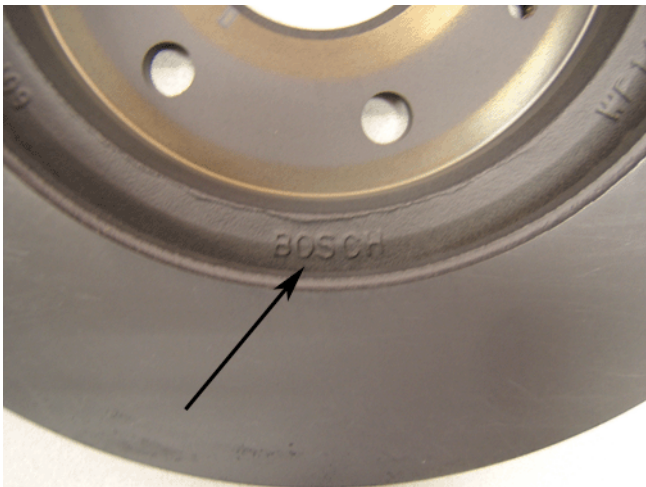
- It is critical to use the proper OEM brake rotors. Use of Non-OEM rotors may prevent the condition from being corrected long term.
 - If Non-OEM rotors are identified, these rotors are **NOT** covered under the GM New Vehicle Limited Warranty.
1. Inspect the front brake rotors to ensure that they are OEM rotors.
 - Remove the brake rotor from the vehicle.

- Inspect the back side of the rotor for the Bosch Logo. If the Bosch logo **IS NOT** present, replace with OEM GM rotors, P/N♦25819670.
- 2. Inspect the front brake rotors for Assembled Lateral Runout (LRO) and thickness variation. Follow SI procedures.
- 3. Inspect the front brake rotors for minimum thickness. Follow SI procedures.
- 4. If the rotors are within specifications, **DO NOT** refinish or replace the rotors.
- 5. If the rotors are out of specifications, refinish the rotors on a qualified lathe, or replace the rotors as appropriate. Follow SI procedures.
