# Service Bulletin

**Subject:** Diagnosis and Repair - Malfunction Indicator Lamp (MIL) Illuminated, Reduced Engine Power Message Displayed, DTC P2135 Set

**Models:** 2009-2011 Buick Lucerne  
2006-2008 Chevrolet Malibu  
2006-2011 Chevrolet Impala  
2006-2009 Pontiac G6  
Equipped with Engine RPO LGD, LZ4, LZ8 or LZE

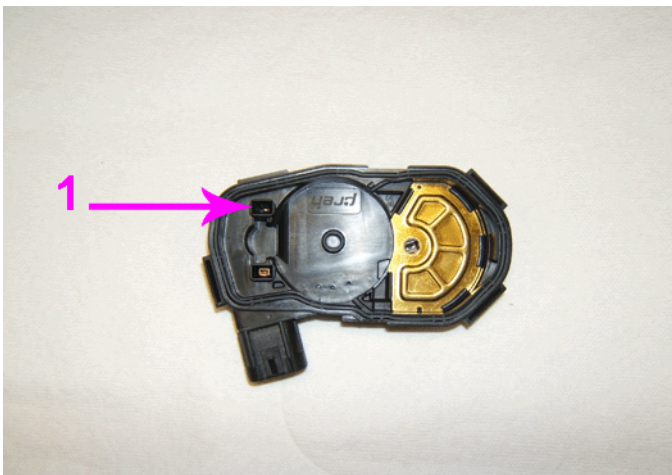
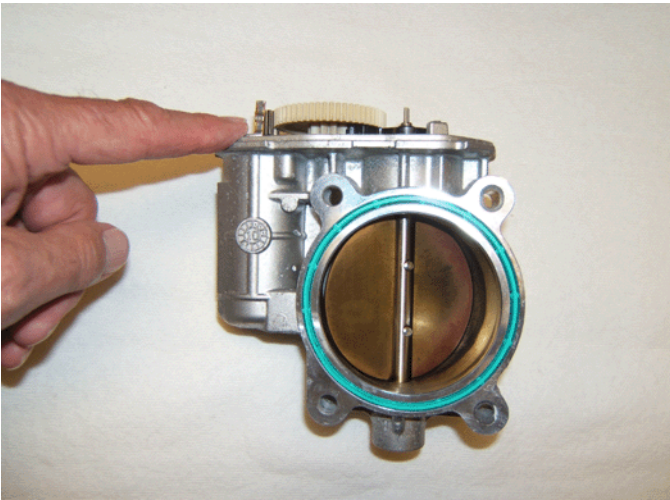
12. Inspect the TP sensor cover and verify that the TP sensor cover gasket **has remained** in the TP sensor cover as shown. Ensure that the gasket is accounted for and remains with the old TP sensor cover.

13. Observe the TP sensor cover for missing female throttle actuator motor terminals (1). Verify that the female throttle actuator motor terminals **have remained** in the TP sensor cover and **have not** been retained on the throttle actuator motor male terminals as shown. Discard the old TP sensor cover, gasket and terminals.
  - ⇒ If one or both of the TP sensor cover female throttle actuator motor terminals have been retained on the throttle actuator motor male terminals, remove and discard those female terminals.
14. Remove the new TP sensor cover from the protective shipping wrapper.
