Service Bulletin

PRELIMINARY INFORMATION

Subject: Accessory Soft Tonneau Cover Loose

Models: 2004-2012 Chevrolet Colorado
2007-2013 Chevrolet Silverado
2004-2012 GMC Canyon
2007-2013 GMC Sierra

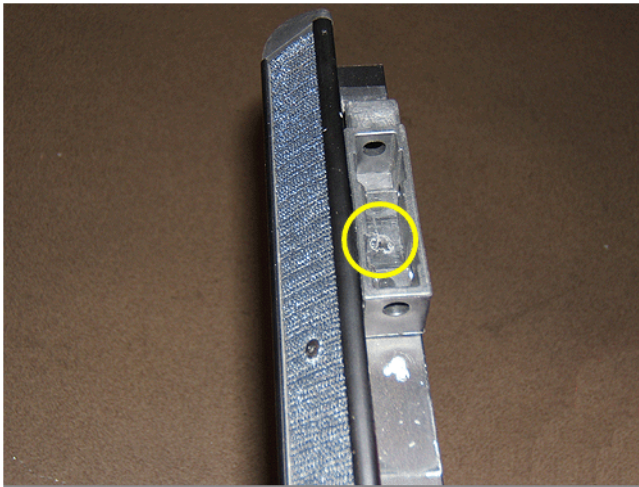
A rivet (location shown circled in the graphic above) that retains the pivot blocks to the side rail assembly may have loosened or detached.

Do This	Don't Do This
Install new pivot block rivets to side rail assembly.	DO NOT replace the tonneau cover or side rails.

Important: When a pivot block rivet is found to be loose on either end of a tonneau side rail, always replace the rivets on BOTH of that rail's pivot blocks. Verify the condition and install a new rivet to each pivot block on the affected side rail(s). Follow the steps below, starting with the front pivot block location.
