#### Service **Technical Information** 29/12 ENU WC23

### WC23 - Replacing Vacuum Pump (Workshop Campaign)

Vehicle Type: Panamera/Panamera 4

Concerns: Vacuum pump

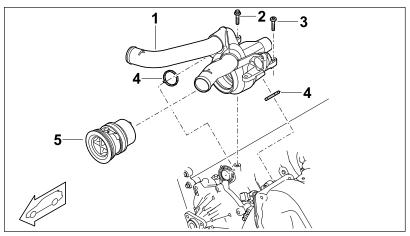
Figure 3

- 4.1 Remove coolant regulator housing ⇒ Workshop Manual '195519 Removing and installing coolant regulator housing'
- 4.2 Carefully **clean** components and lines soiled with engine oil.
- 4.3 **Both seals**  $\Rightarrow$  *Figure 3-4-* on the coolant regulator housing  $\Rightarrow$  *Figure 3-1-* must be replaced.

- 4.4 Install coolant regulator housing ⇒ Workshop Manual '195519 Removing and installing coolant regulator housing'.
- Install new vacuum pump  $\Rightarrow$  Workshop Manual '477619 Removing and installing vacuum pump'.
- 6 Check engine-oil level and correct it if necessary ⇒ Workshop Manual '170101 Checking engine-oil level'.
- 7 Enter the workshop campaign in the Warranty and Maintenance booklet.
