Service Bulletin

Subject: Engine Oil Consumption on Aluminum Block/Iron Block Engines with Active Fuel Management (AFM) (Install AFM Oil Deflector and Clean Carbon from Cylinder and/or Install Updated Valve Cover)

Models: 2007-2011 Cadillac Escalade Models
2007-2011 Chevrolet Avalanche, Silverado 1500, Suburban, Tahoe
2010-2011 Chevrolet Camaro
2007-2011 GMC Sierra 1500, Sierra Denali, Yukon Models
2008-2009 Pontiac G8 GT
Built Prior to February 1, 2011 (Updated Valve Cover) and October 2010 (AFM Shield)
Equipped with Any of the Following Engines:
– Aluminum Block V8 Engine with Active Fuel Management (AFM) (RPOs L94, LZ1, L99, LC9, LH6, L76, LFA, L92)
– Iron Block V8 Engine with Active Fuel Management (AFM) (RPOs LMG, LY5)
– Hybrid Engine (RPO LFA – Only Applies to Hybrid Models Built July 7, 2009 - February 1, 2011 – Prior Builds Not Cast For AFM Valve)

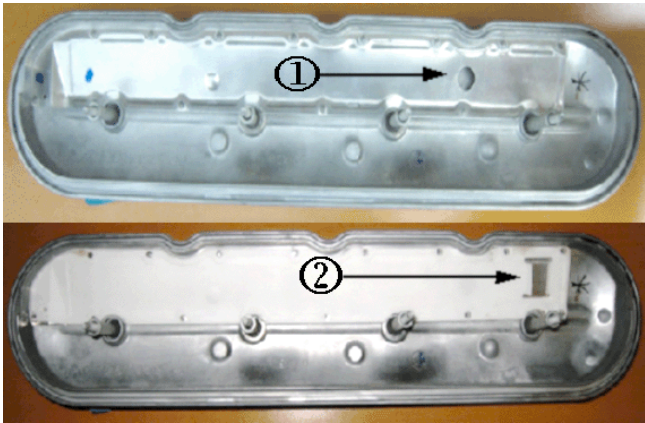
1) Old Design

2) New Design

PCV pullover or an overactive lifter can cause oil to be pulled through the PCV system even at low vehicle mileage. A correctly functioning PCV system will only leave a film of oil in the intake manifold. Inspect the intake manifold to see if there is any oil puddling in the bottom. If there is you will need to replace the left valve cover. Two new left rocker arm covers have been released for trucks and vans. Technicians should replace the left rocker arm cover with GM P/N 12570427 for 2007-2008 or GM P/N 12642655 for 2009-2011. Refer to the Parts Information below for the Camaro. This rocker arm cover has a relocated PCV drain hole that prevents oil from entering the intake manifold. Refer to Valve Rocker Arm Cover Replacement - Left Side in SI.

Note: These rocker covers are for specific years. The PCV orifice is different for each. The correct cover must be used or an SES light may set.
