# Service Bulletin

**Subject:** Information On Identifying Duramax™ Diesel Overpower Engine Breakdown or Non-Function Due to Aftermarket Power-Up Devices vs. Non Overpower Engine Non-Function of Pistons, Cylinders, Valvetrain Components, DTC P003A or P111D Set

**Models:** 2001–2013 Chevrolet Silverado  
2003–2009 Chevrolet Kodiak  
2006–2013 Chevrolet Express  
2001–2013 GMC Sierra  
2003–2009 GMC TopKick  
2006–2013 GMC Savana  
Equipped With Duramax™ Turbocharged Diesel Engine RPO LB7, LBZ, LLY, LML, LMM, or LGH

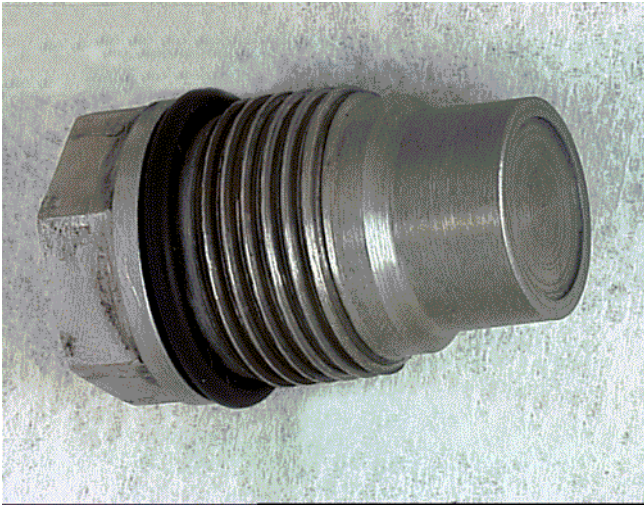
Aftermarket companies have developed a performance pressure relief fuel valve for Duramax™ diesel engines. Refer to above graphic illustration. The performance pressure relief fuel valve attaches to the fuel rail in place of the OEM valve and will not allow any fuel return to the tank, giving 100% of the fuel to be available for additional engine performance. This may cause additional fuel related driveability concerns and may set the following DTCs:

- DTC P1093 Fuel Rail Pressure (FRP) Low During Power Enrichment
- DTC P0087 Fuel Rail Pressure (FRP) Too Low

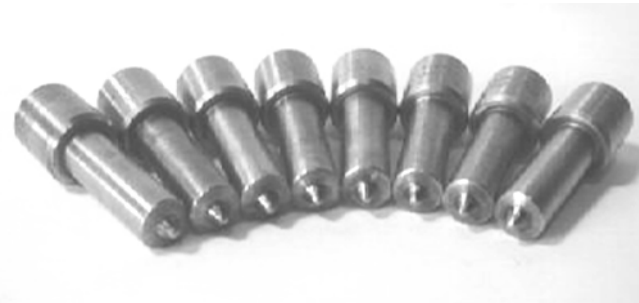
Aftermarket companies have developed a replacement performance/economy fuel injector nozzle. Refer to above illustration. The performance/economy fuel injector nozzles replace the OEM fuel injector nozzles. The aftermarket companies claim increased horsepower, improved fuel atomization, lower exhaust gas temperatures and increase fuel economy. This may cause additional fuel related driveability concerns and may cause internal engine damage to the pistons and fuel injector nozzles.

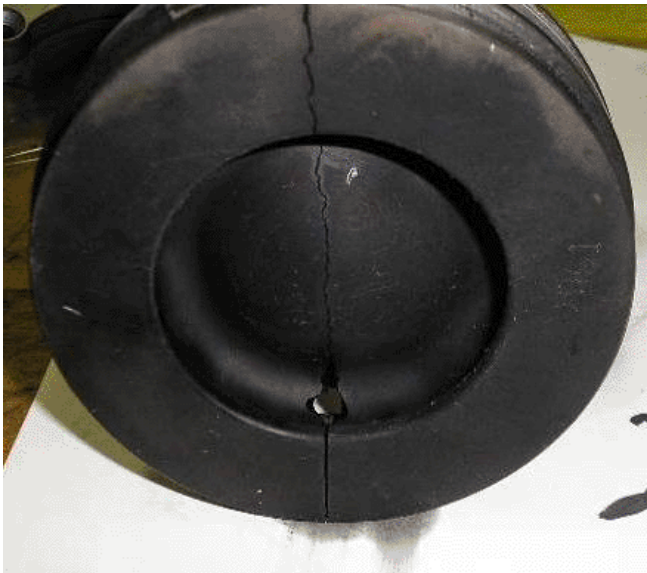
- Pistons will be cracked in the lip area, or a hole in the pistons.

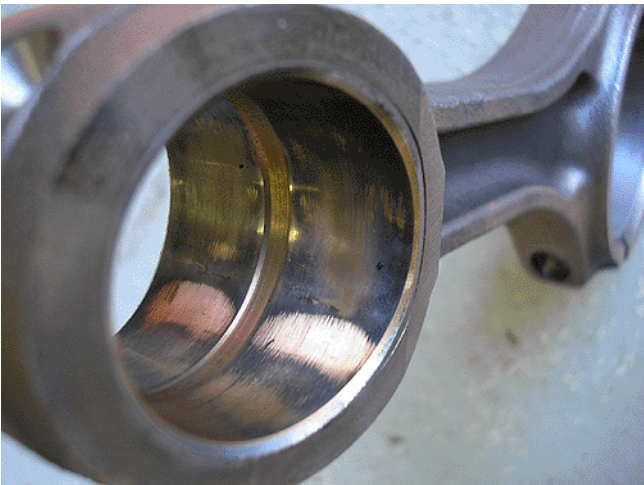
- Piston pin bore will show signs of scoring, the wrist pins will be discolored, and can have oil coking on them. The connecting rod bushing surface will have accelerated wear. The above illustration shows a connecting rod bushing.

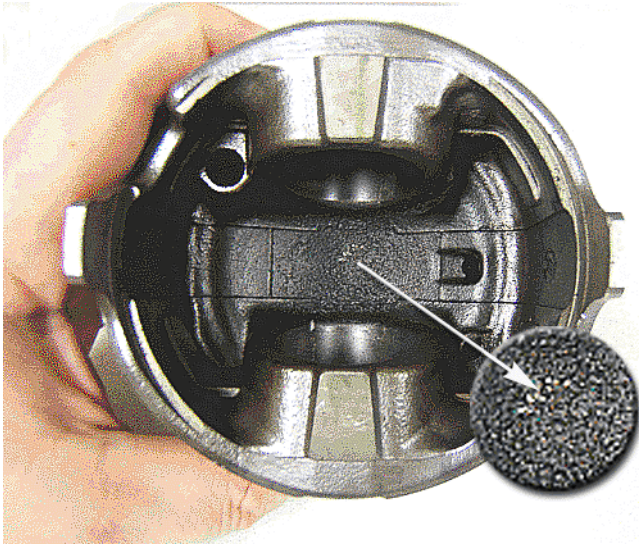
- Oil coking on the underside of the piston between the wrist pin bosses.

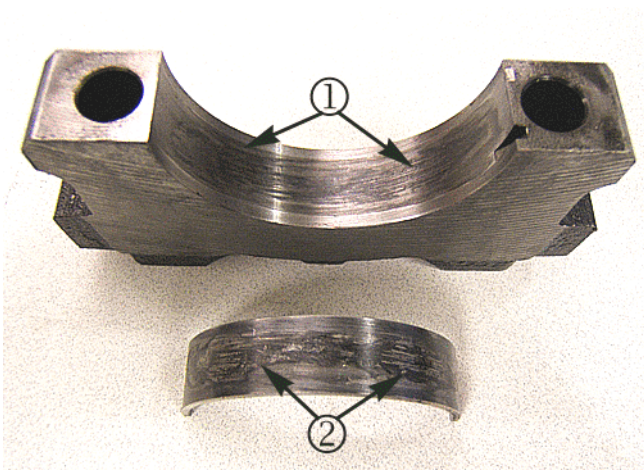
- Signs of bearing fretting will also be noticed on the connecting rod and main bearing caps. Refer to the above illustration for fretting of main bearing cap 1 and back side of connection rod bearing 2.

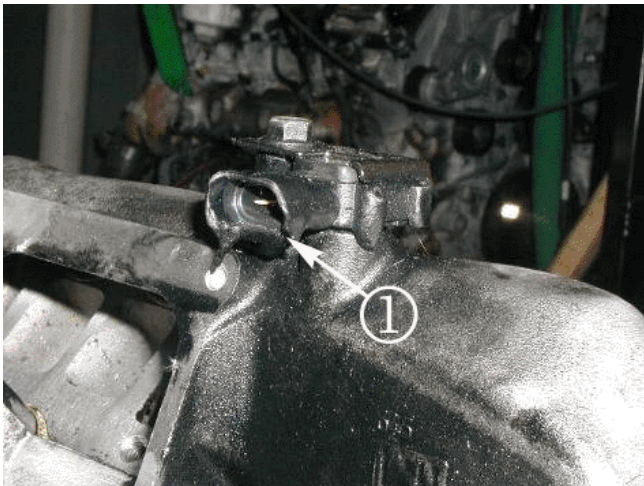
- Excessive heat in engine compartment caused by overpower device. Refer to above illustration (1).

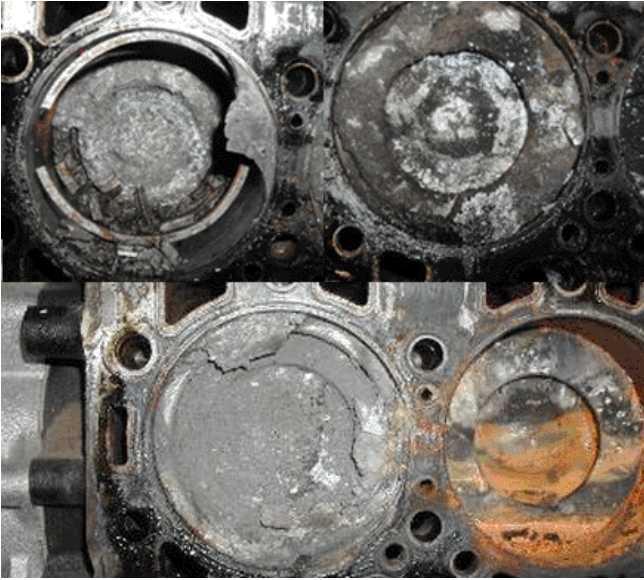
Overheat can be caused by a loss of coolant or a general cooling system failure. Some of the indicators of overheat are:

- Melted pistons.
- Head gasket breakdown or non-function.
- Warped cylinder heads.
- Crankshaft and connecting rod discolored.

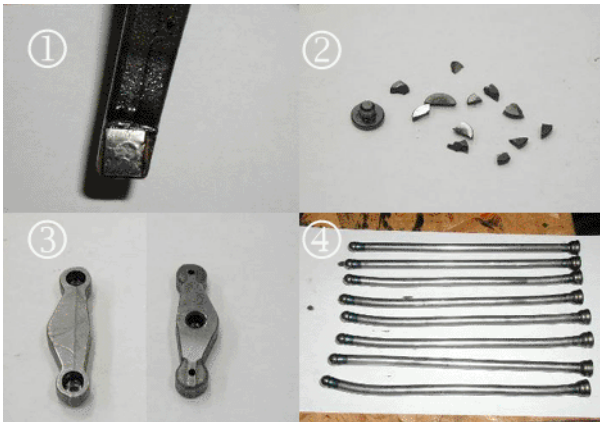
- Valve train damage.
- Pushrods that are bent (4).
- Broken valve bridge buttons after cylinder head removal (2).
  - Rocker arm tip damage (1).
  - Dry or rusted cylinders from the use of ether, propane or nitrous oxide.

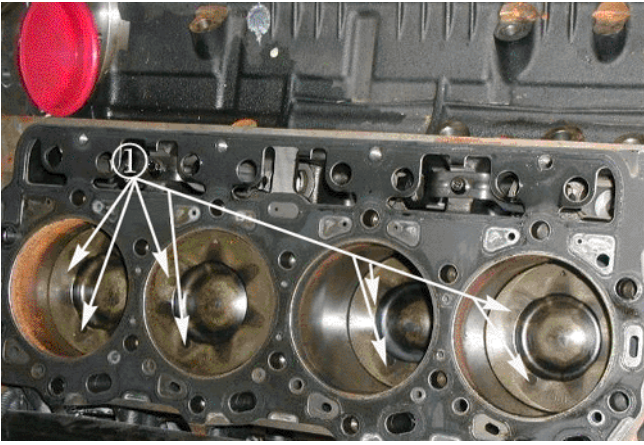
- Piston to valve contact.
- Cam gear pin shear.

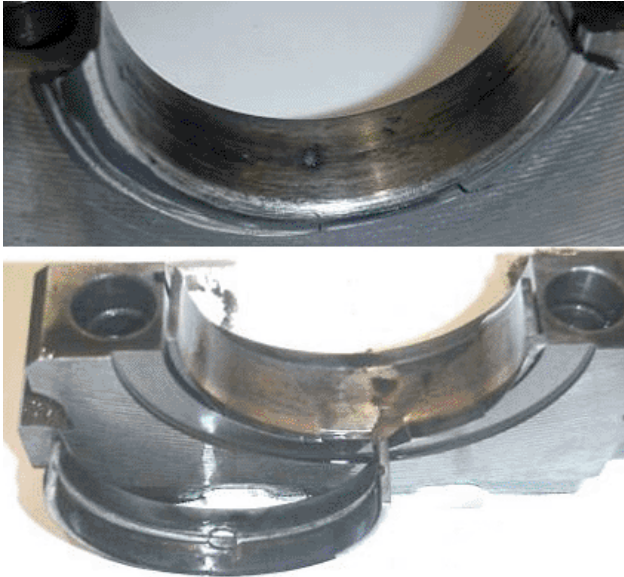
Lack of lubrication causes rapid bearing wear or bearing to seize.

Bearing failure. Spun main bearings.

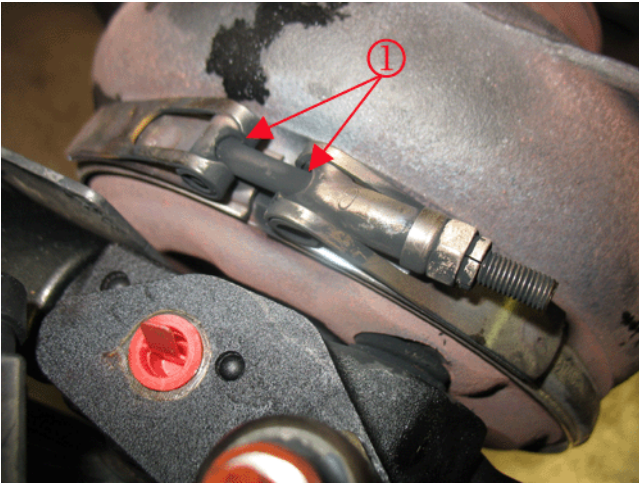
General Motors has identified a turbocharger (TC) failure mode involving Power-Up Kits that causes soot leakage and DTC P003A to be set. The Power-Up Kits create an over temperature condition from the increased exhaust gas temperatures that results in a permanent and excessive turbine housing distortion at the TC case halves.

1. A technician may observe one or more of the following conditions:
  - DTC P003A being set as Current or in History.
  - An unusual odor emanating from the TC due to an overtemperature condition.
  - Soot leaking and accumulating at the V-band clamp that secures the TC case halves together.
  - Limited or unresponsive travel when Commanding the TC Vane Pos. Ctrl. Solenoid ON and OFF with a scan tool.

2. If DTC P003A is found as Current or in History, **OR** there is evidence of soot leakage (1) in the area of the V-band clamp (1), then technicians **MUST** verify if the engine control module (ECM) has a Power-Up Kit aftermarket calibration installed or an aftermarket hardware device has been installed.  
**Refer to the latest version of Corporate Bulletin Number #08-06-04-006 for the calibration verification information and procedures.**
