# Service Bulletin

**Subject:** Information for Identifying Non-GM ECM Calibration Use and Power-Up Hardware Detection in Duramax™ Diesel Engines — Photograph Tech 2® Calibration IDs, Calibration Verification Numbers (CVNs) and Transmission Data Screen

**Models:** 2006-2013 Chevrolet Express, Kodiak, Silverado  
2006-2013 GMC Savana, Sierra, TopKick  
Equipped With Duramax™ Turbocharged Diesel Engine RPO LB7, LBZ, LLY, LML, LMM, or LGH

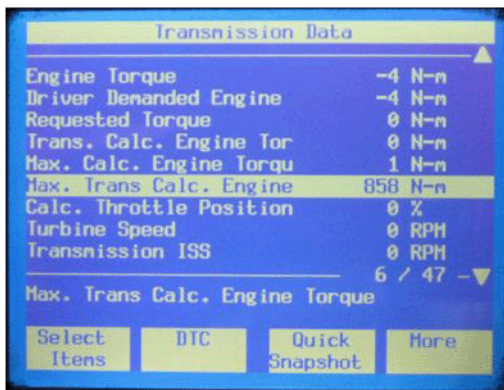
### Transmission Data Screen (Max. Transmission Calc. Engine Torque Parameter)

A transmission control module (TCM) algorithm has been implemented that records a maximum calculated input torque. This information is available via the Tech 2®.

6. Take a clear digital picture in the .jpg file format of the Tech 2® screen showing the Transmission Data and the Max. Transmission Calc. Engine Torque parameter.
7. Retain the Tech 2® Transmission Data screen photograph with the repair order.
